# Inspection Report

1889 Cyrene Dr.  
Carson CA 90746

**Kleen Inspections**

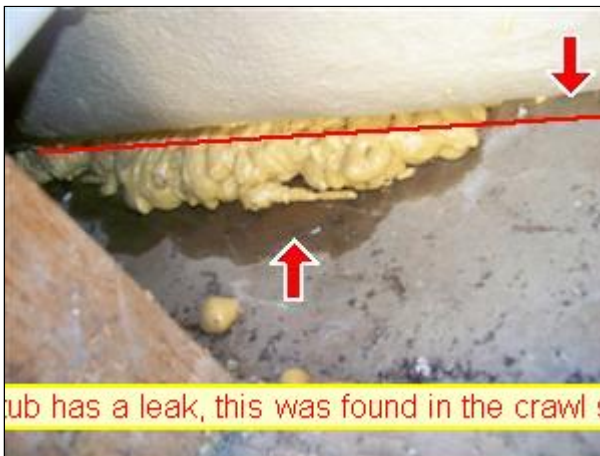
1.0 Picture 1 Crawl Space Area

🔧 1.0 Inspector found a leak in the crawl space, at recommended that a licensed plumber assess, and repair leak.

Inspector found a leak in the crawl space, at recommended that a licensed plumber assess, and repair leak.

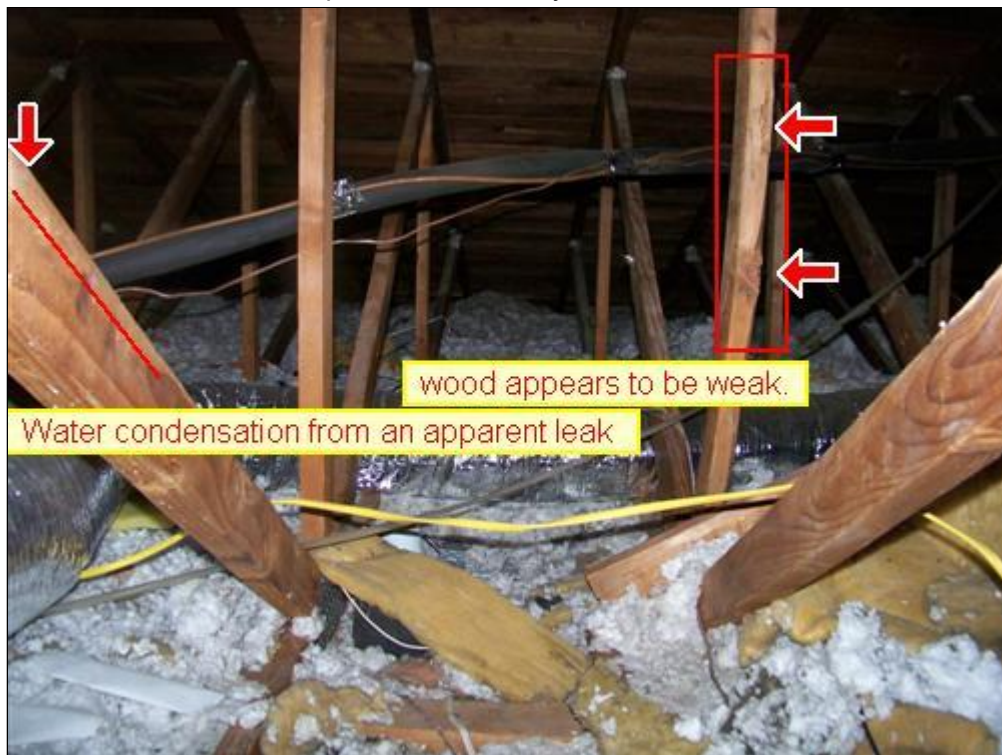
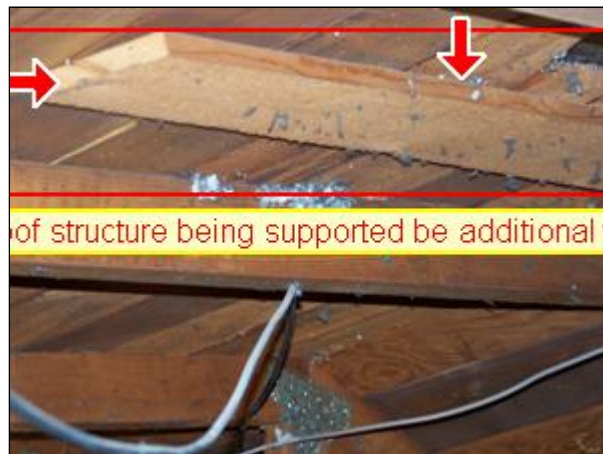
1.5 (1) There were water condensation from on the wood structure, and wood that appears to be weakened by moisture or poor grade. The attic ventilation is blocked, which if a leak did happen the moisture has no to breath. This creates a resting place for mold. Also there was additional wood found to support weak structure. Please contact your licensed roofing consultant to determined the problem and life of your roof.

(1) There were water condensation from on the wood structure, and wood that appears to be weakened by moisture or poor grade. The attic ventilation is blocked, which if a leak did happen the moisture has no to breath. This creates a resting place for mold. Also there was additional wood found to support weak structure. Please contact your licensed roofing consultant to determined the problem and life of your roof.
-

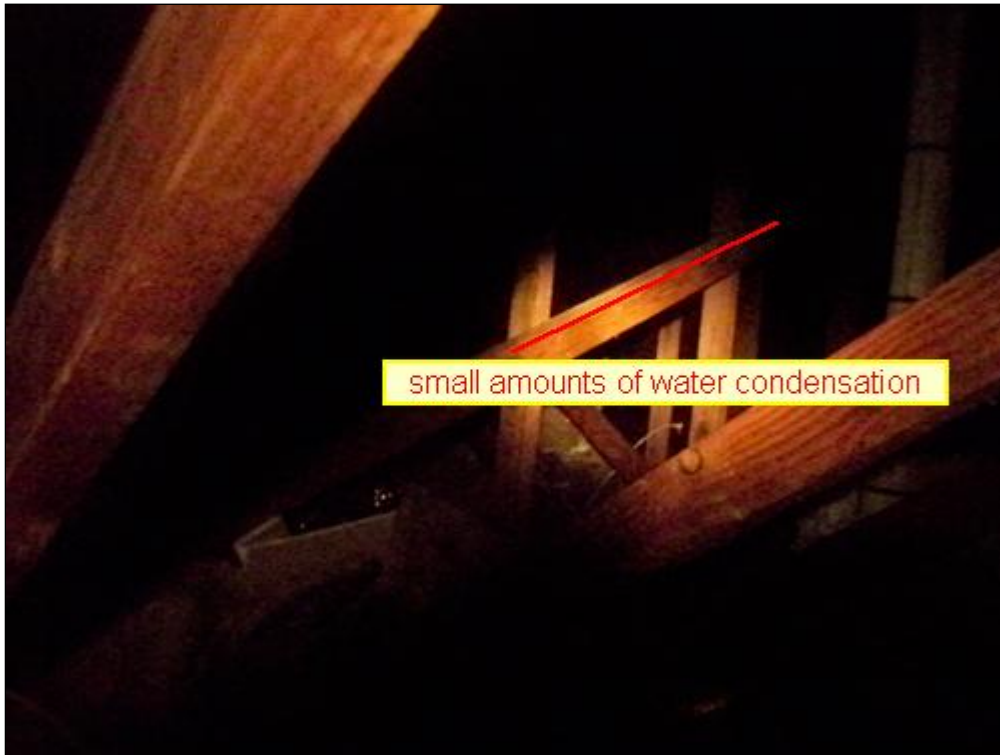
1.5 Picture 3 roof structure and attic

(2) There were small amounts of water condensation found on this beam, Inspector recommends that a qualified and licensed contractor investigate the ventilation, and any other issue that causing or has caused this problem to occur. There were repairs made, but the accuracy of the repairs cannot be determined unless we have a nice size rain.

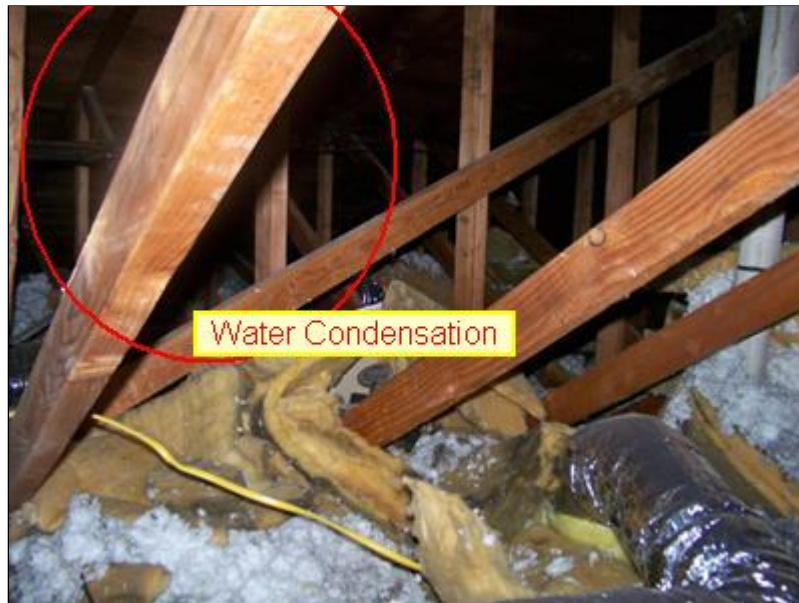
1.5 Picture 4

(3) Please have a qualified licensed contractor to investigate the above mentioned problem. It's probably due to poor ventilation after a repair; but check with the a licensed contractor to be safe.

(3) Please has a qualified licensed contractor to investigate the above mentioned problem. It's probably due to poor ventilation after a repair; but check with the a licensed contractor to be safe.

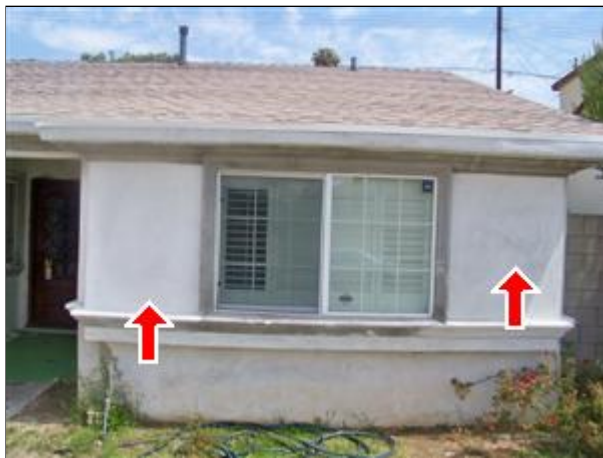
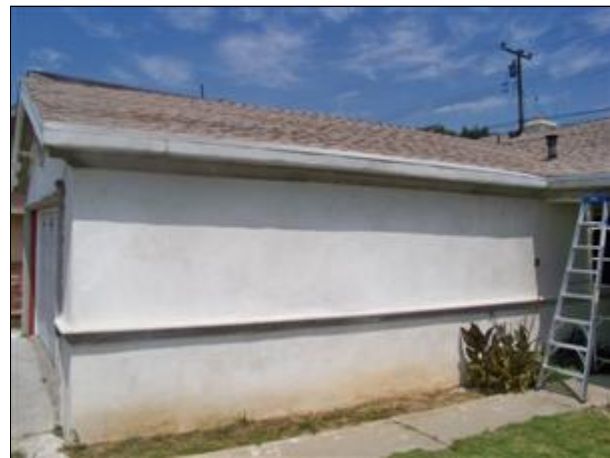
**2.0** (1) During Inspection there were no stucco found, it appears that the home exterior walls were in the process of being re-surfaced. Please contact a licensed contractor to continue the stucco work. The cosmetic repair to the exterior wall that can be fixed during the stucco work.

(1) During Inspection there were no stucco found, it appears that the home exterior walls were in the process of being re-surfaced. Please contact a licensed contractor to continue the stucco work. The cosmetic repair to the exterior wall that can be fixed during the stucco work.
-

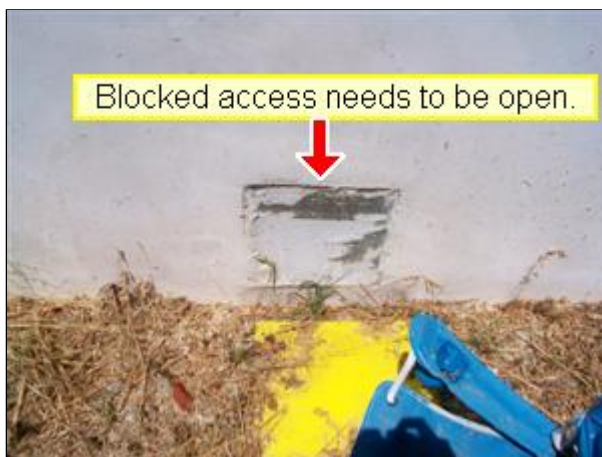
2.0 Picture 3

🔍 (2) This access panel leads to plumbing that was ran for a new tub. Please have a qualified licensed contractor to create a access panel that is accessible.

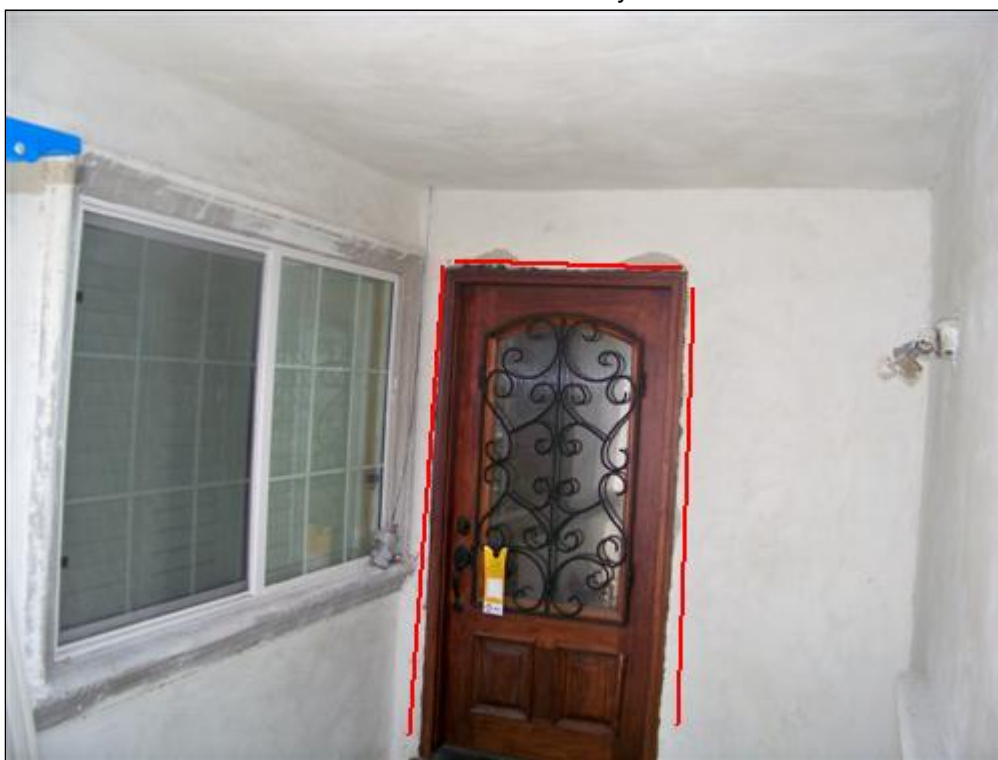
2.1 Picture 1

🔍 2.1 There were cracks around the door, that allows the elements to enter into the home, but this can be repaired during stucco work. Please make sure that the licensed seal this area correctly.

There were cracks around the door, that allows the elements to enter into the home, but this can be repaired during stucco work. Please make sure that the licensed seal this area correctly.

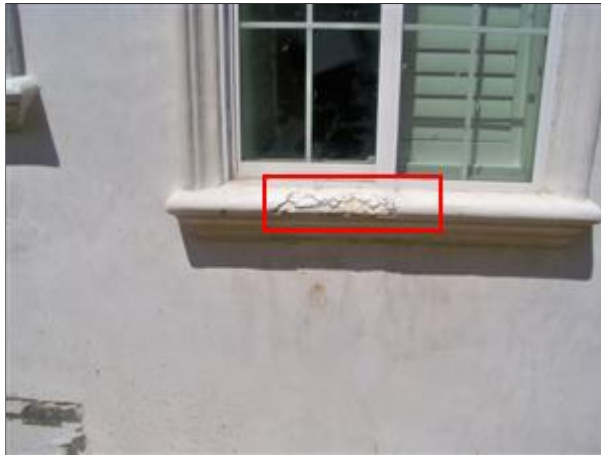
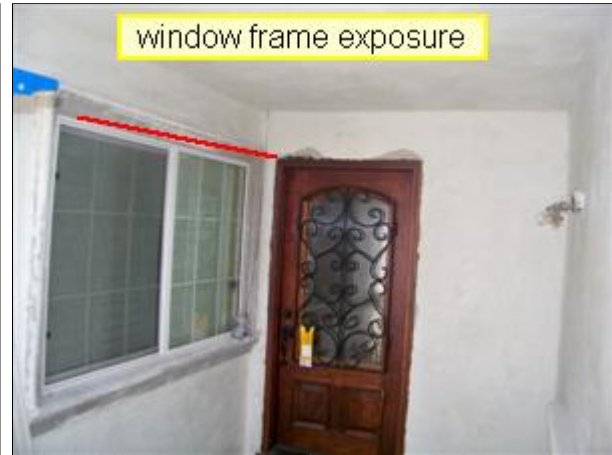
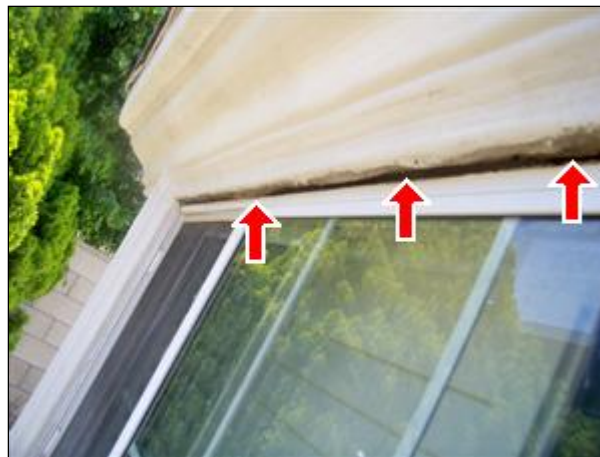
2.2 There were exterior breaks in the rear window sill, during my inspection. this can be fixed during the stucco work. Please make sure the licensed contractor repairs this area before stucco is applied. also the contractor need to make sure to seal around all exterior window that stucco was removed, Inspector found opening around the frame.

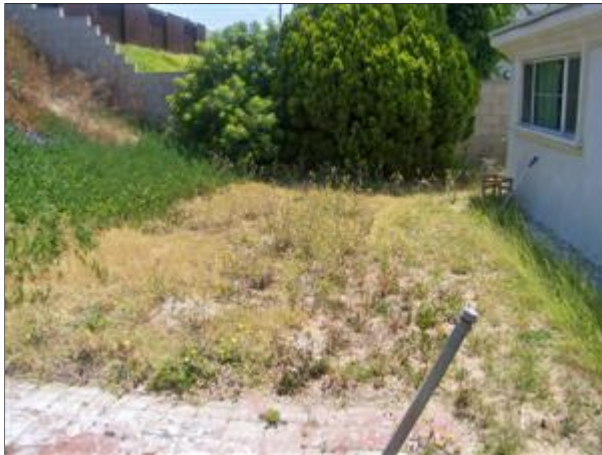
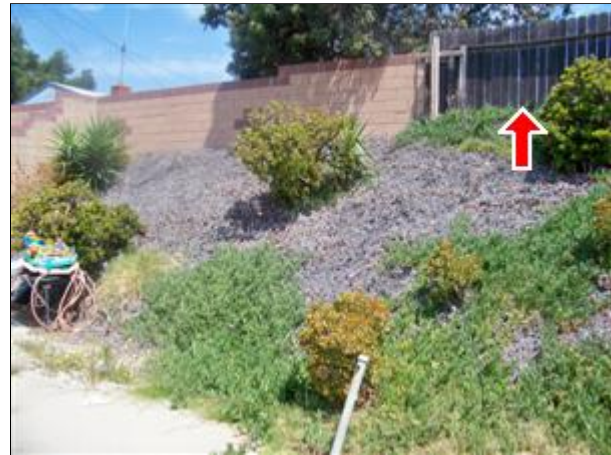
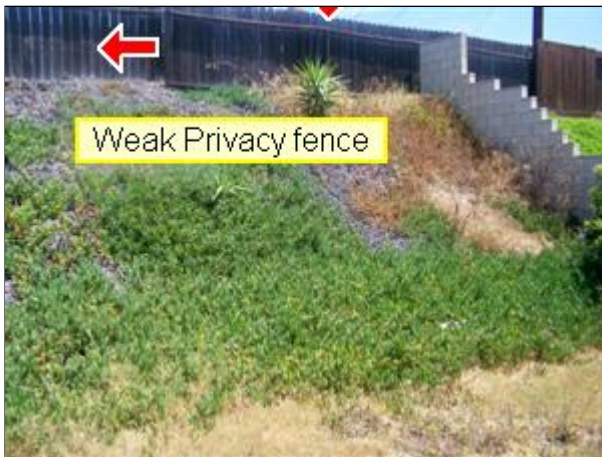
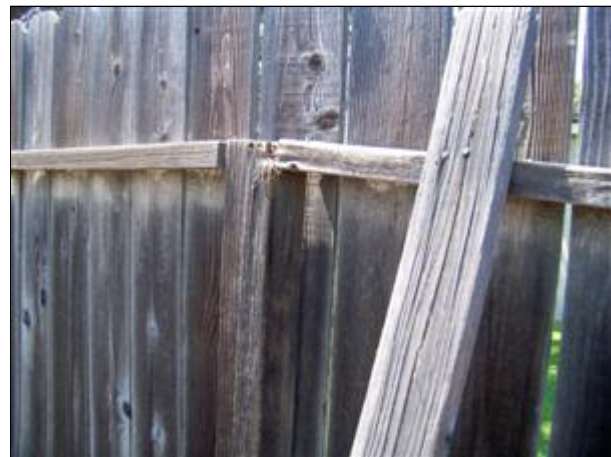
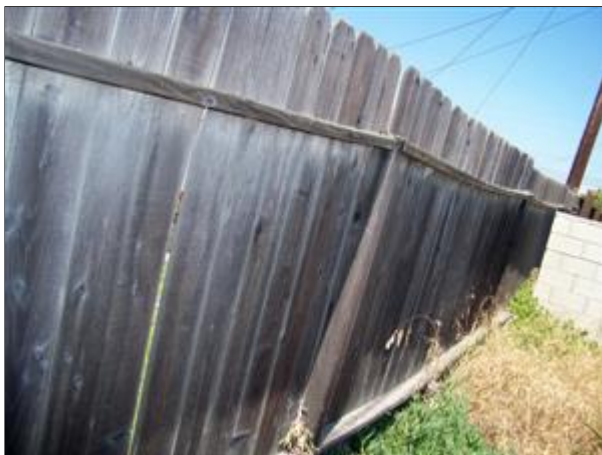
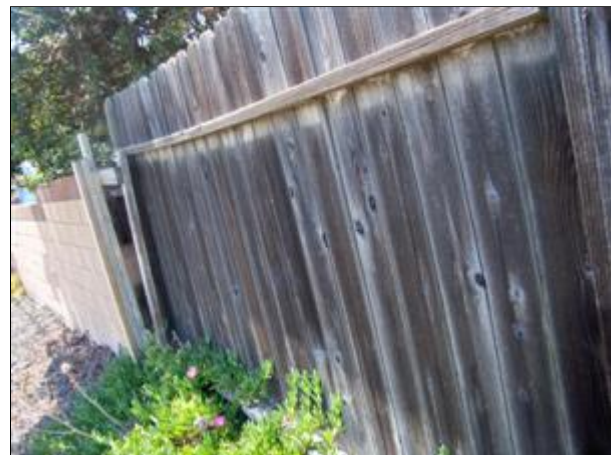
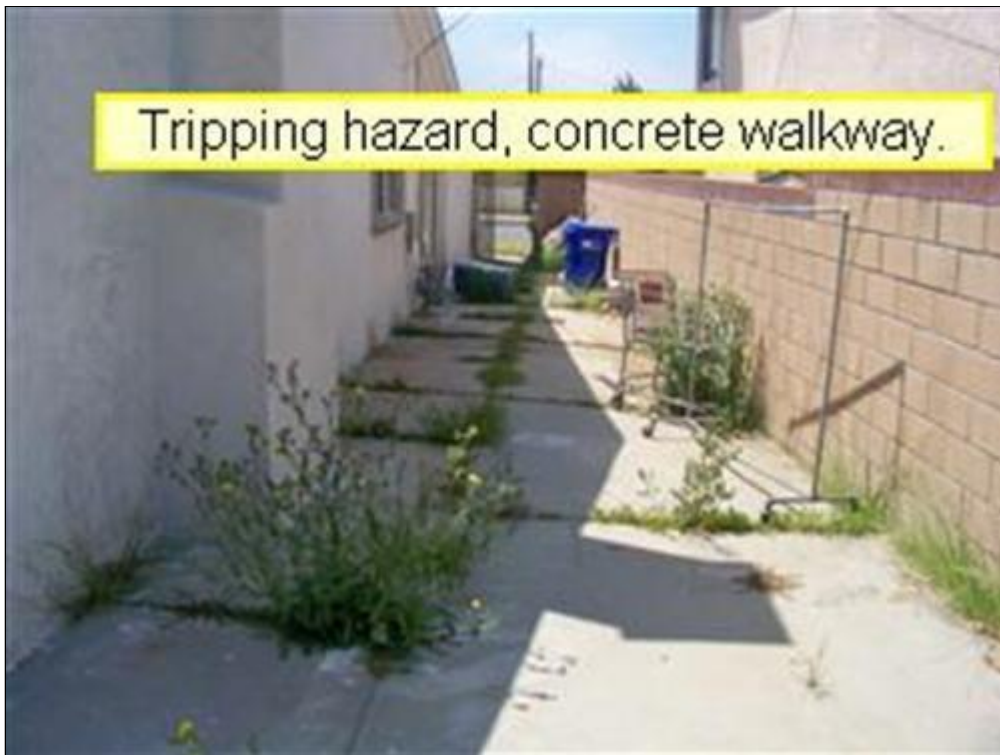
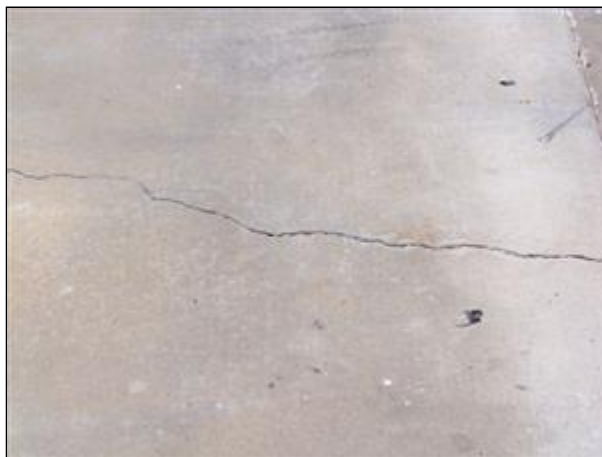
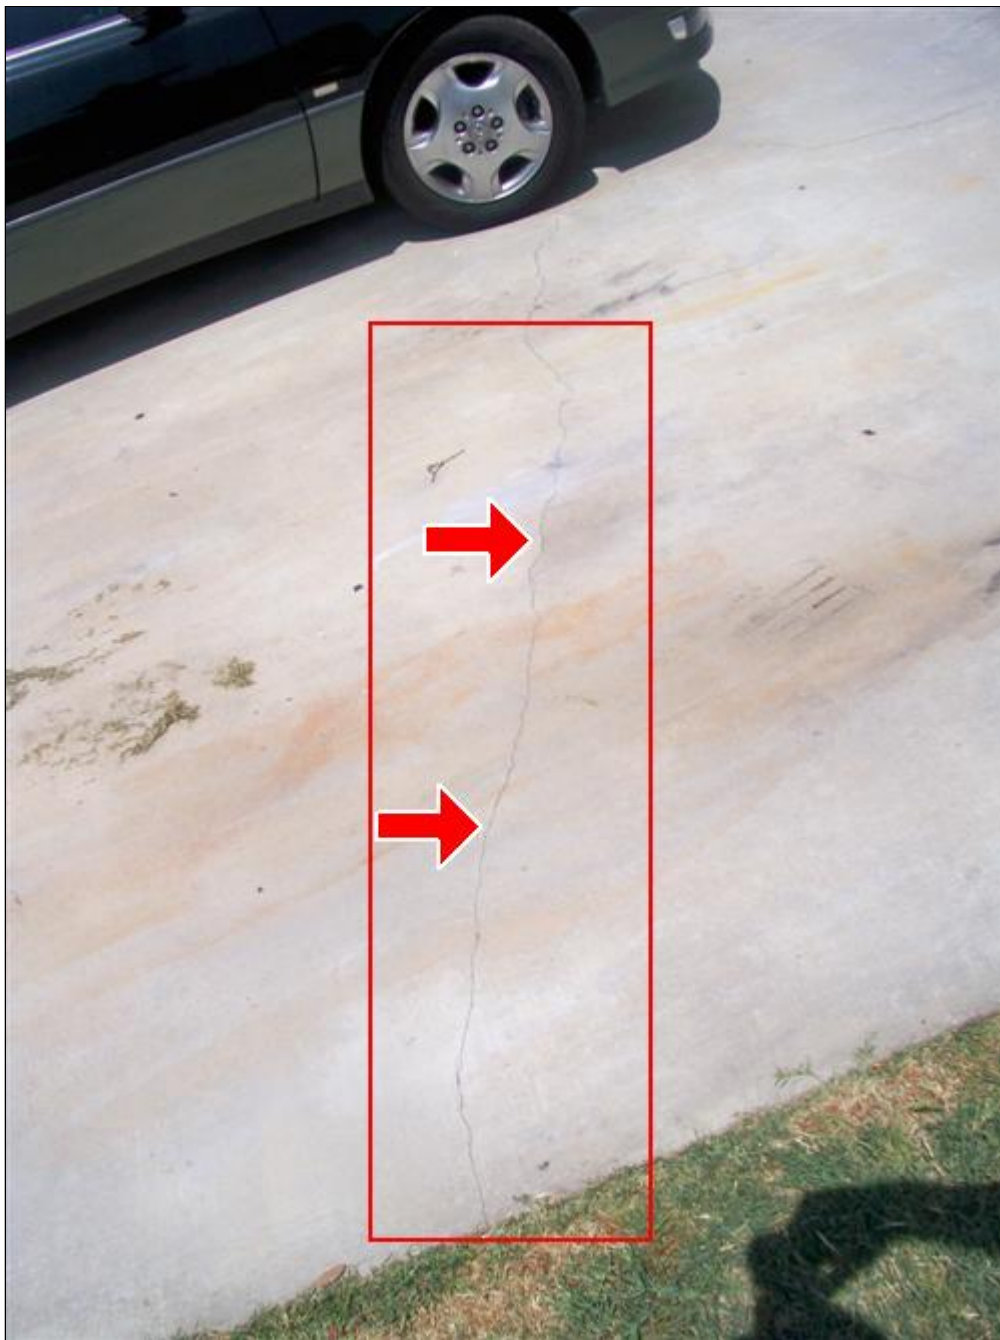
🔍 2.4 (1) During inspection it was found that that vegetation is overgrown, dry, and that can be a concern for fires. Please have a professional landscaping company clean-up debris and overgrown vegetation. The privacy fence is very weak, and needs to be repaired by a licensed contractor.

(1) During inspection it was found that that vegetation is overgrown, dry, and that can be a concern for fires. Please have a professional landscaping company clean-up debris and overgrown vegetation. The privacy fence is very weak, and needs to be repaired by a licensed contractor.

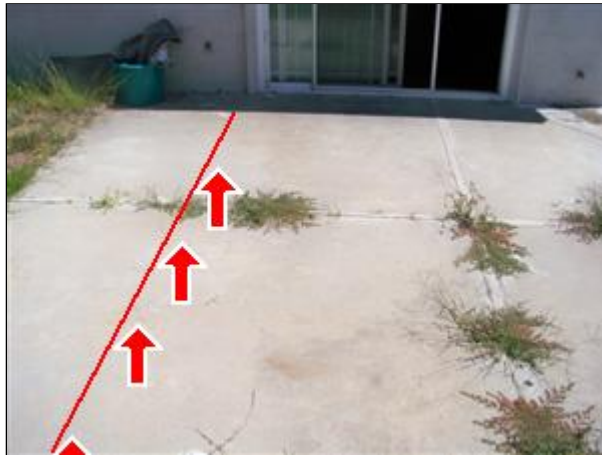
2.4 Picture 10

(2) during inspection the rear foundation concrete slab is sloping towards the house and can cause possible flooding. Please have a qualified contractor investigate this matter and repair if needed.

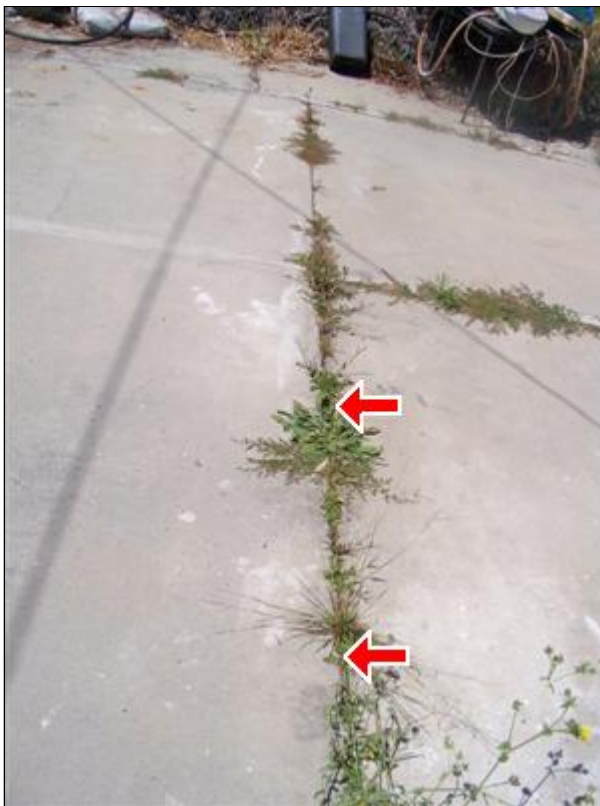
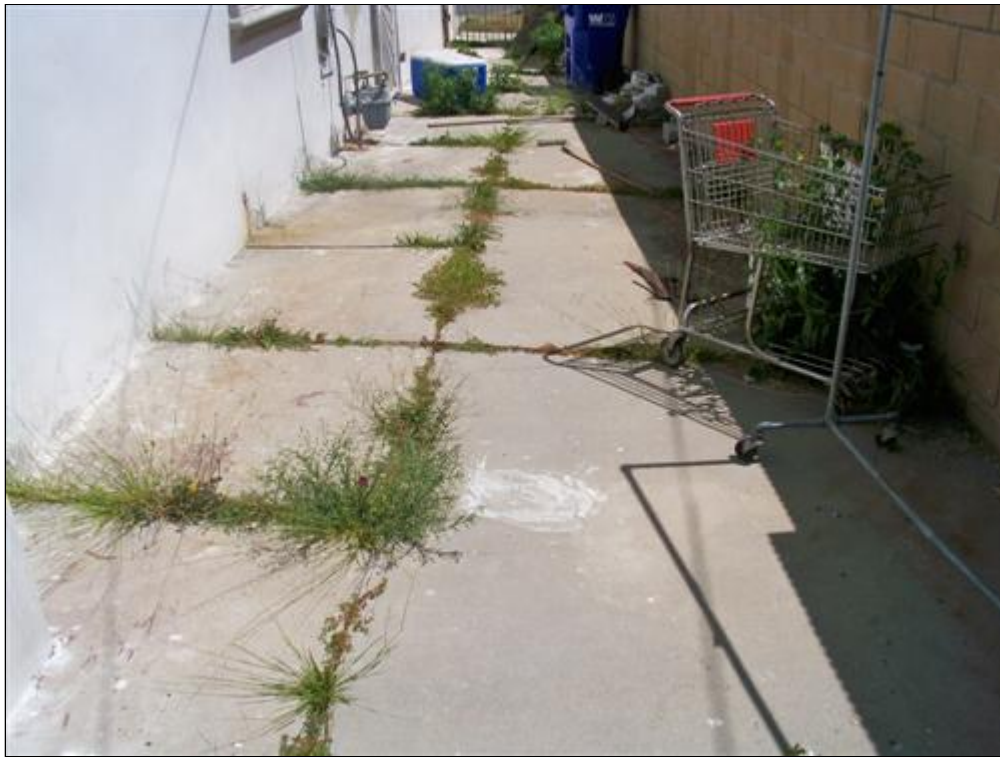
(3) During inspection there were a great deal of settlement issues in the rear walkway. This need to be fixed by a qualified contractor, and possibly a structural engineer, to determine why the ground is shifting. The garage driveway also showed vertical settlement cracks. This could be from weight of cars, or poor material used. Please contact your licensed consultant to determine whether or not this is a concern.

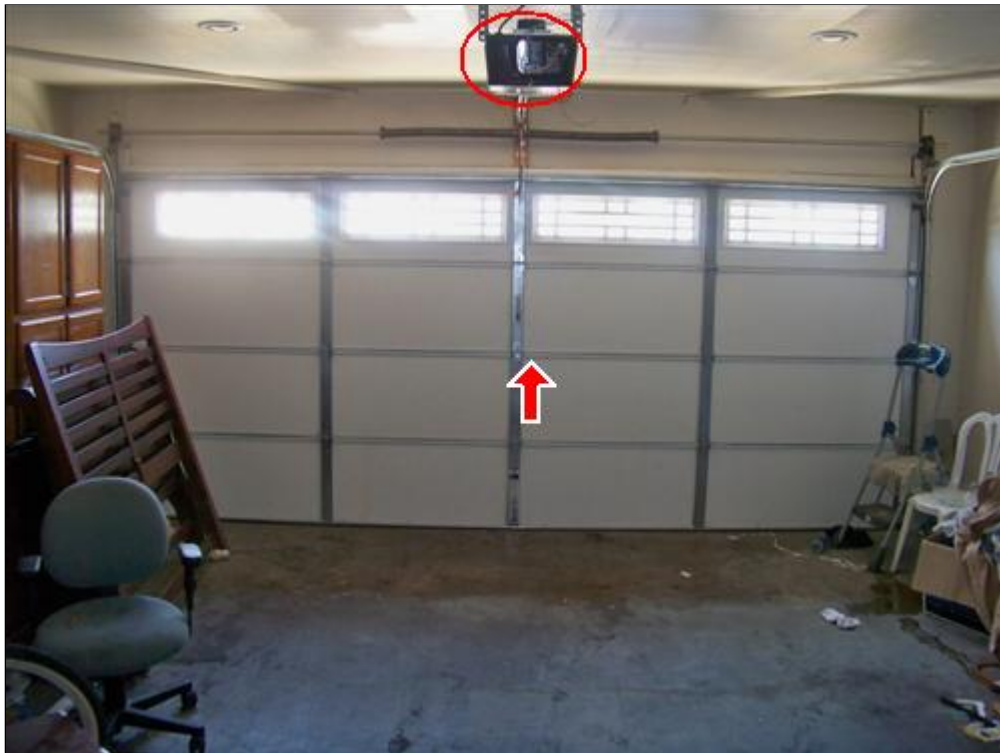
2.7 Picture 1

🔍 2.7 The garage door was found inoperable, and electronic eye was not lit at time of inspection.

The garage door was found inoperable, and electronic eye was not lit at time of inspection.

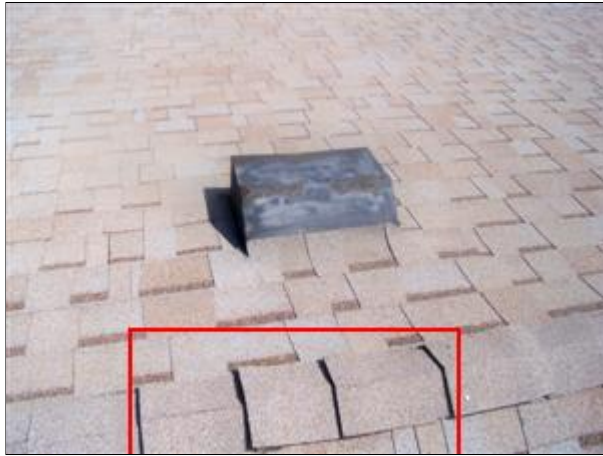
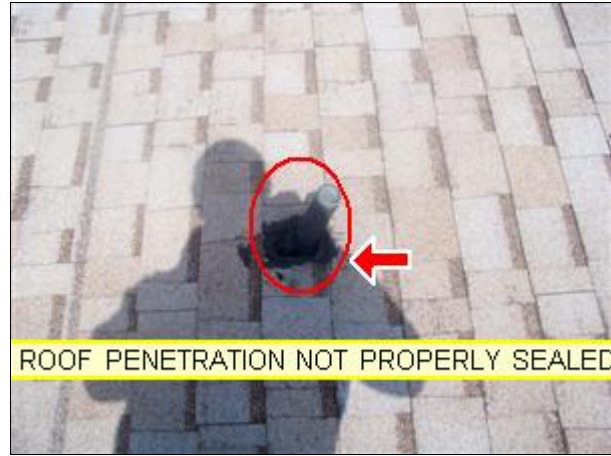
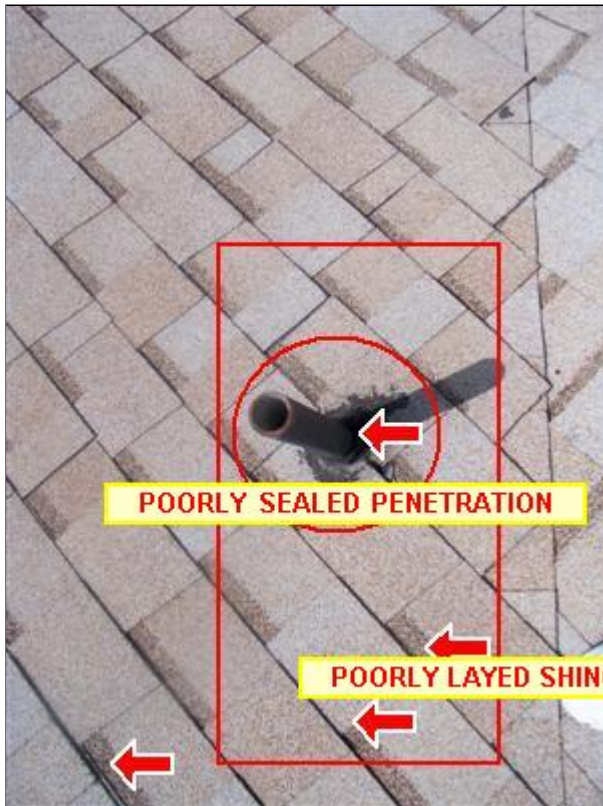
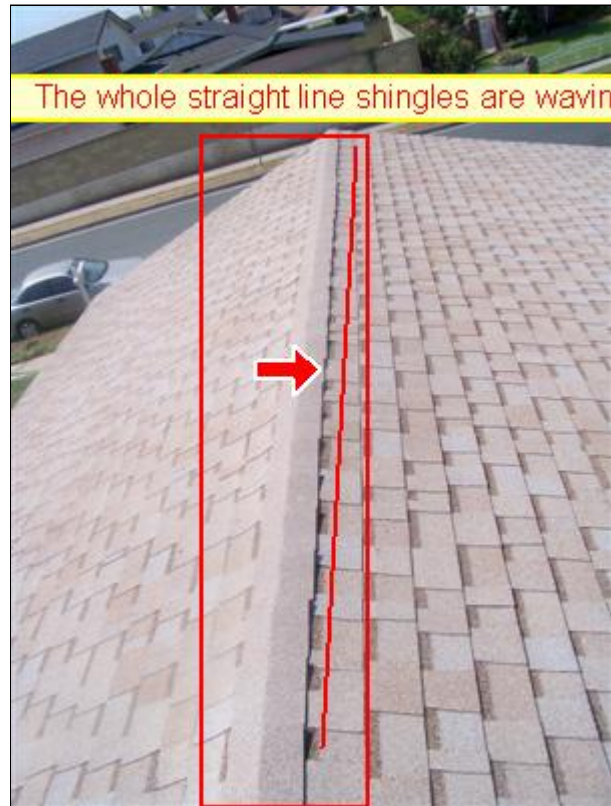
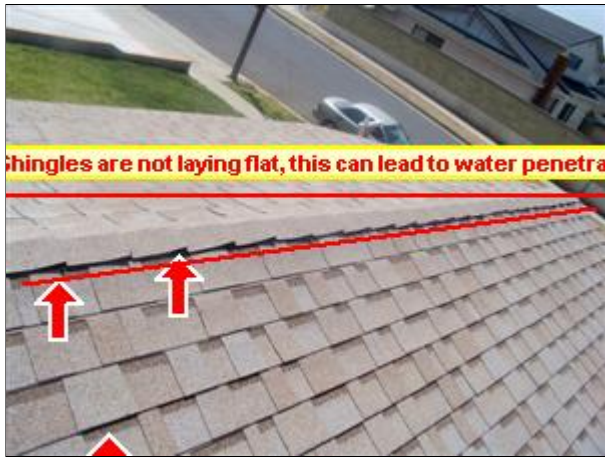
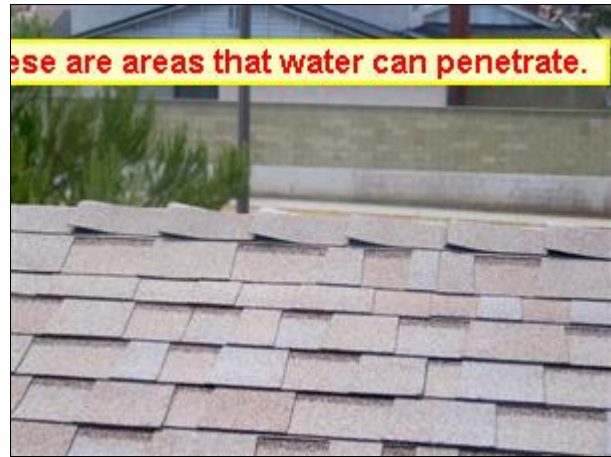
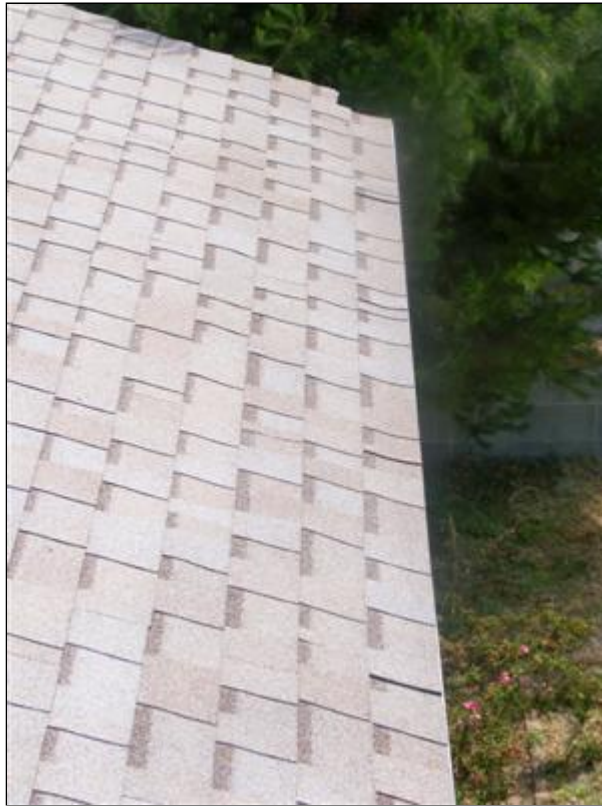
3.0 (1) During inspection it was found that multiple layers of shingles were found throughout the roof, and it appears that it does not lay flat to the roof, which poses concern for water penetration. Please have a licensed roofer to investigate the roof, and repair if needed. A certification should be requested to figure out the roof life expectancy. There were many areas of the roof that was waving; these areas need to be checked because multiple shingles stated possible that was not done correctly. shingles needs to lay flat to give complete protection to the structure.

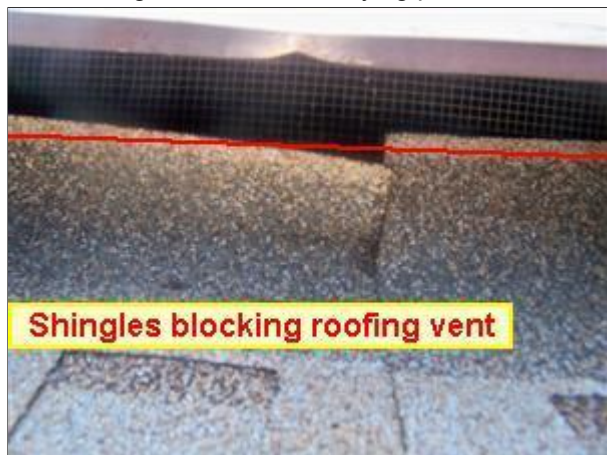
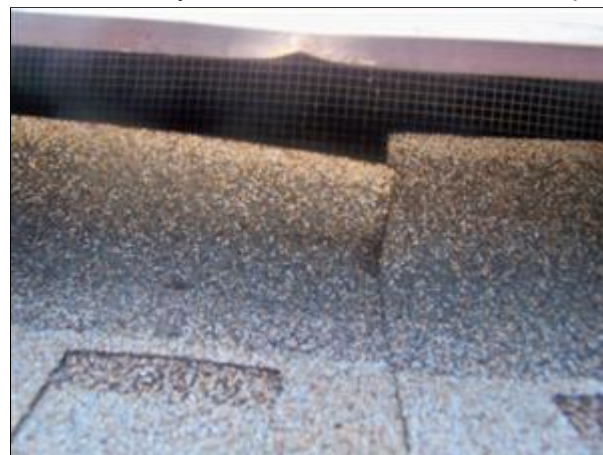
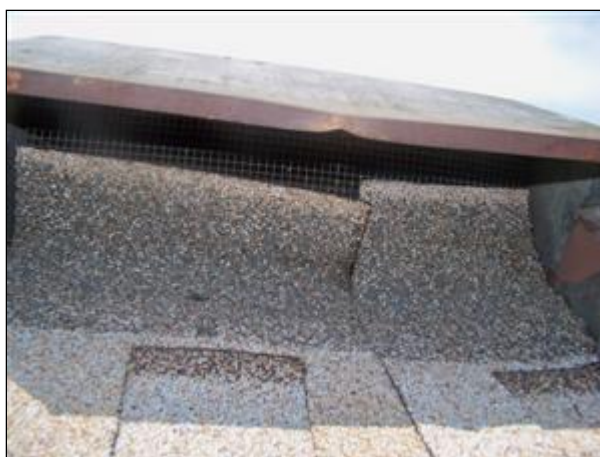
(2) Roofing shingles blocking attic vent, this can pose as a problem because the attic needs to breath, in order to prevent moisture, which bring forth wood destroying pest, and mold. Please contact you licensed roofer to correct the problem.

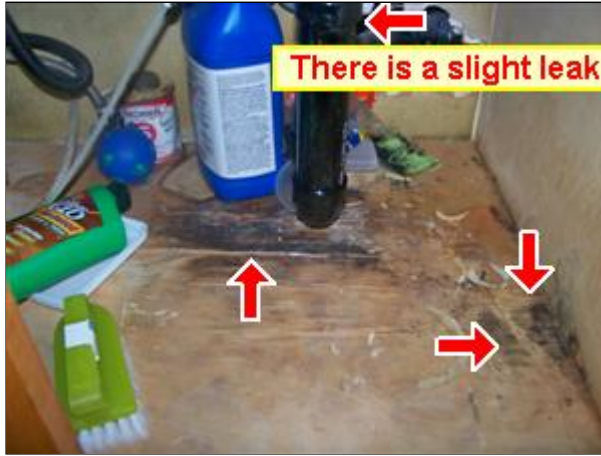
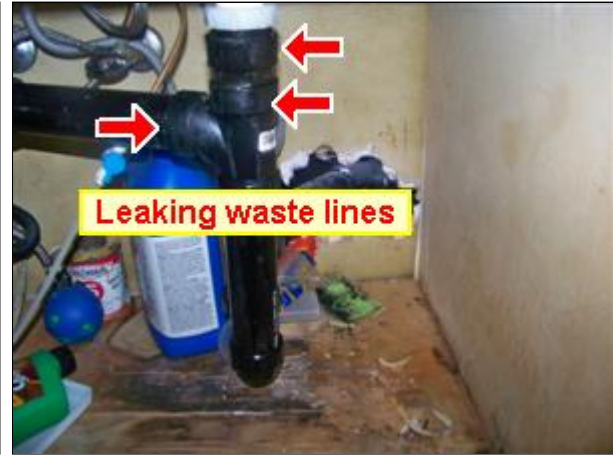
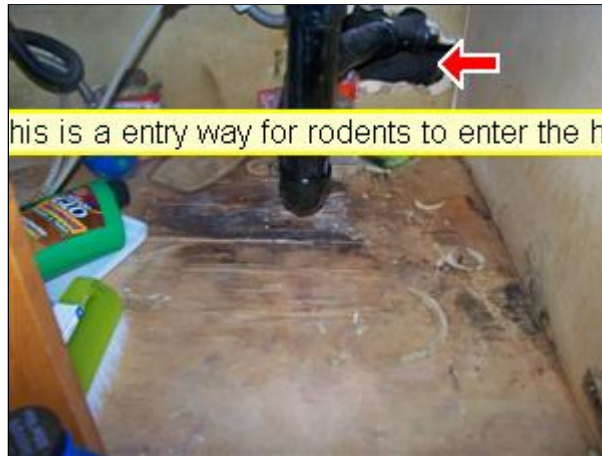
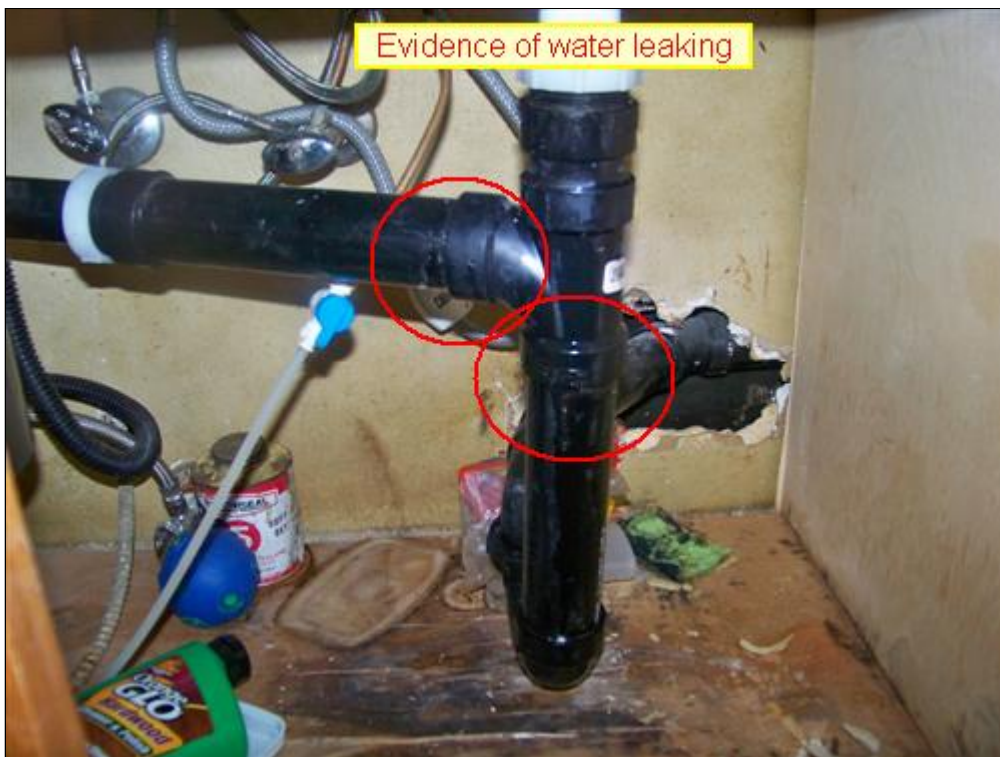
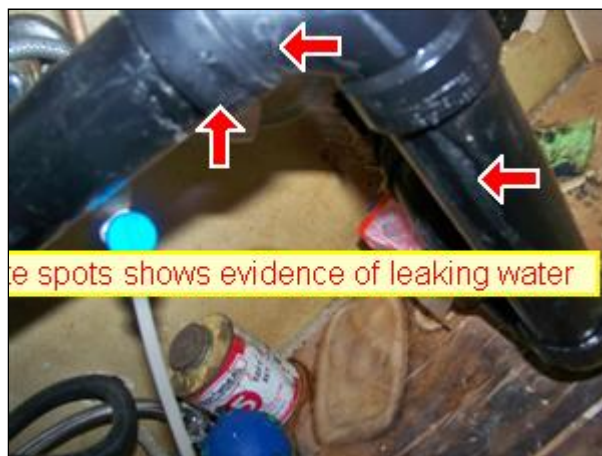
🔍 4.0 (1) There is a slight leak in kitchen sink, which more than lightly contributed to what appears to be mold spores at the bottom of the cabinet. Please contact your licensed contractor to clean or replace cabinet, and fix leak to waste lines. Please repair hole to prevent rodents or other pest from entering the home. The bathroom sink needs to be repaired, water drains very slow.

(1) There is a slight leak in kitchen sink, which more than lightly contributed to what appears to be mold spores at the bottom of the cabinet. Please contact your licensed contractor to clean or replace cabinet, and fix leak to waste lines. Please repair hole to prevent rodents or other pest from entering the home. The bathroom sink needs to be repaired, water drains very slow.
-

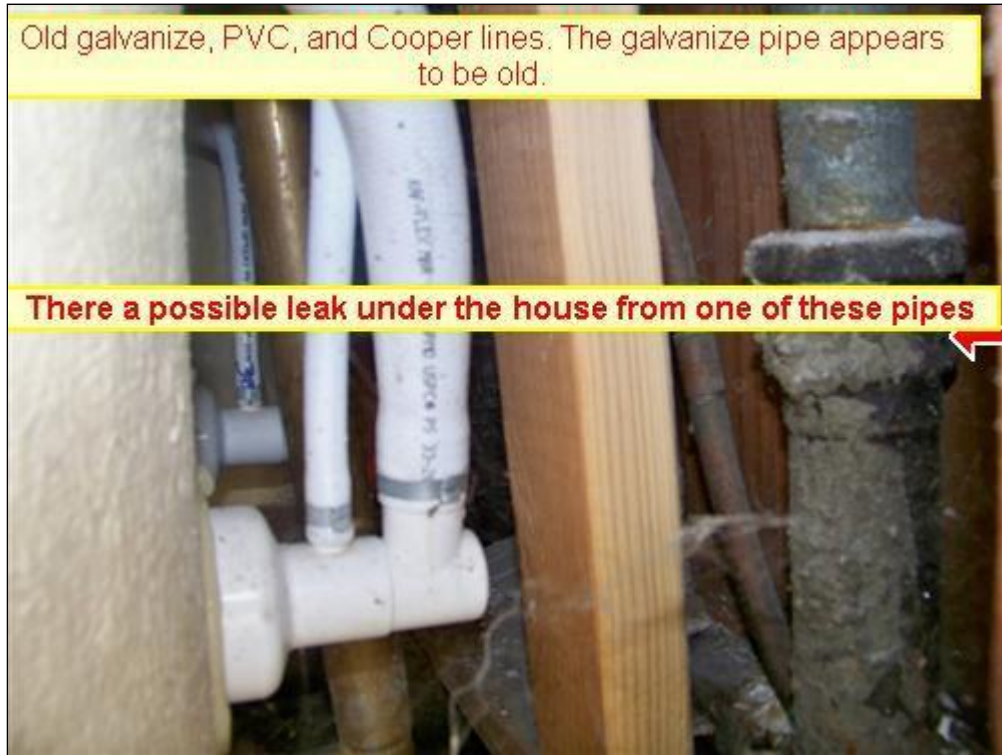
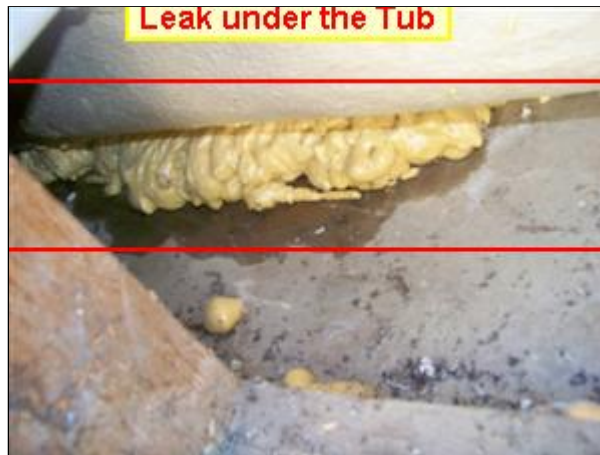
🔍 (2) There is a leak under the house from that new tub installed; this is under a crawl space that do not allow entry at the rear of the dwelling. Please consult a licensed plumber to investigate and repair leak before additional problem result from this leak.

(2) There is a leak under the house from that new tub installed; this is under a crawl space that do not allow entry at the rear of the dwelling. Please consult a licensed plumber to investigate and repair leak before additional problem result from this leak.

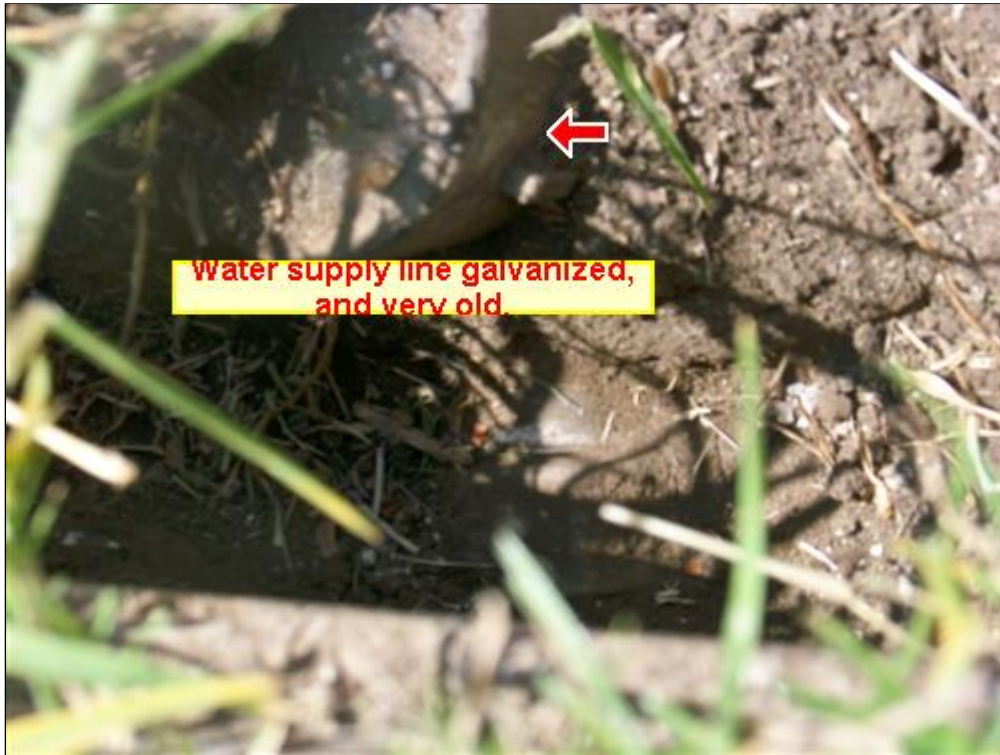
4.1 Picture 1 Water Supply at the Curb

4.1 The water supply line is old galvanized plumbing, its recommended to get licensed plumber opinion to replace with copper to prevent line ruptures. This will cause a stoppage in water be supplied to the home if it breaks. There were no evidence of a leak at this time.

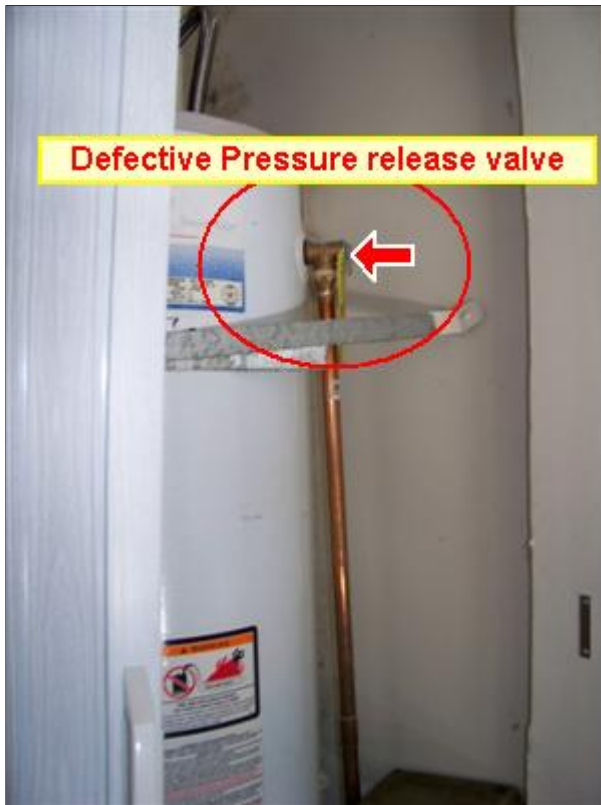
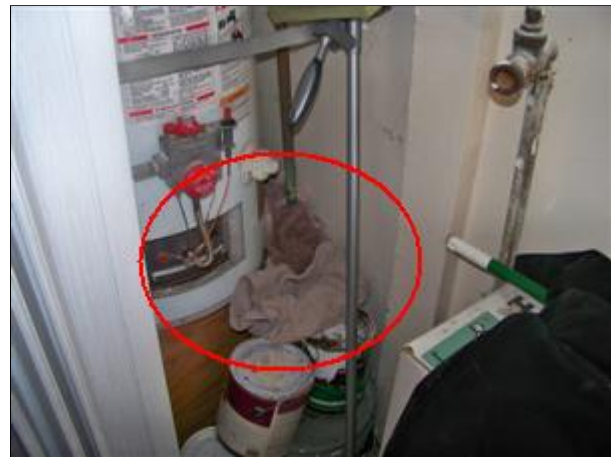
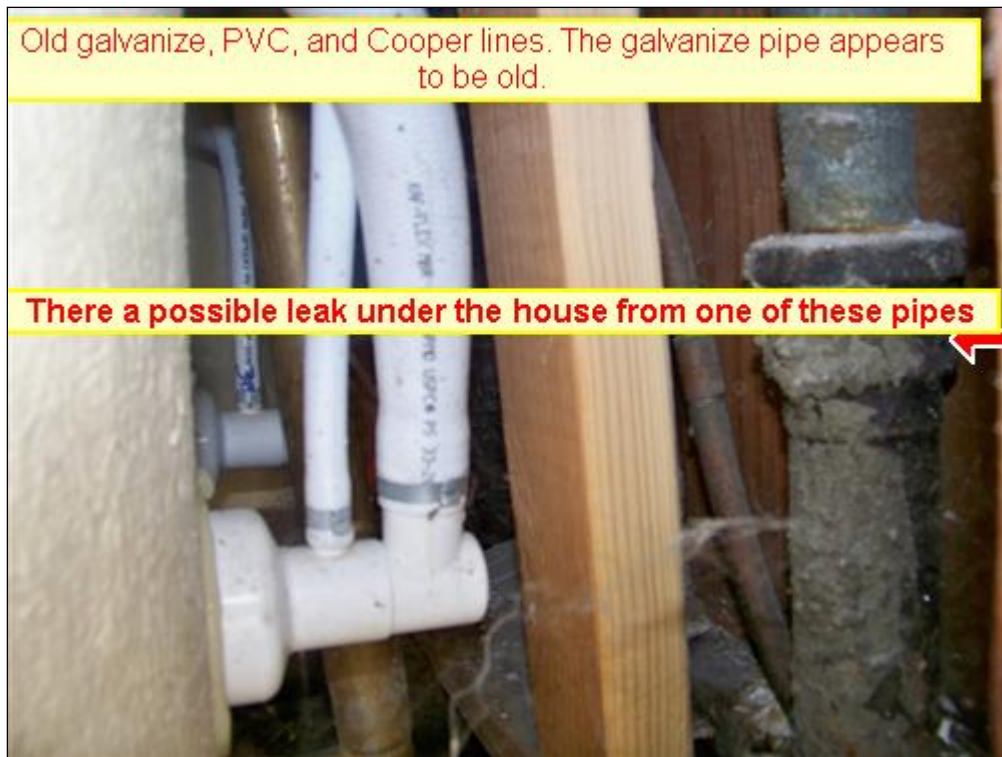
4.2 Please have a licensed plumber to replace pressure release valve, due to leaking. There is a leak under the house from that new tub installed; this is under a crawl space that do not allow entry at the rear of the dwelling. Please consult a licensed plumber to investigate and repair leak before additional problem result from this leak.

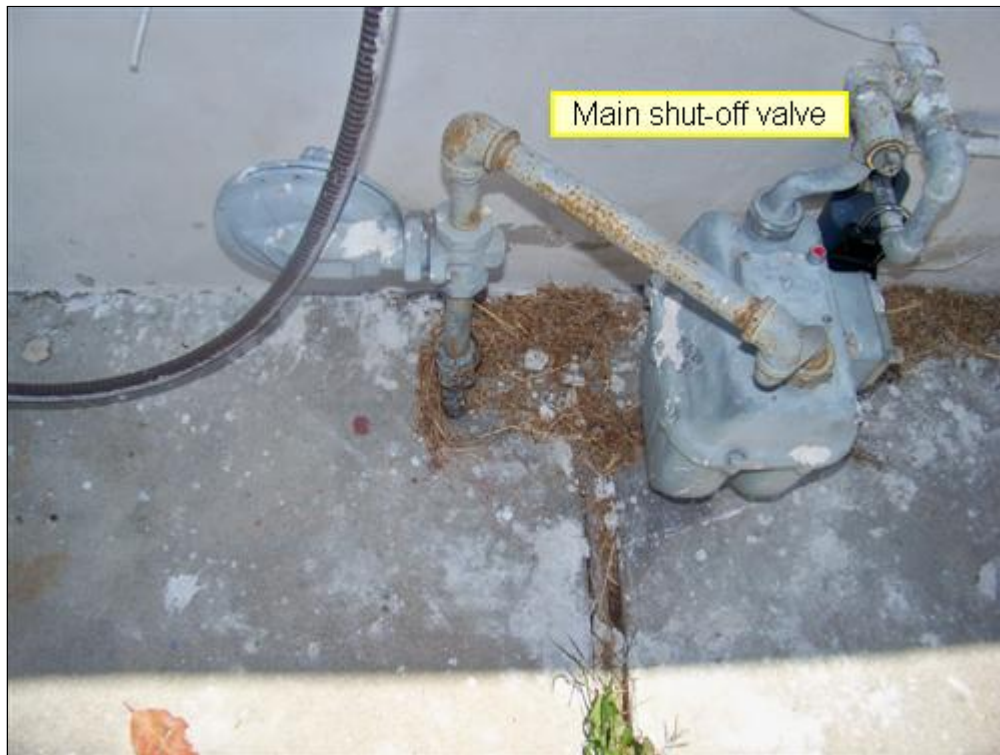
4.5 Picture 1

4.5 The main shut-off valve appears to be in good condition, no apparent leaks at time of inspection. The unit needs a earth quake valve to protect the lines from any sudden earth quake. This is not a requirement, only a suggestion. If this is something you want, please contact your licensed plumber to consult with you about installing safety unit.
