# Inspection Report

1889 Cyrene Dr.  
Carson CA 90746

**Kleen Inspections**

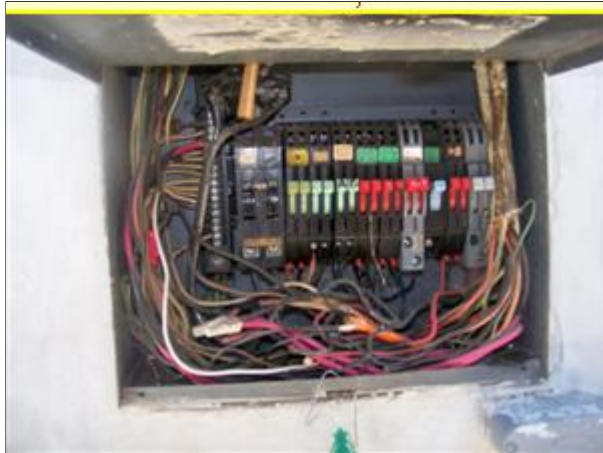
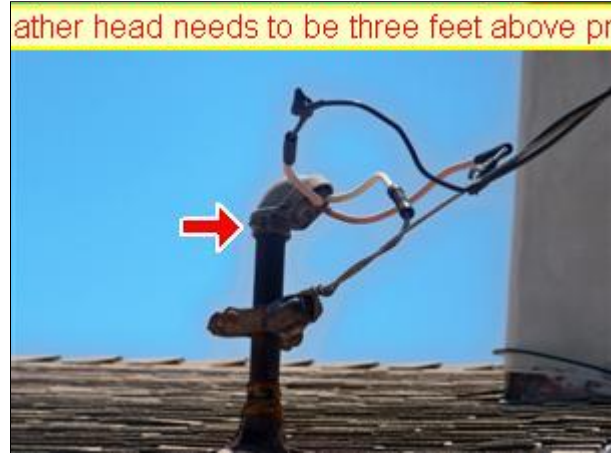
🔍 5.1 (1) This main service panel was found to have no safety plate to protect against being shocked or seriously injured. This panel need to be services by a licensed electrical contractor. Please consult with your licensed electrician to install a weather head that is at least three feet above the dwelling.

(1) This main service panel was found to have no safety plate to protect against being shocked or seriously injured. This panel need to be services by a licensed electrical contractor. Please consult with your licensed electrician to install a weather head that is at least three feet above the dwelling.

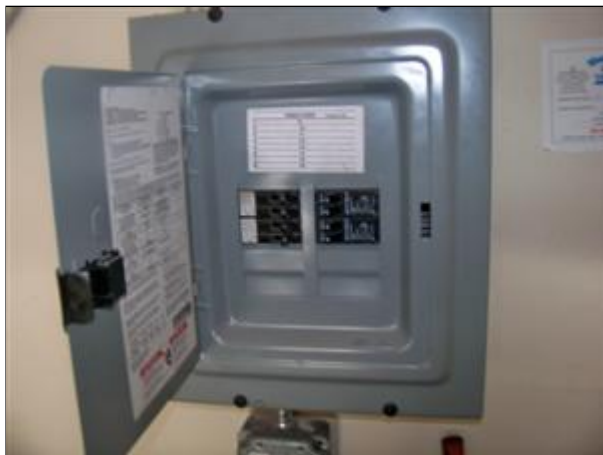
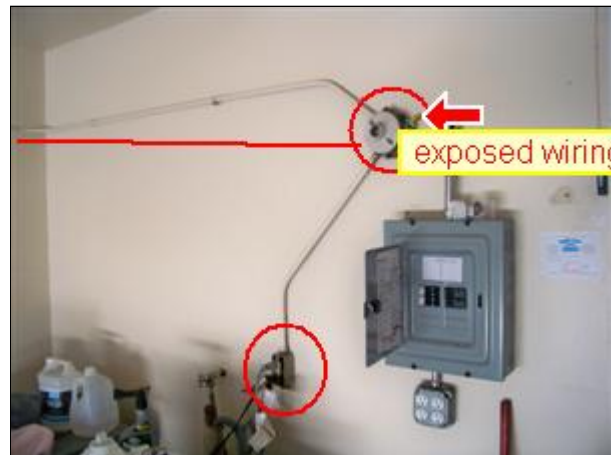
(2) The sub-panel box found in the garage appears to be ran without a city permit, please check with building and safety to ensure that it wiring. The panel box installation appears to be questionable because of the final enclosure. The holes must be closed without any exposed wiring. The outlet registered live when tested at the exposed side of the box. Please consult a licensed electrician to investigate sub-panel box, and make all outlets GFCI throughout garage.

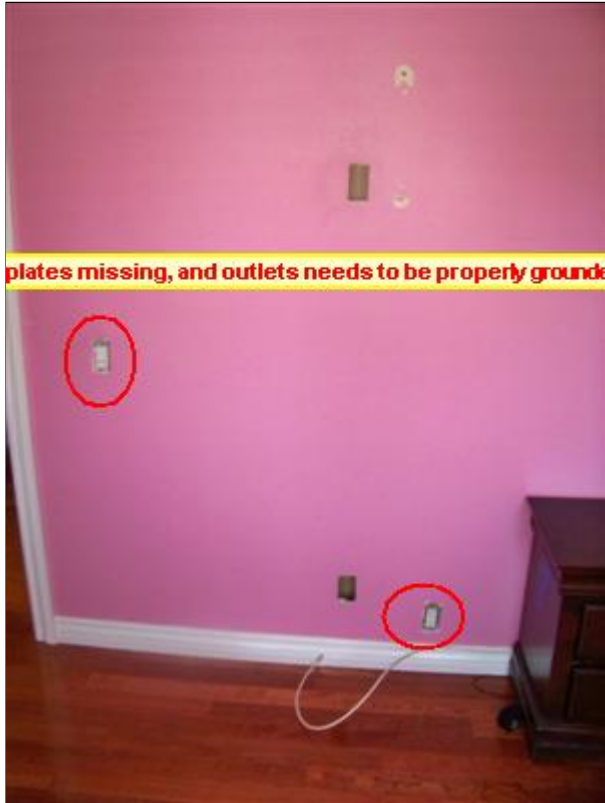
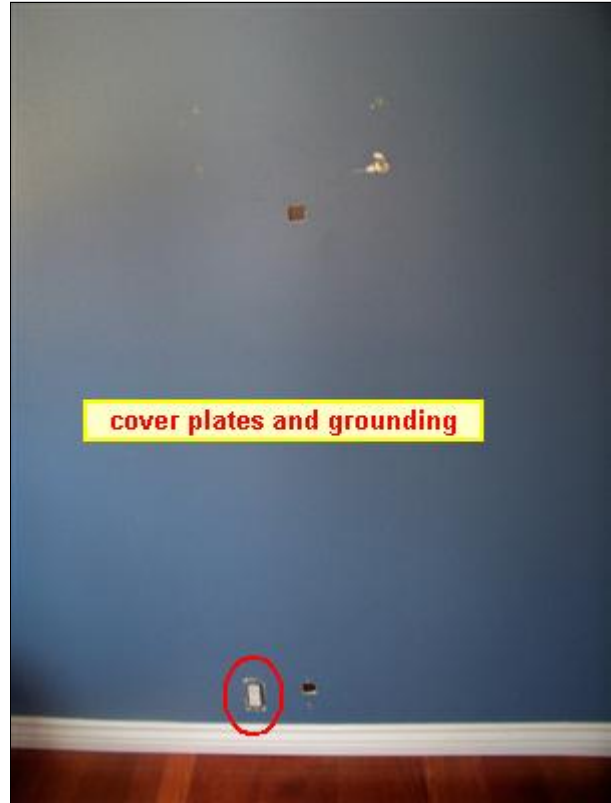
5.3 (1) During inspection it was found that outlets throughout the entire house is not grounded properly. Please consult with a licensed electrician to repairs all outlets, and add coverplates for safety.

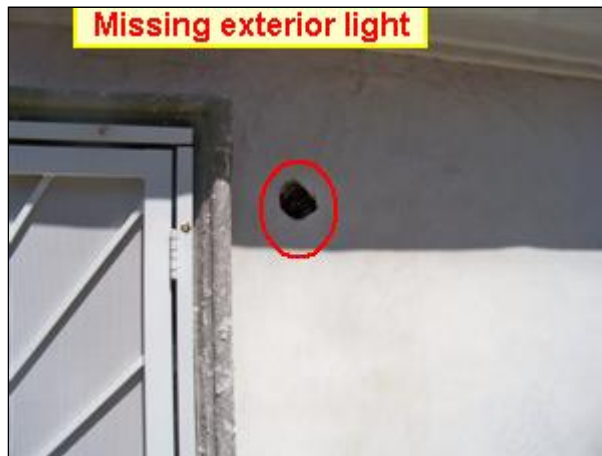
5.3 Picture 3

(2) There were a number of exterior lights that were missing during inspection, please have licensed electrician replace as needed.

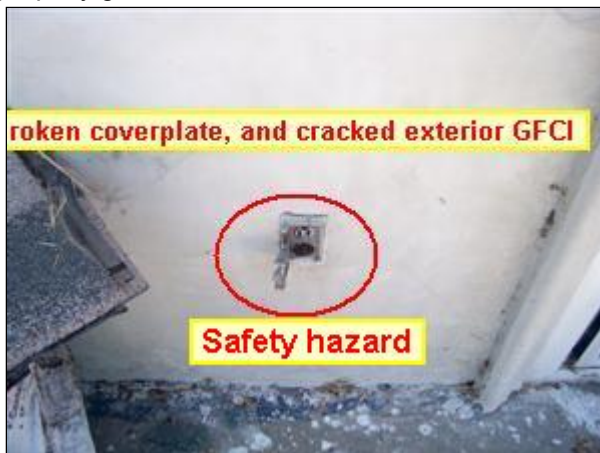
5.4 Picture 1

5.4 Please contact your licensed electrician to repair exterior GFCI, this outlet is a safety hazard. The inspector found outlets in the garage that were not properly grounded, and needs to be GFCI.

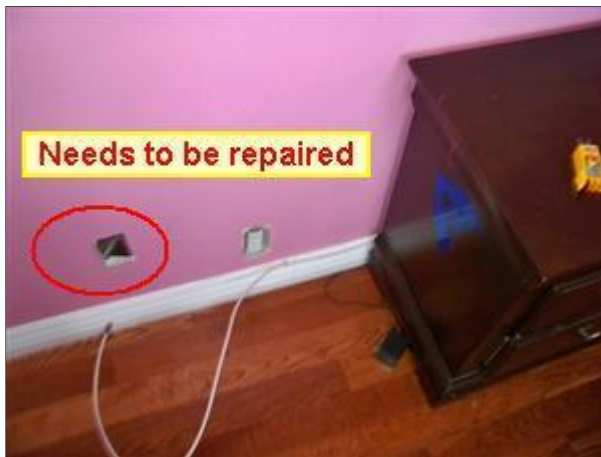
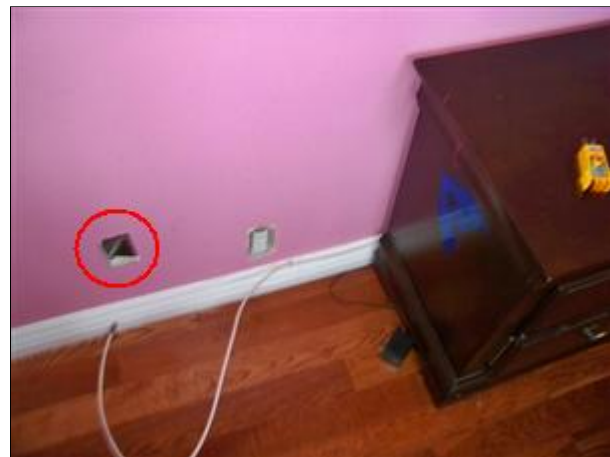
**8.1** There are holes throughout dwelling that needs to be repaired, Please contact your licensed paint, to repair any hole if painting is required.

There are holes throughout dwelling that needs to be repaired, Please contact your licensed paint, to repair any hole if painting is required.

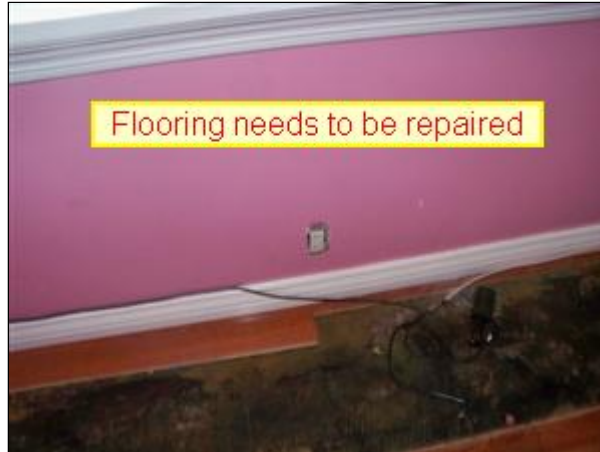
8.2 Picture 1

**8.2** Flooring needs to be repaired by a licensed contractor, and please check for any additional water damage to floor foundation.

Flooring needs to be repaired by a licensed contractor, and please check for any additional water damage to floor foundation.

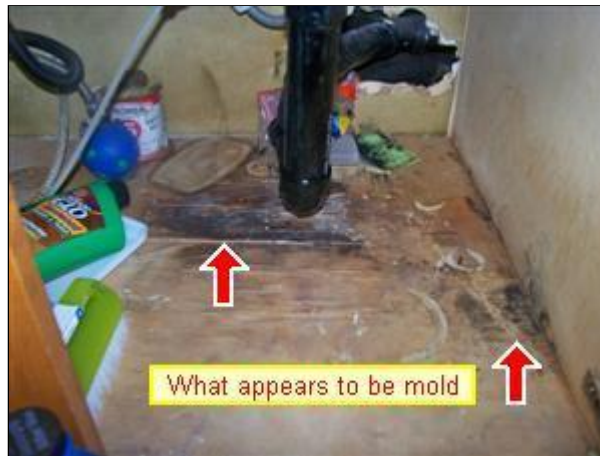
8.4 Picture 1

**8.4** Cabinet in the kitchen needs to be cleaned and repaired or replaced. There is what appears to be mold spores. Please contact your licensed contractor to test, remediate, and repair or replace cabinet floor.

Cabinet in the kitchen needs to be cleaned and repaired or replaced. There is what appears to be mold spores. Please contact your licensed contractor to test, remediate, and repair or replace cabinet floor.

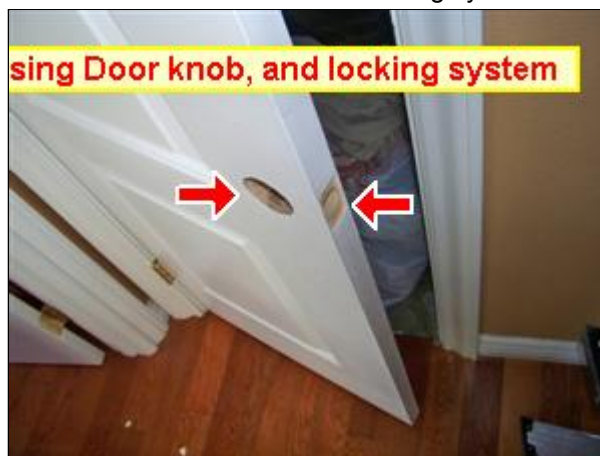
8.5 Picture 1

**8.5** Please have your licensed contractor to install door knob and locking system.

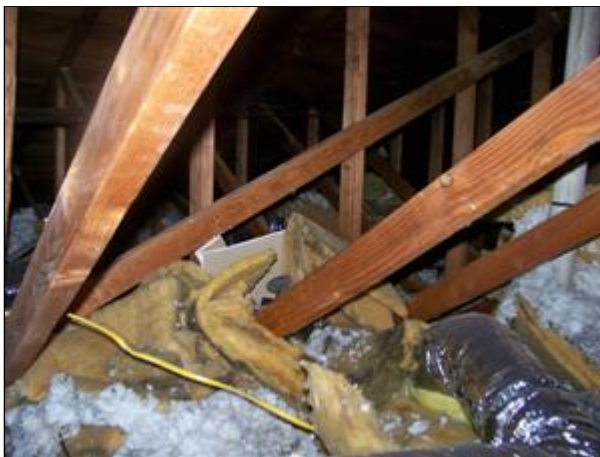
9.0 Picture 1

**9.0** The attic insulation needs to be replaced. Please contact your licensed contractor to install new installation.

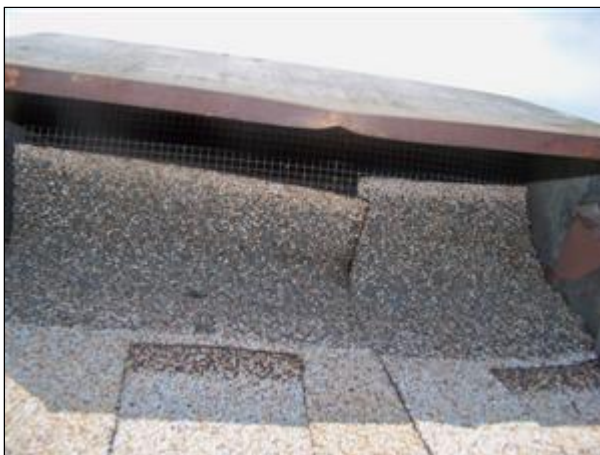
9.3 Picture 1

**9.3** The attic ventilation was blocked by roofing shingles, please consult with licensed contractor to remove blockage to allow venting in the attic.
