Inspection Report

Property Address:
1414 West 137th Street
Compton CA 90222

Date: 3/21/2013	Time: 10:00 AM	Report ID: 032013
Property: 1414 West 137th Street Compton CA 90222	Customer: Mr. Mauricio Zavala	Real Estate Professional: Oracio Carrillo ReMax VIP

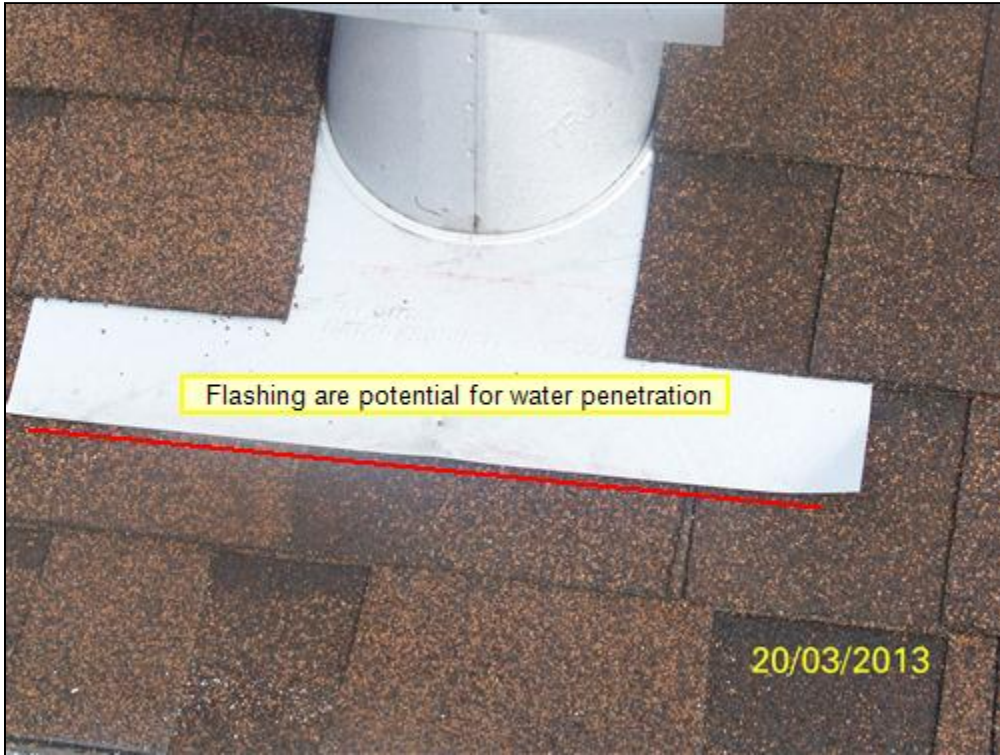
1.1 Picture 1

1.1 Inspector found flashing raised instead of being flat; which can have a potential for water intrusion. Inspector found no leaks in the home to state that the flashing is allowing water to penetrate.

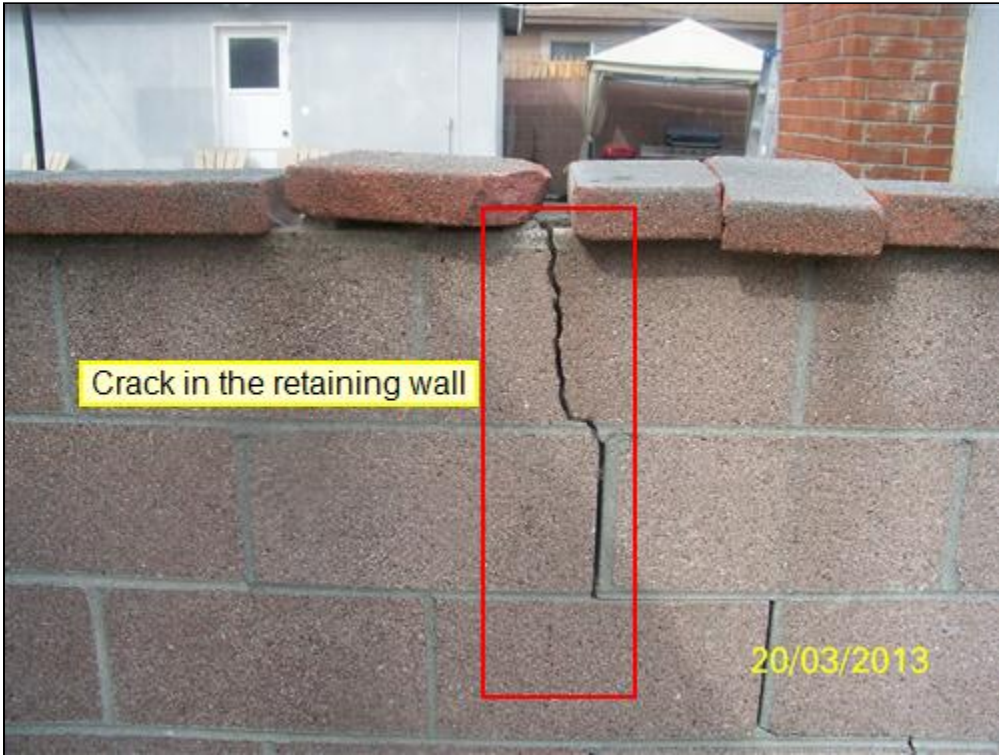
2.4 Picture 1

2.4 Inspector found a crack in the retaining wall. Please have a licensed contractor investigate an repair if needed. Inspector found two large holes in the rear yard. This can be a potential risk to individual walking near and fall into hole. Please have holes sealed with concrete, in order to prevent any incidents from happening.

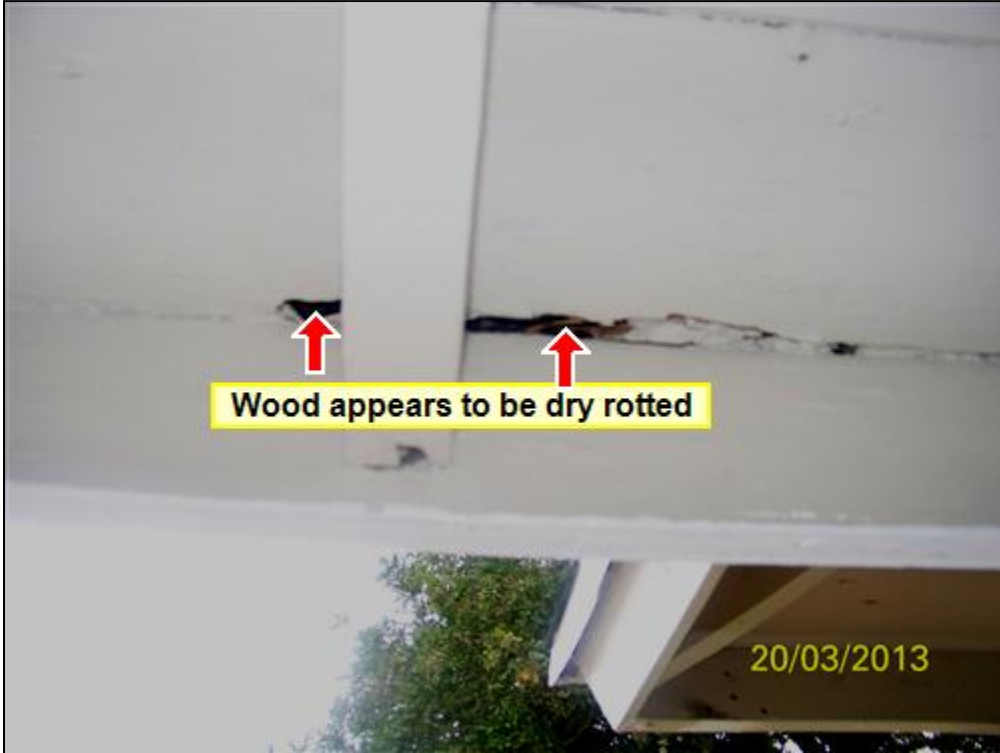
2.5 Picture 1

2.5 (1) Inspector found the exterior fascia boards having dry rot, and water stains from the roof previously leaking. Also beehives were found, please have a licensed contractor

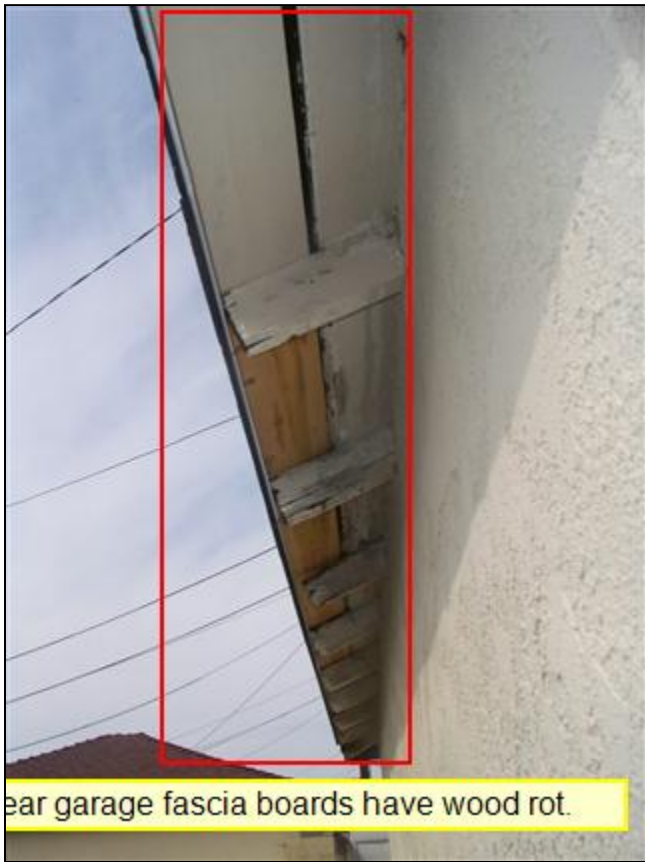
2.5 Picture 7

(2) Inspector found the garage rear fascia boards dry rotted, due to water damage. Please make sure termite inspector check for wood destroying pest. Please have a licensed contractor repair all areas of concern.

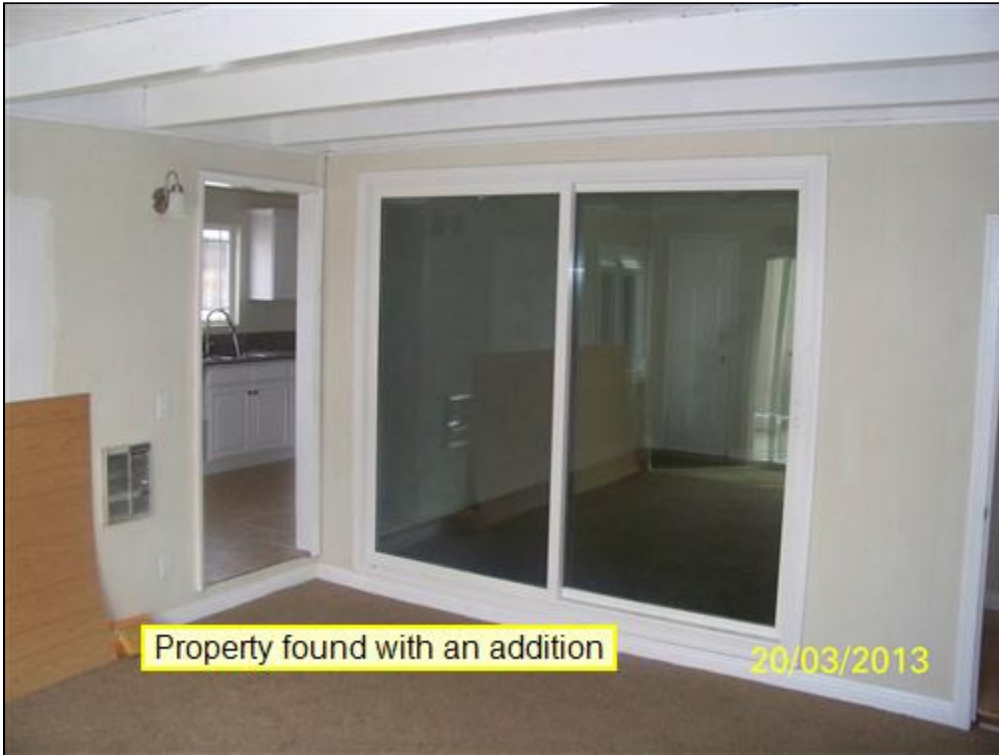
2.6 Picture 1

2.6 Inspector found an addition to dwelling, please have City of Compton come out and perform their mandatory pre-inspection, at this that time all issues with dwelling will be exposed and asked to be permitted or removed.

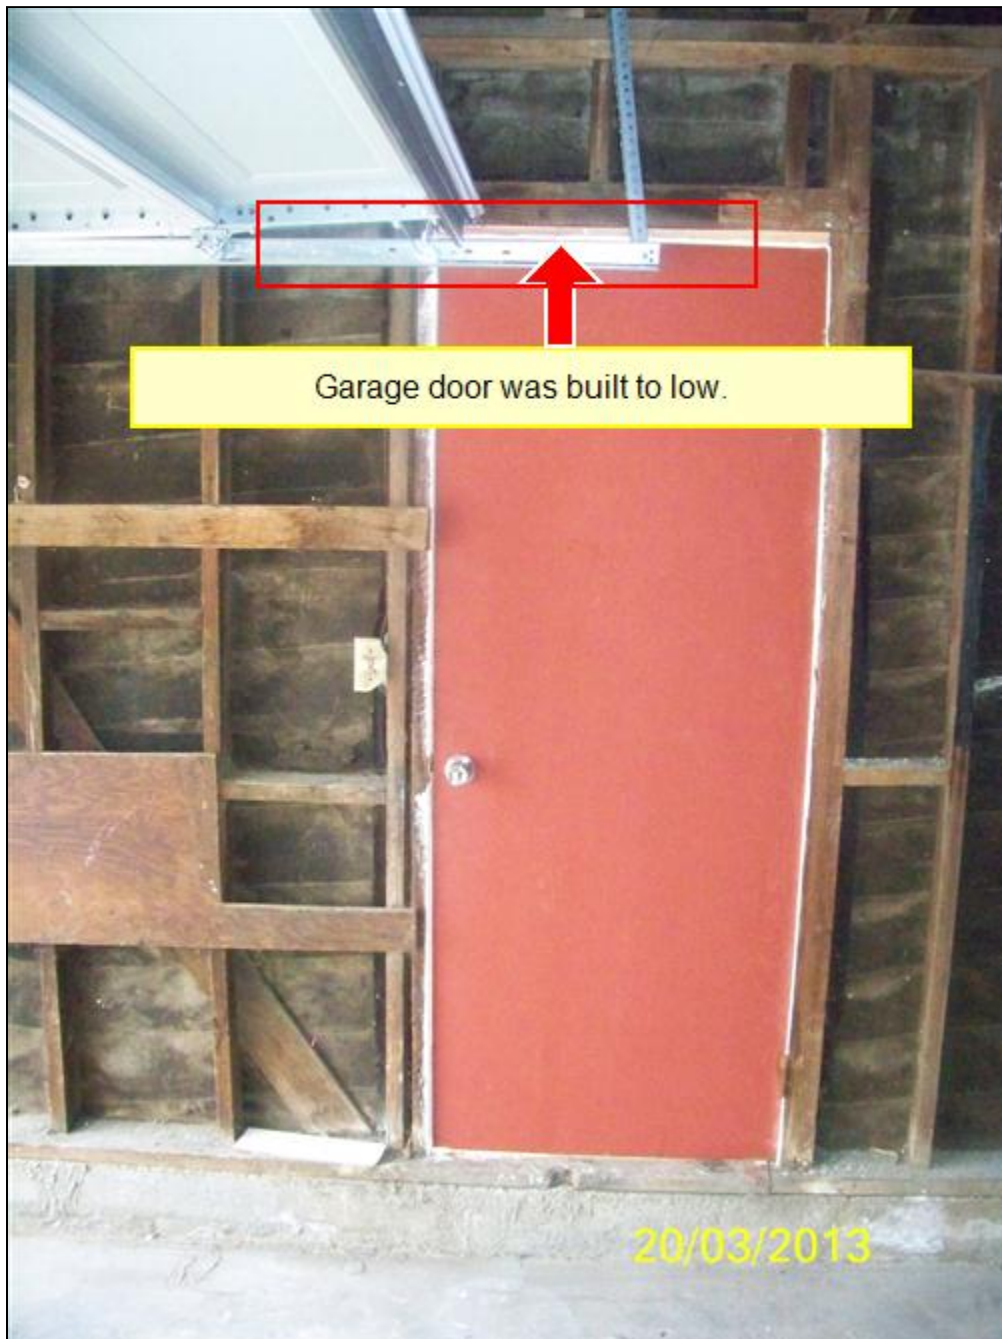
3.3 Picture 1

3.3 The garage door was built to low which prevents the rear exterior door from opening and closing. Please modify garage door, so that rear side door can function properly.

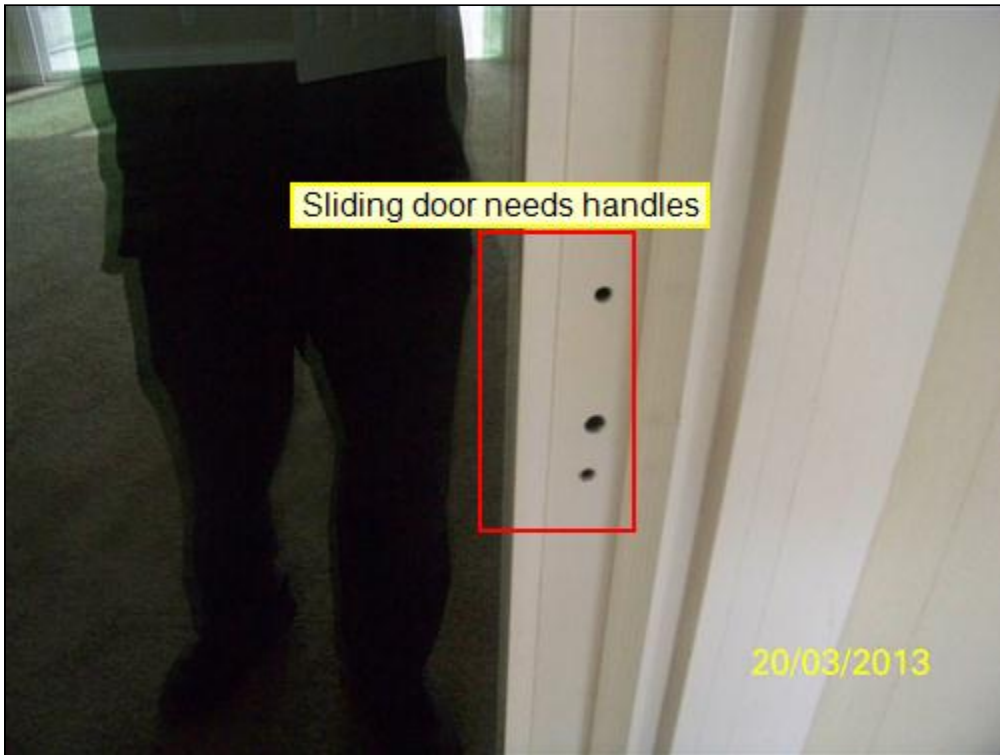
4.5 Picture 1

4.5 Sliding glass and interior bedroom door have no door handles. Please have a licensed contractor repair all areas of concern.

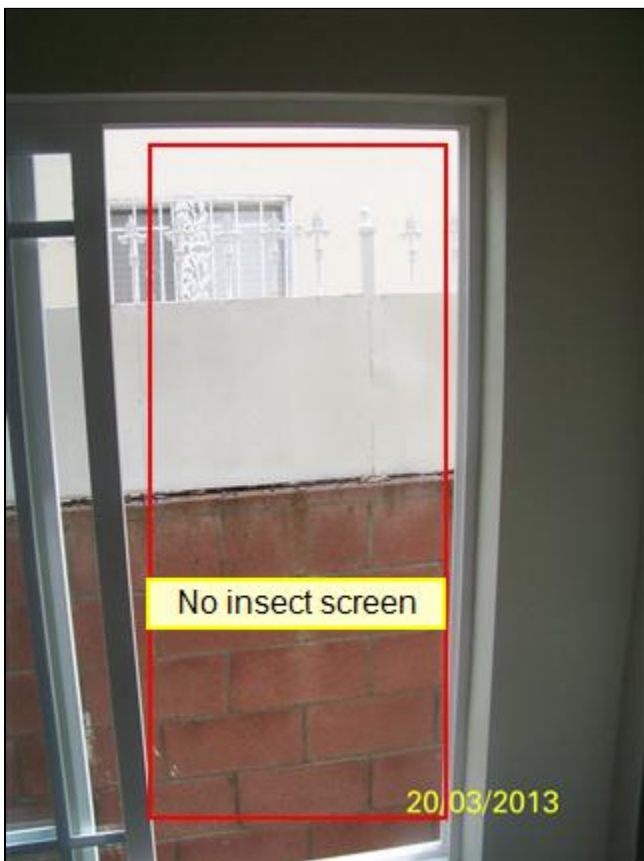
4.6 Picture 1

4.6 Inspector found no insect screen in bedroom window. Please have a screen installed to keep out flying pest.

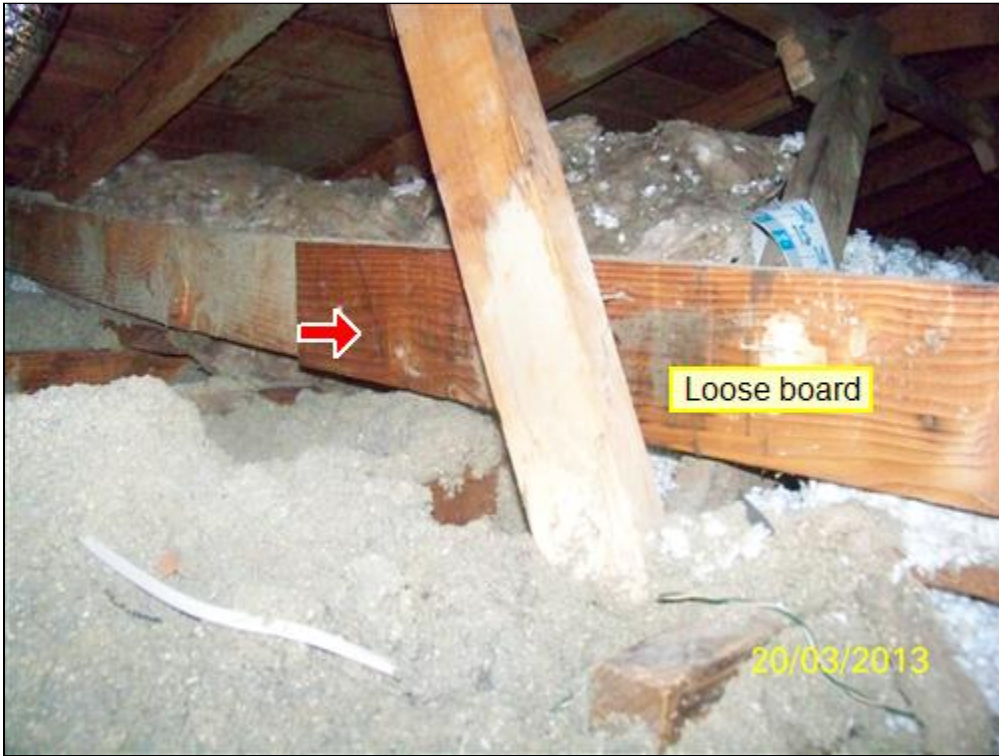
5.5 Picture 1

5.5 (1) Inspector found a loose board in the attic, please have a licensed contractor secure boards to attic foundation.

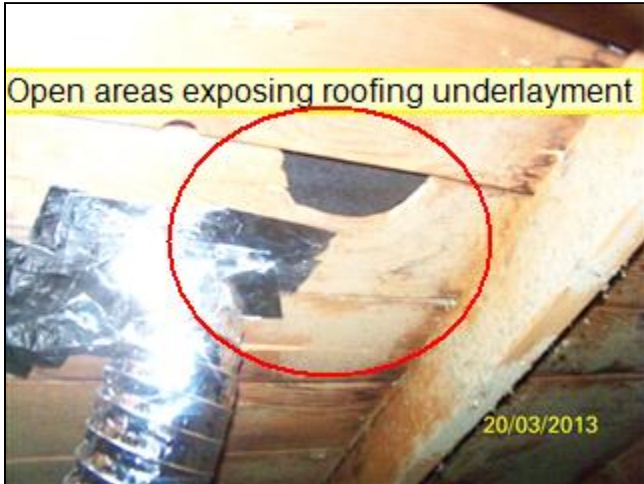
5.5 Picture 2

(2) Inspector found exposed roofing underlayment exposed in the garage. Please have licensed roofing contractor investigate and repair as needed.

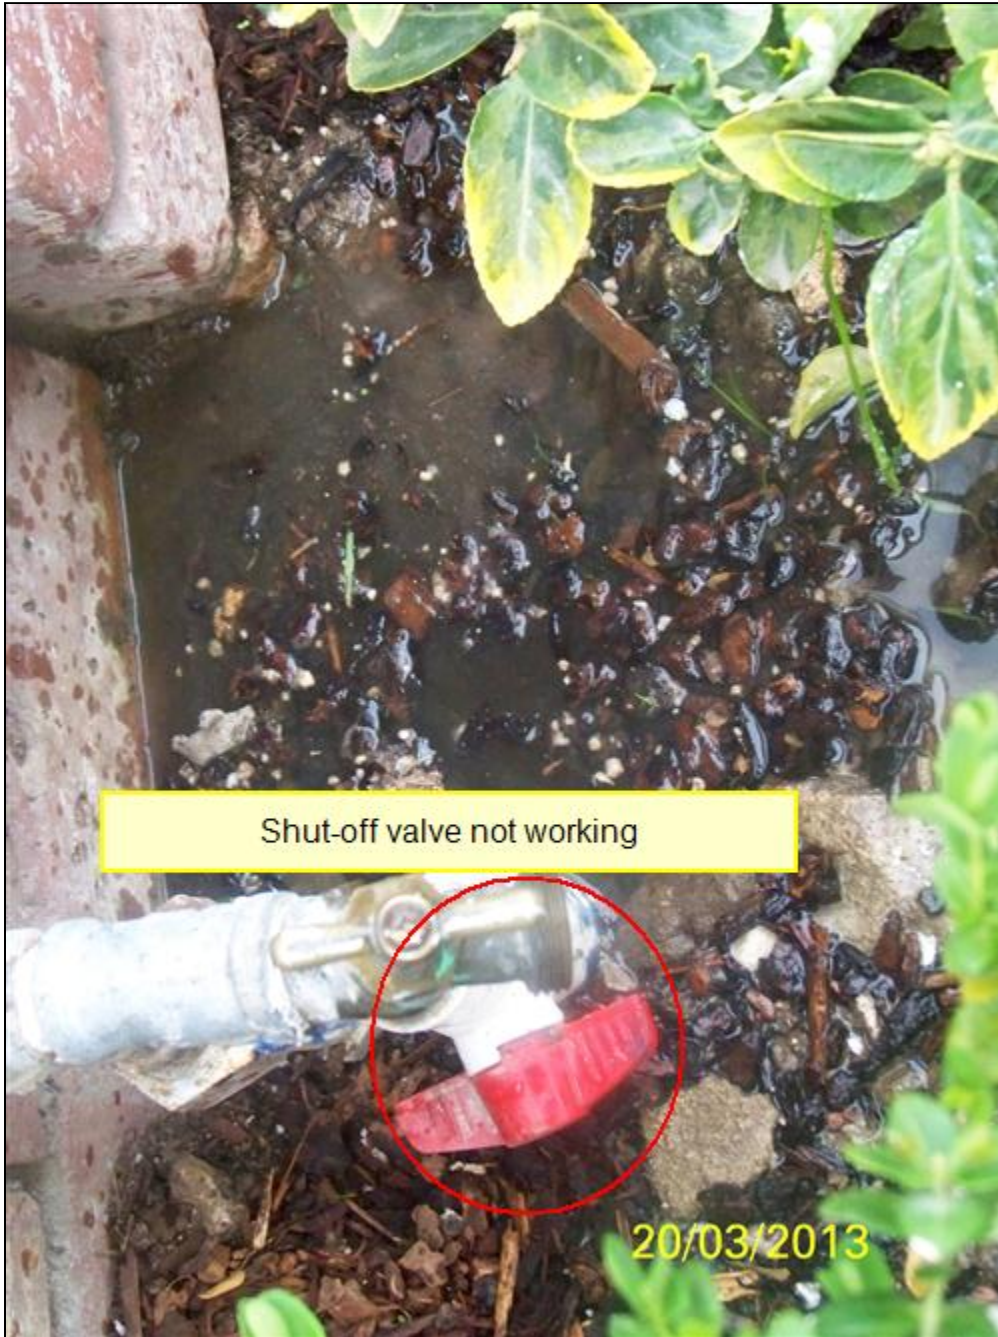
6.1 Picture 1

6.1 Inspector found front hose bibb shut-off valve not working. Please have a licensed plumber correct ball valve to function properly.

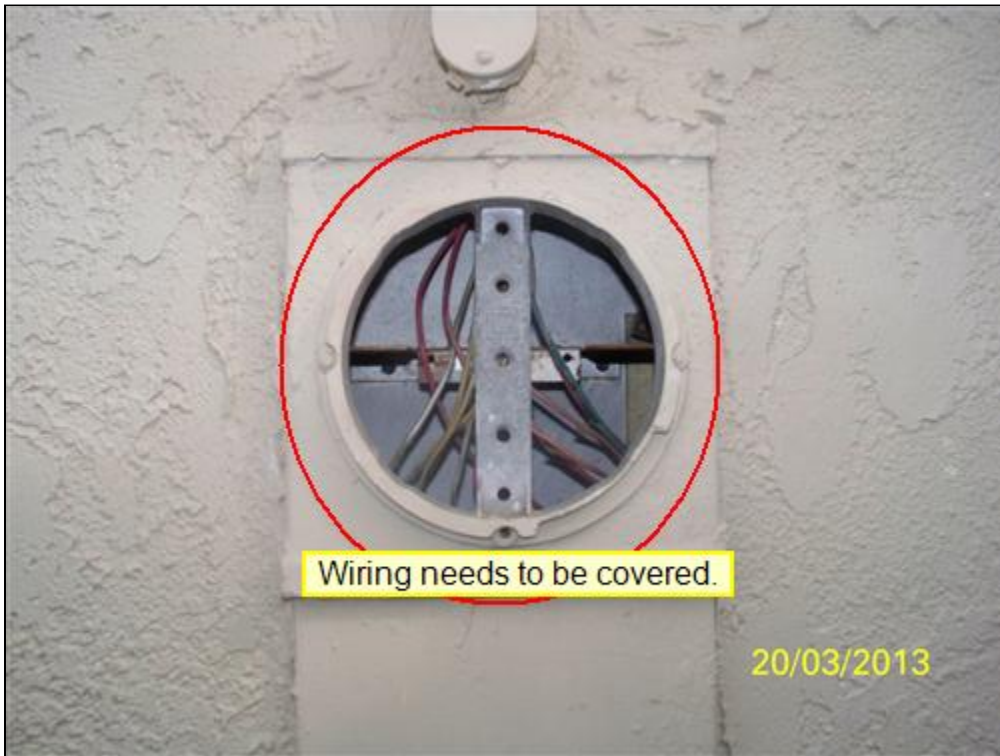
7.1 Picture 1

7.1 (1) Inspector found panel box open with wiring exposed, please close to prevent electrical shock. The weatherhead too low, and live wires lying on the roof. Please have a licensed electrical contractor investigate, and repair wiring system so that it will function properly and be safe.

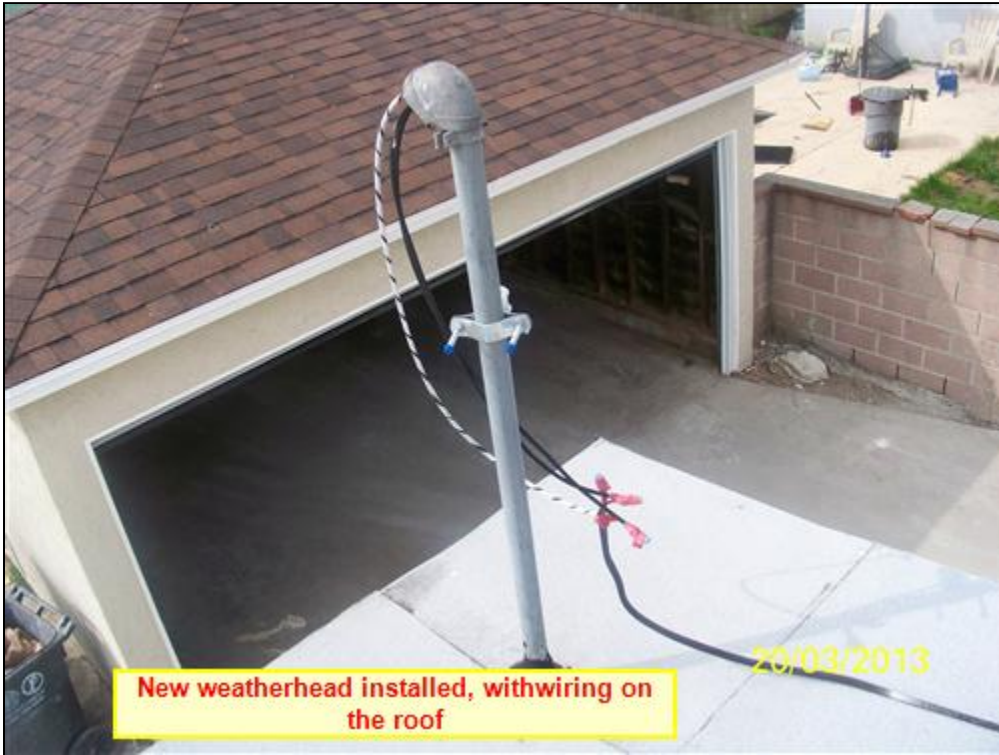
7.1 Picture 5

(2) Inspector found new panel box, and weather head installed. Please make sure new electrical, during pre-inspection was permitted by City.

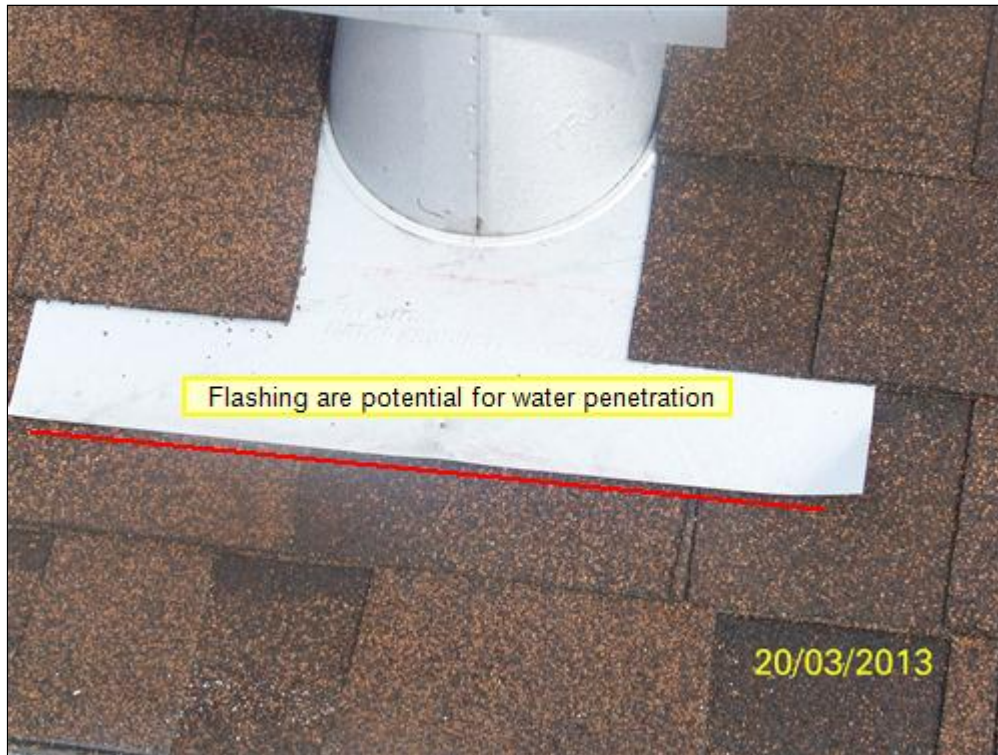
1.1 Picture 1

Inspector found flashing raised instead of being flat; which can have a potential for water intrusion. Inspector found no leaks in the home to state that the flashing is allowing water to penetrate.

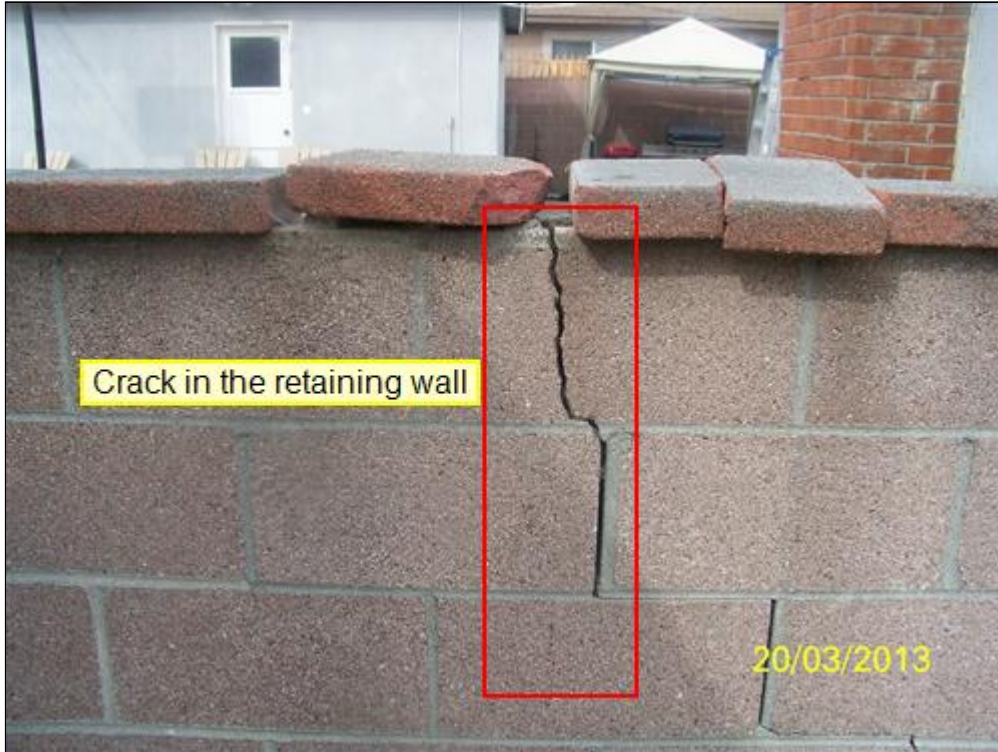
2.4 Picture 1

Inspector found a crack in the retaining wall. Please have a licensed contractor investigate an repair if needed. Inspector found two large holes in the rear yard. This can be a potential risk to individual walking near and fall into hole. Please have holes sealed with concrete, in order to prevent any incidents from happening.

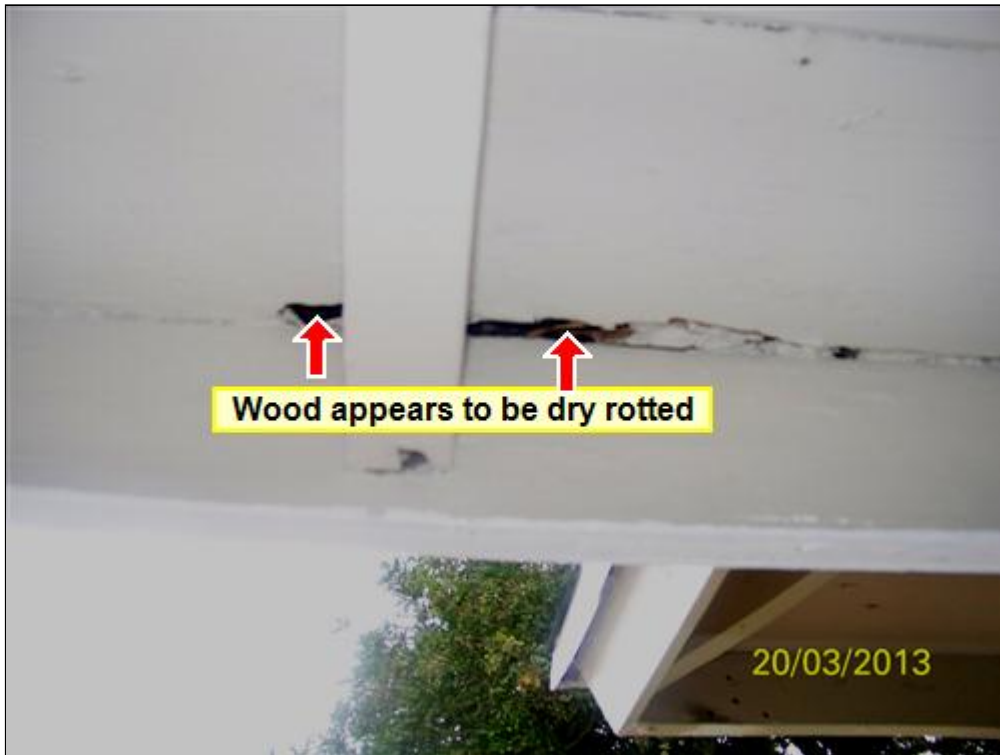
2.5 Picture 1

(1) Inspector found the exterior fascia boards having dry rot, and water stains from the roof previously leaking. Also beehives were found, please have a licensed contractor

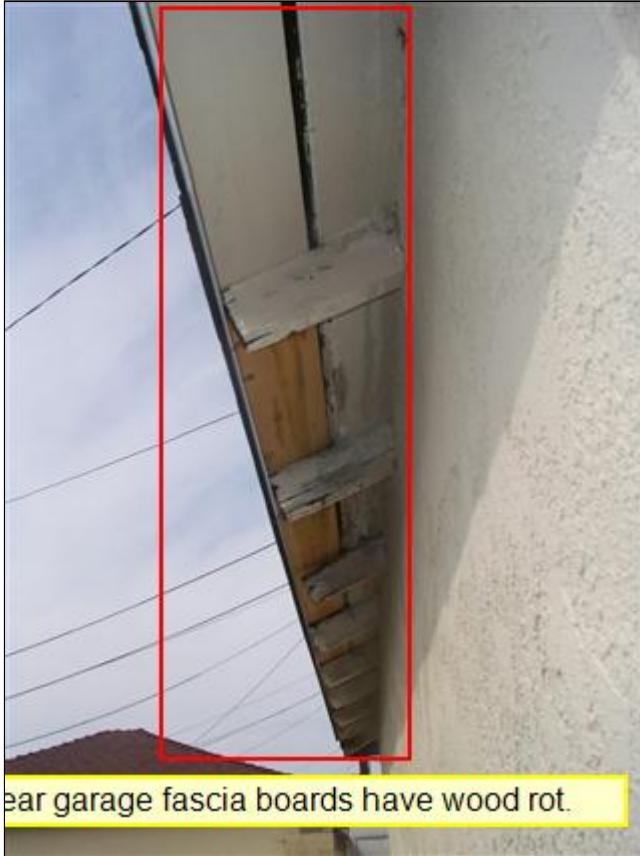
2.5 Picture 7

(2) Inspector found the garage rear fascia boards dry rotted, due to water damage. Please make sure termite inspector check for wood destroying pest. Please have a licensed contractor repair all areas of concern.

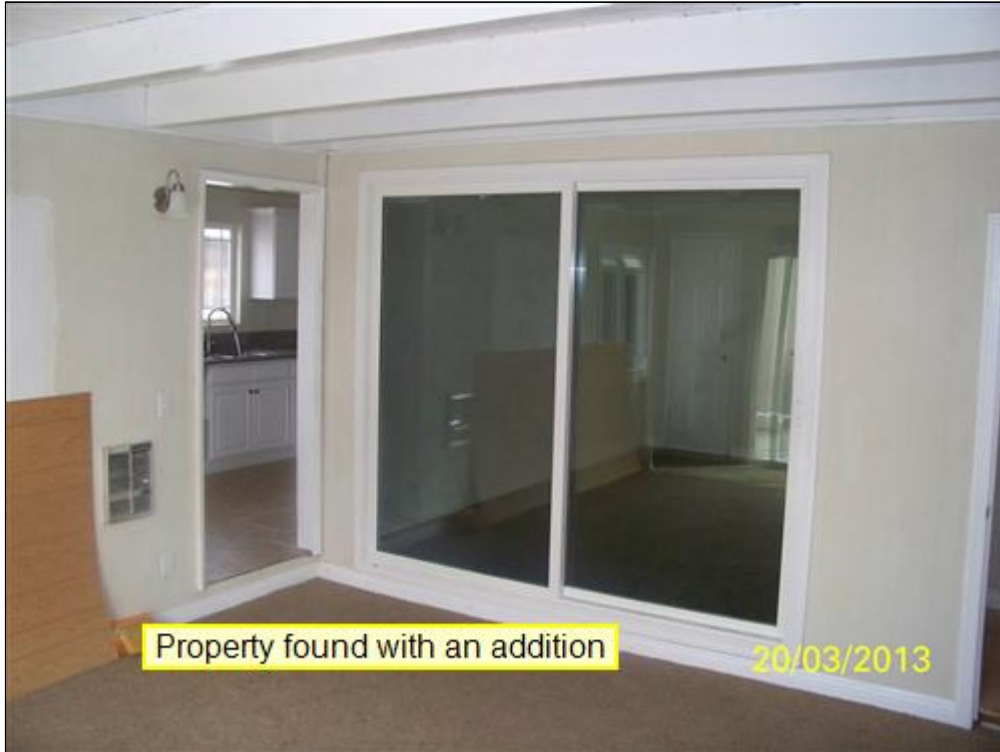
2.6 Picture 1

Inspector found an addition to dwelling, please have City of Compton come out and perform their mandatory pre-inspection, at this that time all issues with dwelling will be exposed and asked to be permitted or removed.

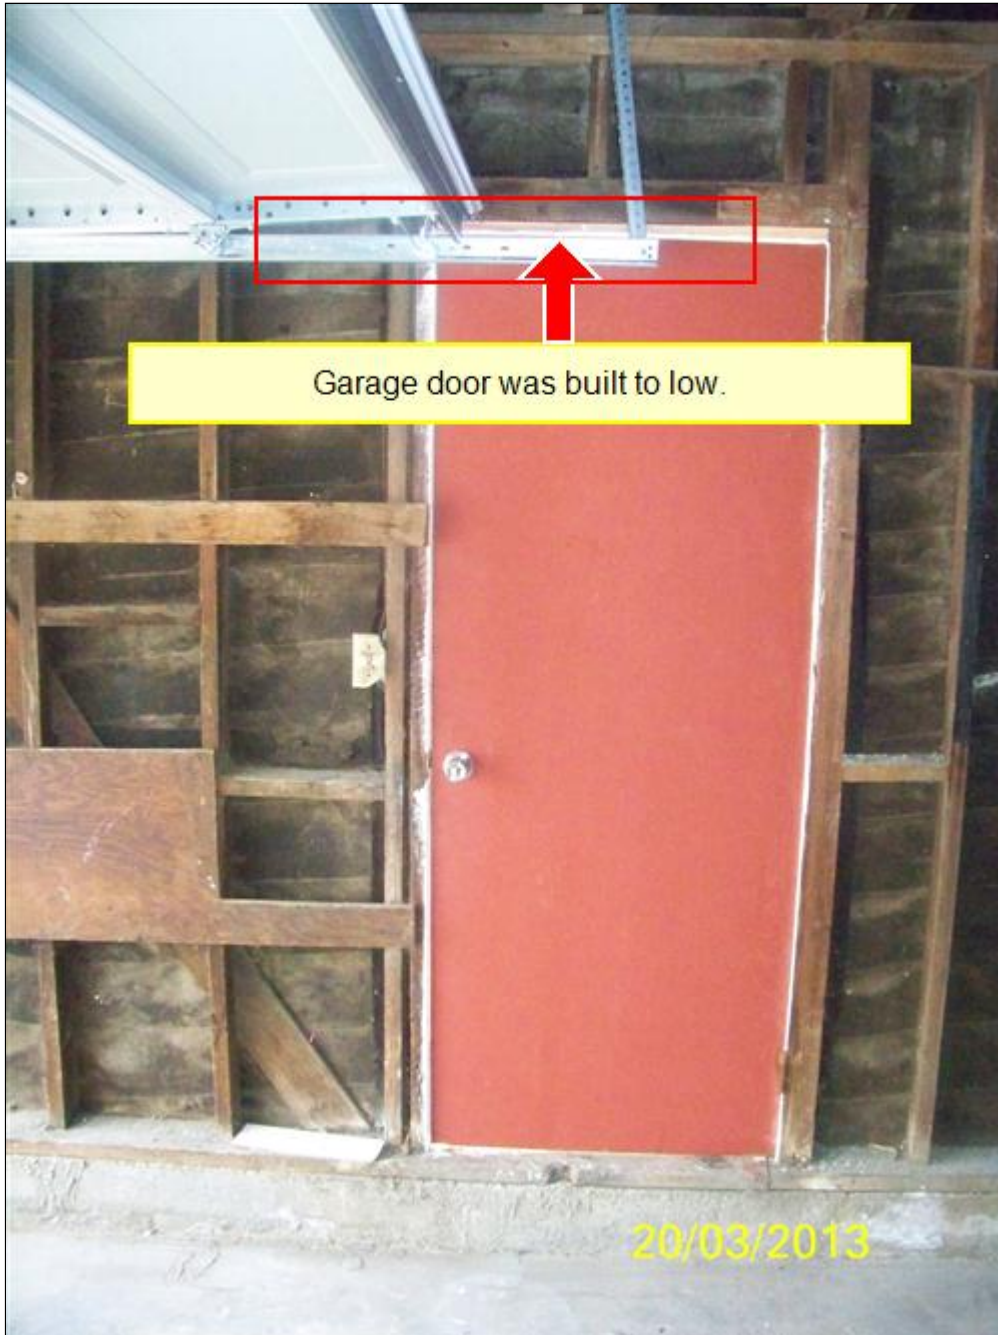
3.3 Picture 1

The garage door was built too low which prevents the rear exterior door from opening and closing. Please modify garage door, so that rear side door can function properly.

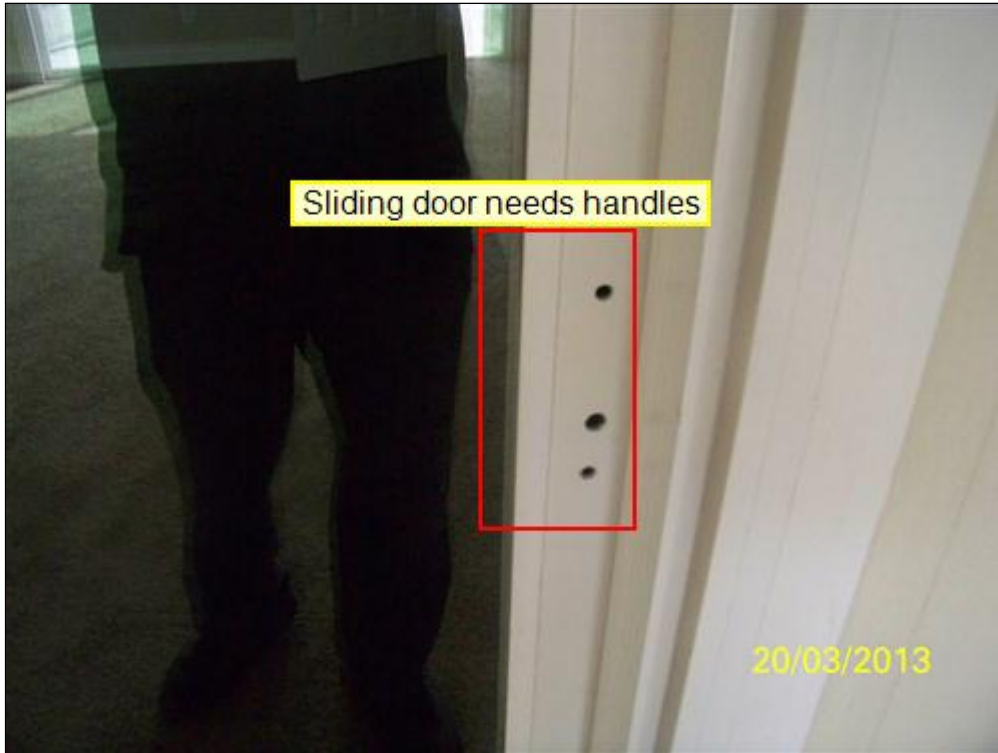
4.5 Picture 1

Sliding glass and interior bedroom door have no door handles. Please have a licensed contractor repair all areas of concern.

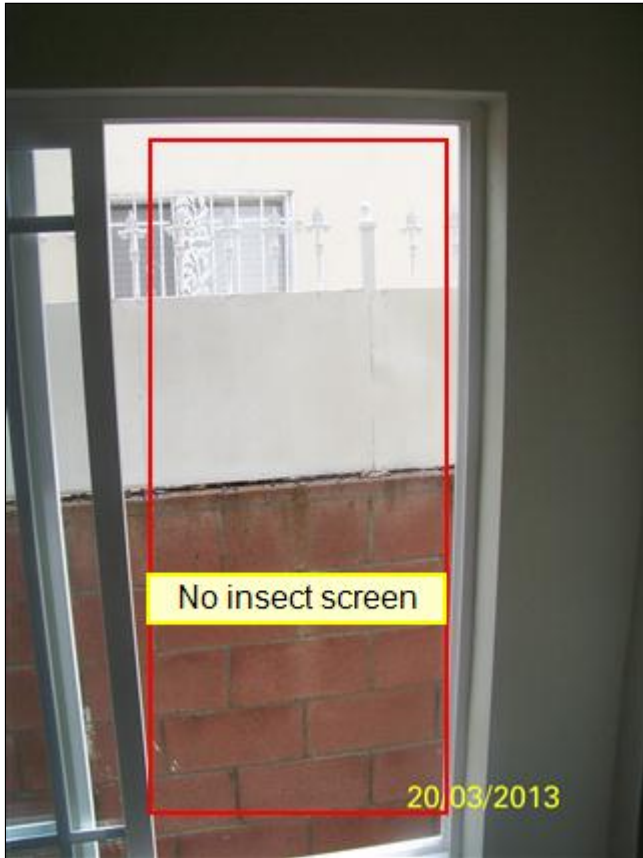
4.6 Picture 1

Inspector found no insect screen in bedroom window. Please have a screen installed to keep out flying pest.

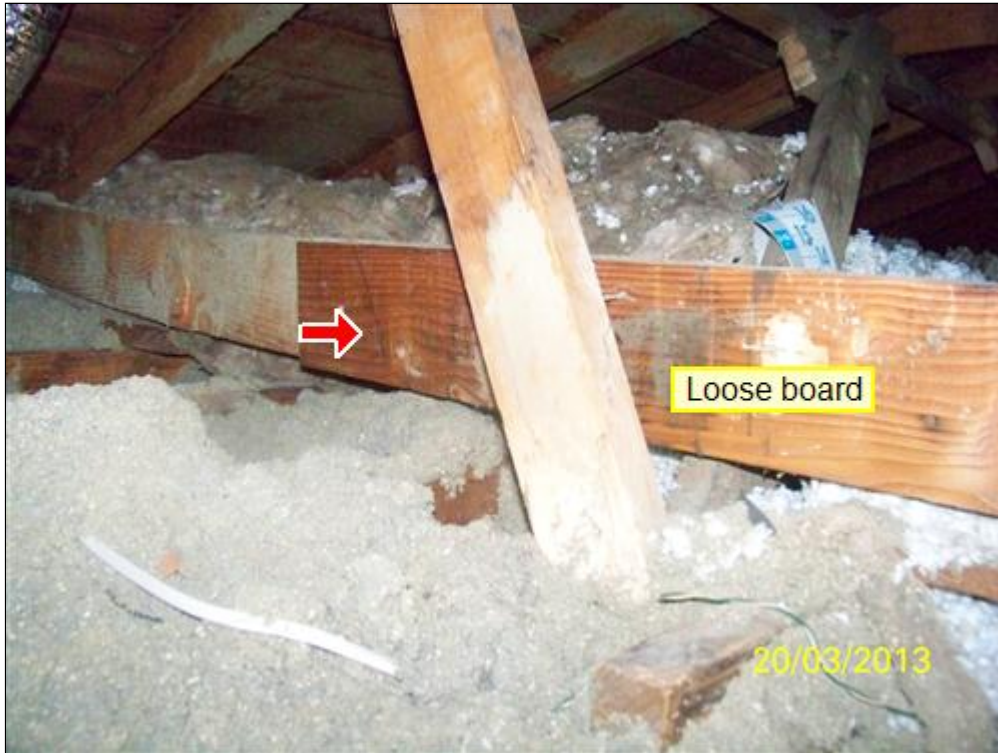
5.5 Picture 1

(1) Inspector found a loose board in the attic, please have a licensed contractor secure boards to attic foundation.

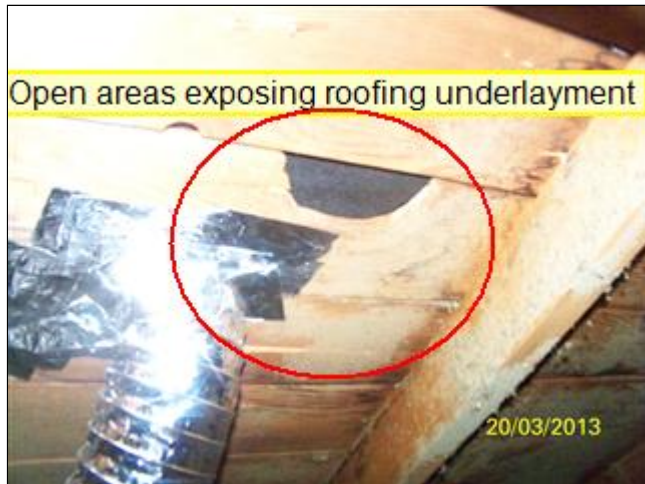
5.5 Picture 2

(2) Inspector found exposed roofing underlayment exposed in the garage. Please have licensed roofing contractor investigate and repair as needed.

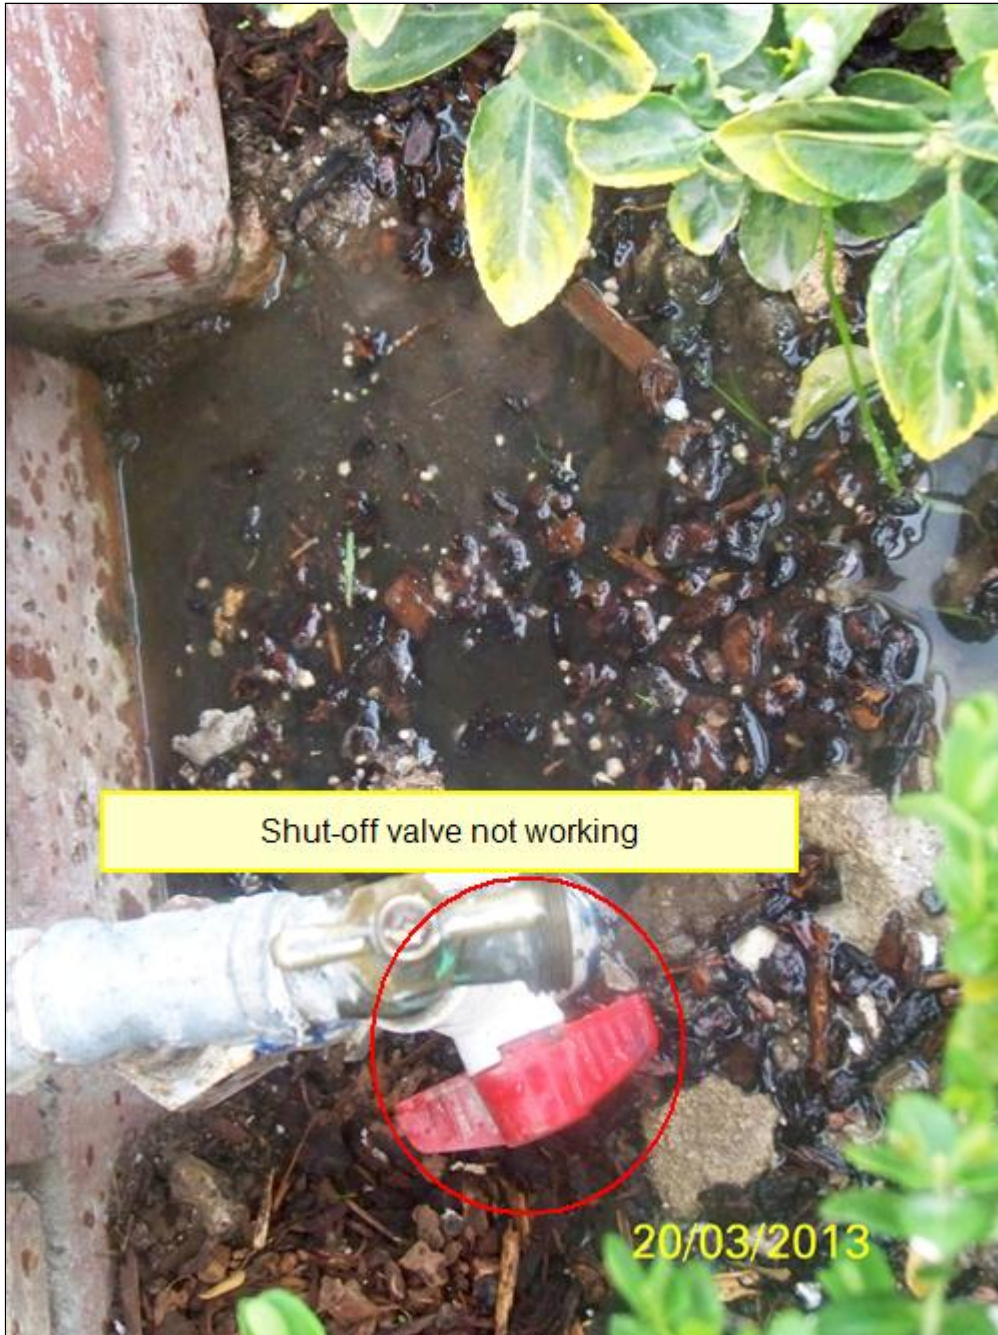
6.1 Picture 1

Inspector found front hose bibb shut-off valve not working. Please have a licensed plumber correct ball valve to function properly.

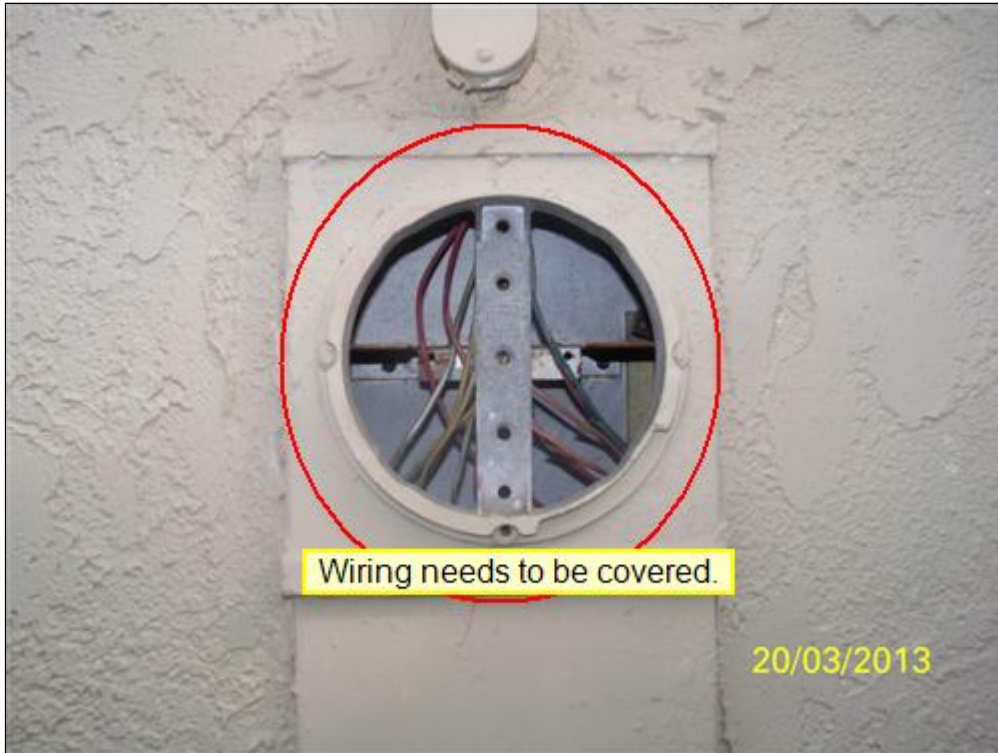
7.1 Picture 1

(1) Inspector found panel box open with wiring exposed, please close to prevent electrical shock. The weatherhead too low, and live wires lying on the roof. Please have a licensed electrical contractor investigate, and repair wiring system so that it will function properly and be safe.

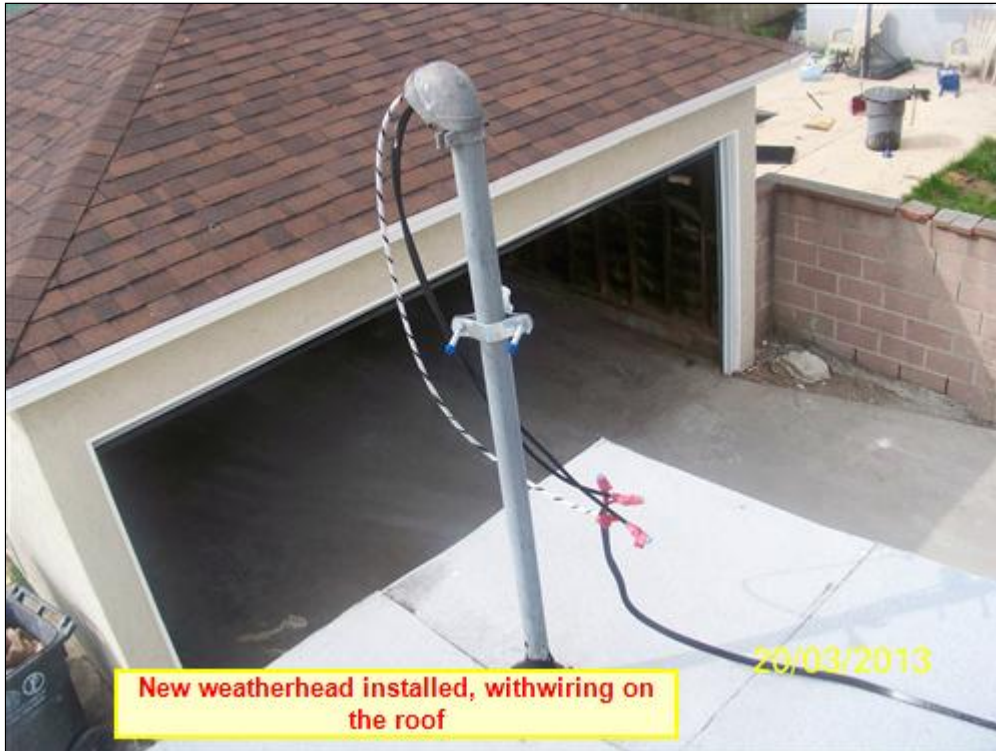
7.1 Picture 5

(2) Inspector found new panel box, and weather head installed. Please make sure new electrical, during pre-inspection was permitted by City.
