# KLEEN INSPECTION

## Inspection Report

**Property Address:**  
3707/3709 Orange Ave.  
Long Beach CA 90807

<b>Date:</b> 3/26/2013	<b>Time:</b> 10:00 AM	<b>Report ID:</b> 032313
<b>Property:</b> 3707/3709 Orange Ave. Long Beach CA 90807	<b>Customer:</b> Ms. Earla Burnette	<b>Real Estate Professional:</b> DJ Bonner Keller Williams

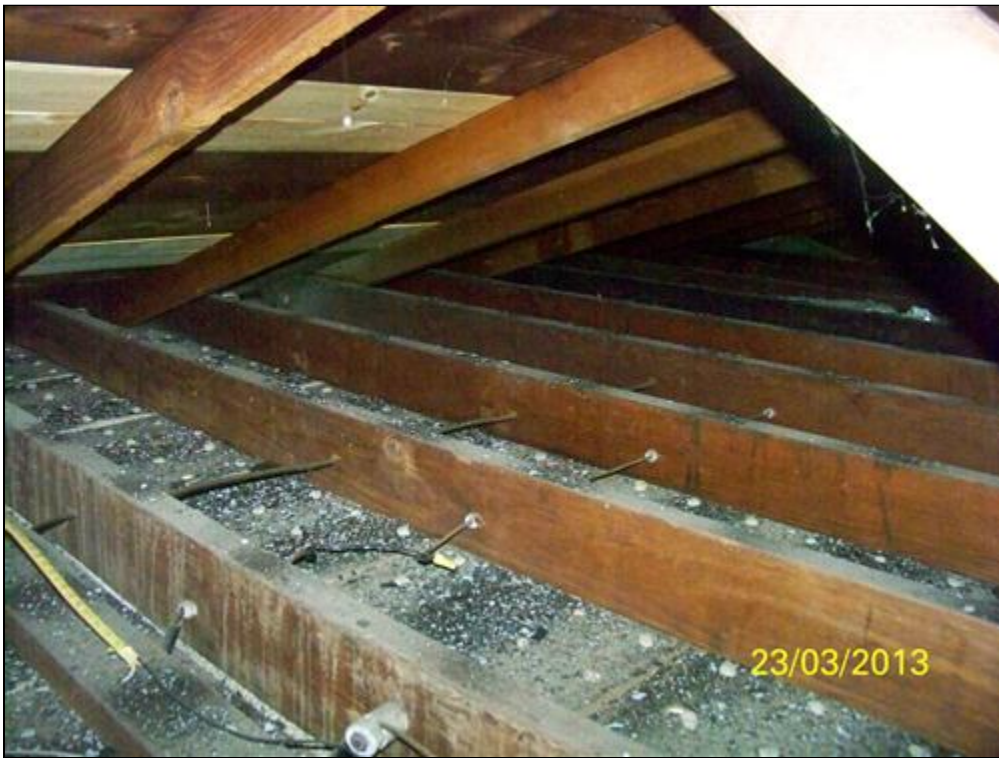
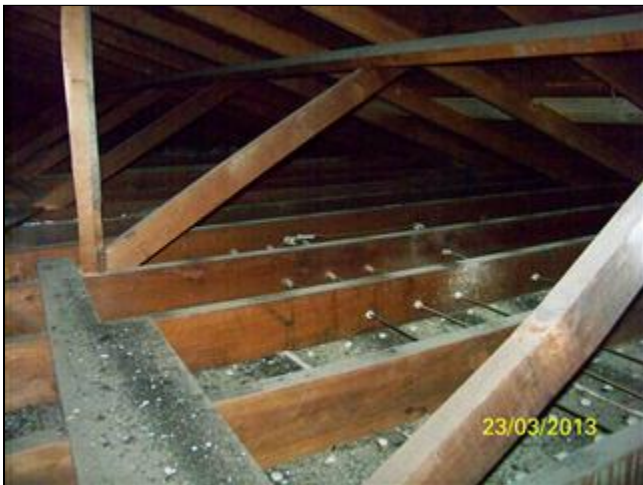
1.7 Picture 1

🏠 1.7 Inspector found no insulation in the attic. Please install insulation in attic by certified installer

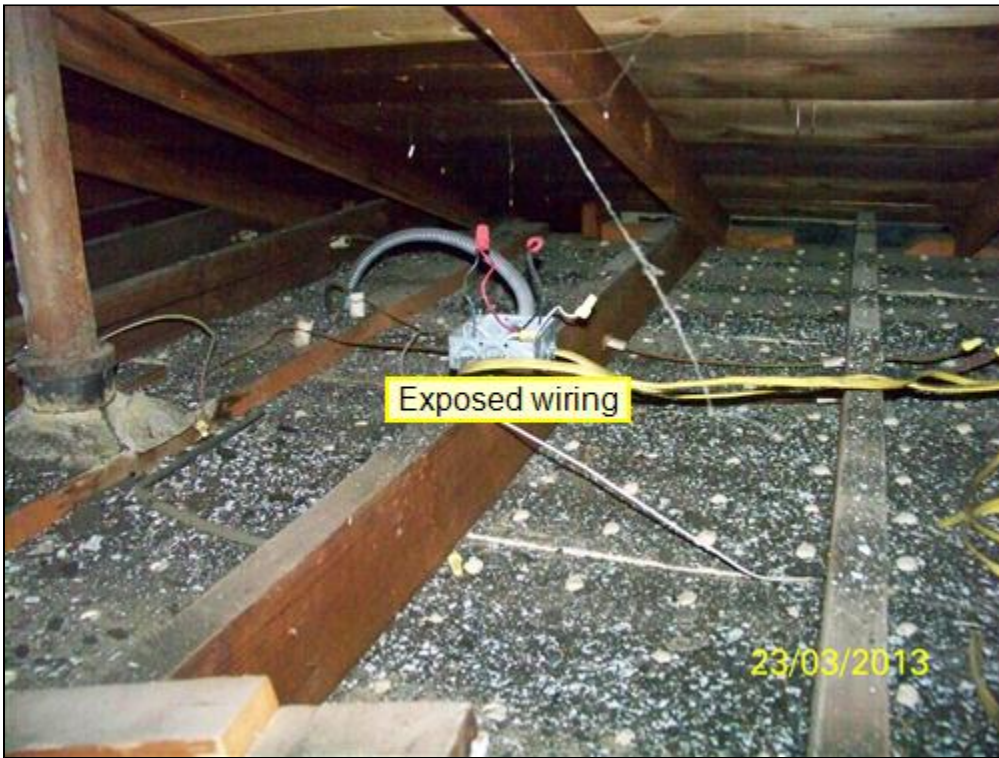
1.9 Picture 1

1.9 Inspector found exposed wiring in attic. Please have a licensed electrician enclose all wiring safely.

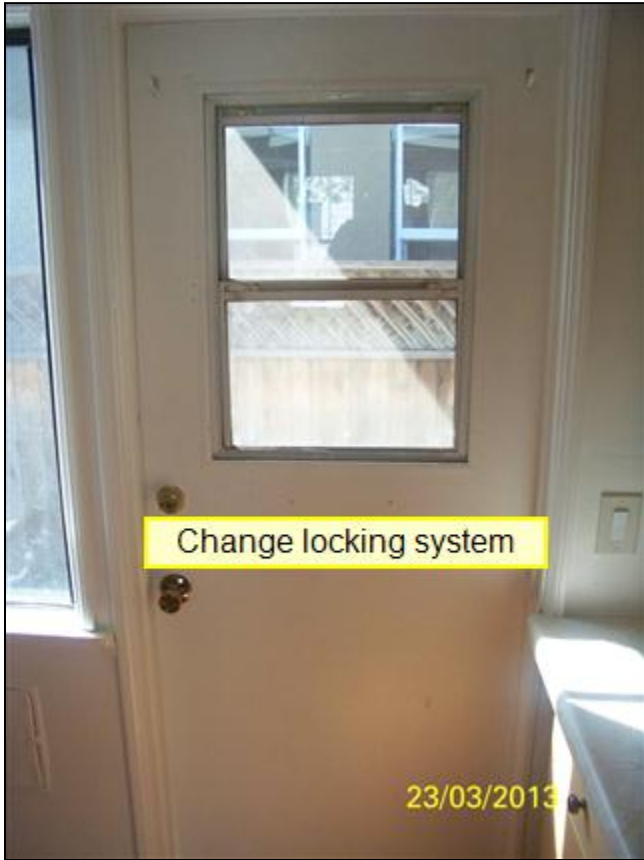
2.1 Picture 1

**2.1** Inspector found that the rear entry door locking system is not secure. Please have locksmith fix or repair locking system.

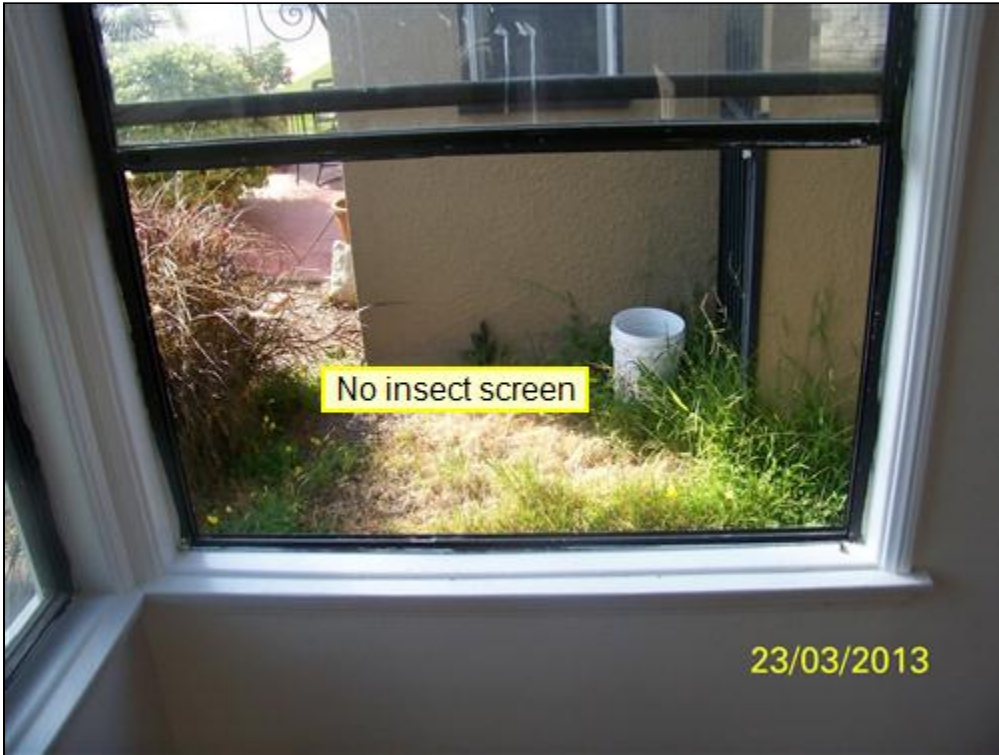
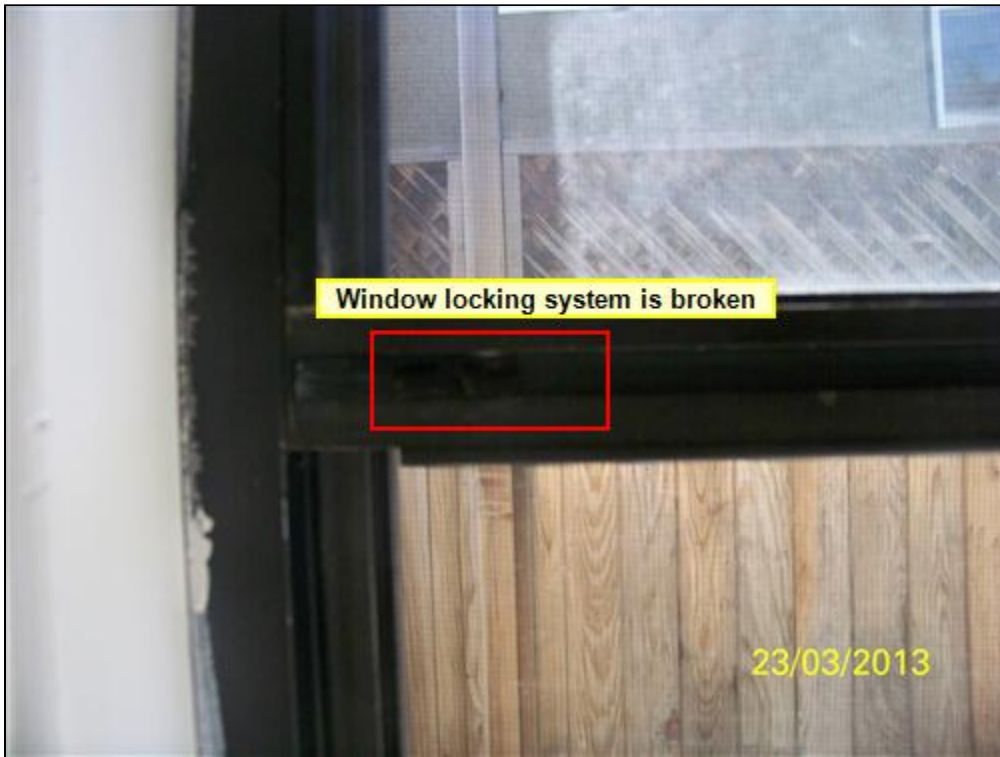
2.2 Picture 1

**2.2** (1) Please have window screen replaced, and locking system repair by licensed contractor.

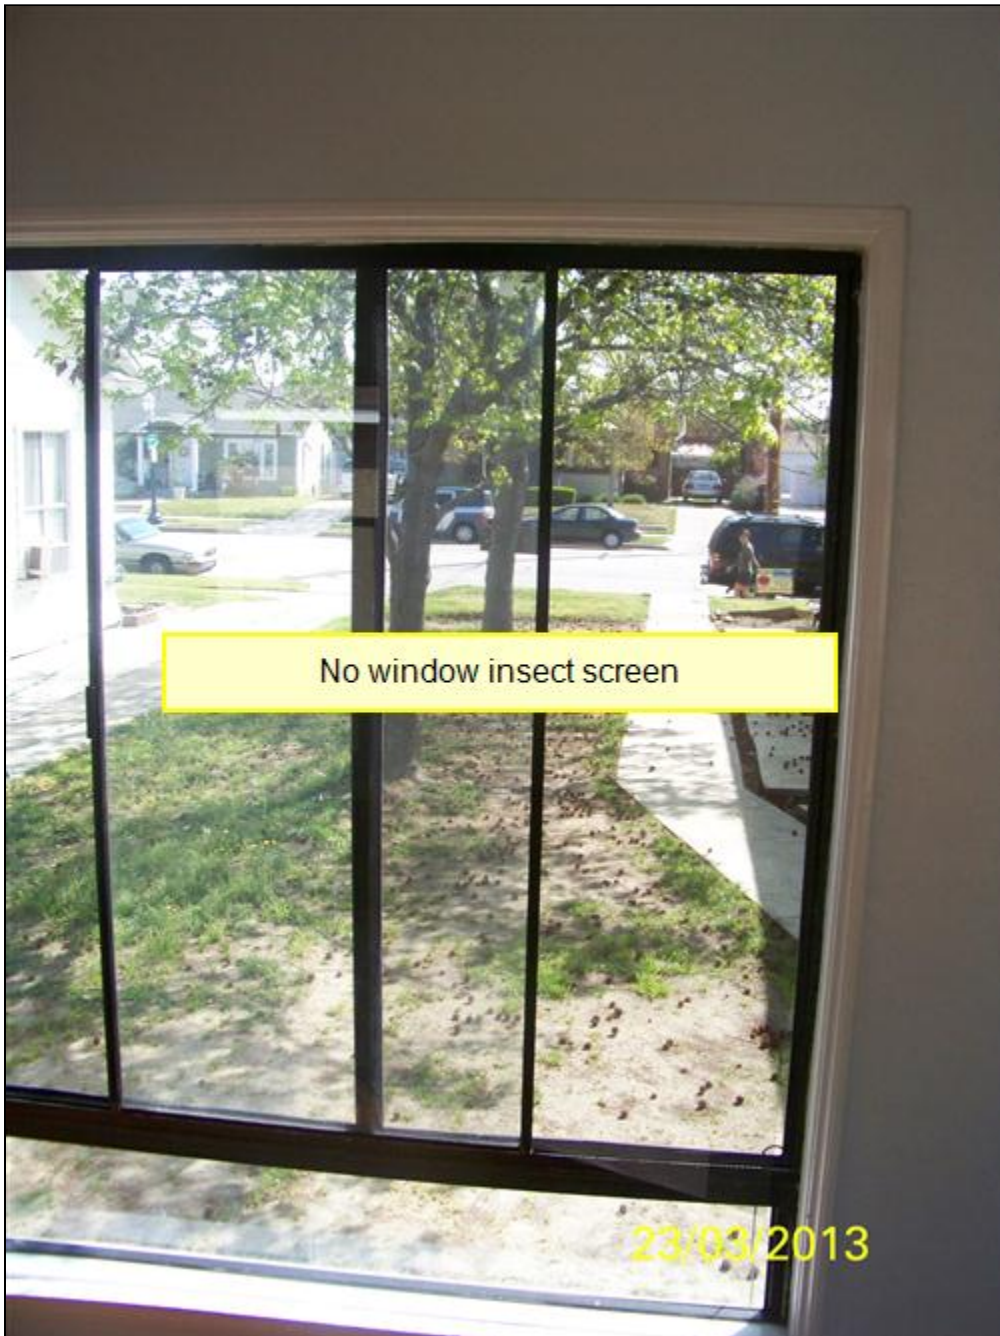
2.2 Picture 4

(2) Inspector found window and door screens either missing or torn. Please have each screen replaced by contractor.

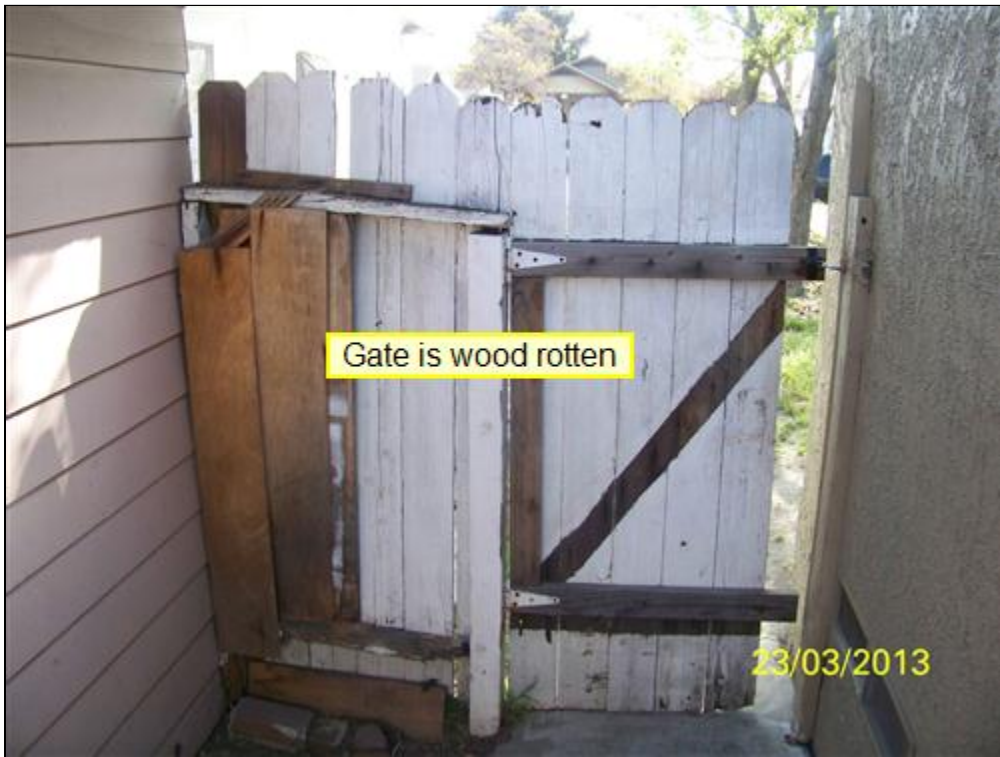
2.5 Picture 1

🏠 2.5 Inspector found that the rear entry gate a wood rotten, and need to be repaired.

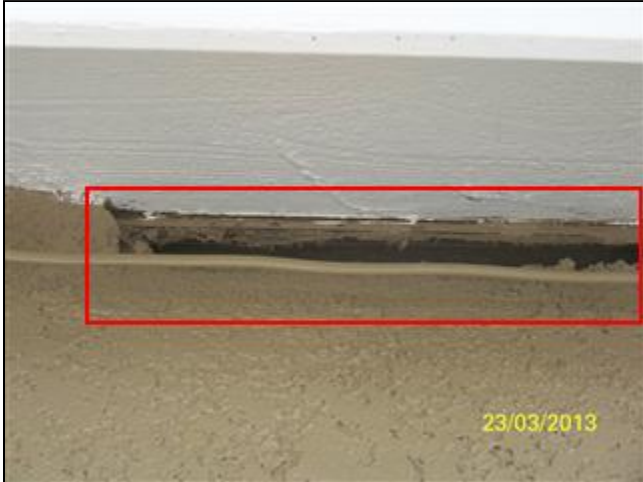
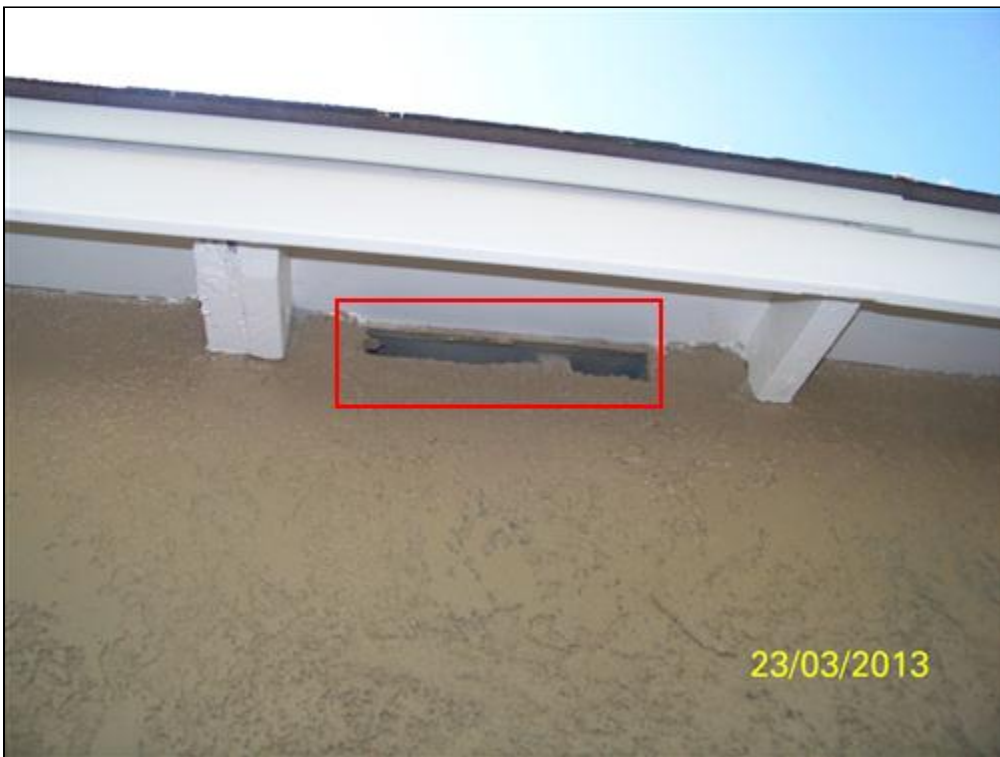
2.6 Picture 1

**2.6** Inspector found the attic screen to be missing or torn. Please have new screens installed to prevent rodent, or bird entry.

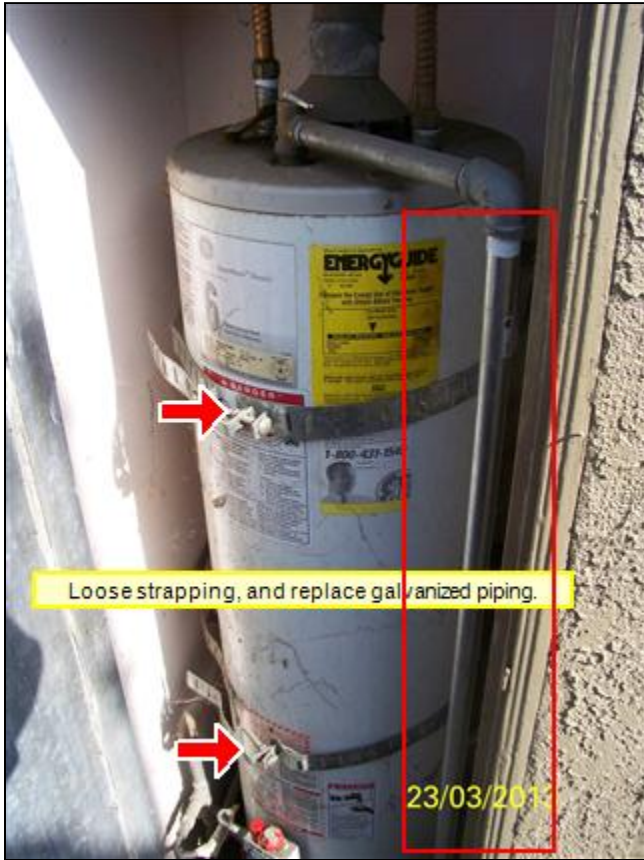
4.2 Picture 1 3707 Water Heater

**4.2 (1)** Inspector found hot water heater for unit 3707 needs to have galvanized piping replaced with copper, and straps tightened.

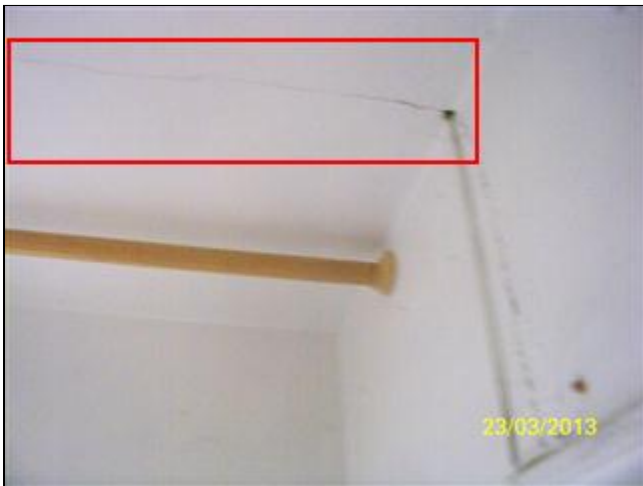
5.0.A Picture 1

**5.0.A** Inspector found a crack in the ceiling. Please have a licensed contractor repair ceiling.

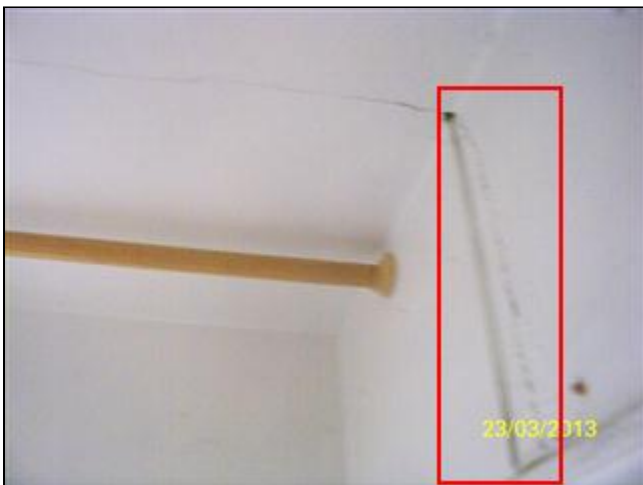
5.1.A Picture 1

**5.1.A** Inspector found crack in the wall, please have a licensed contractor repair wall.

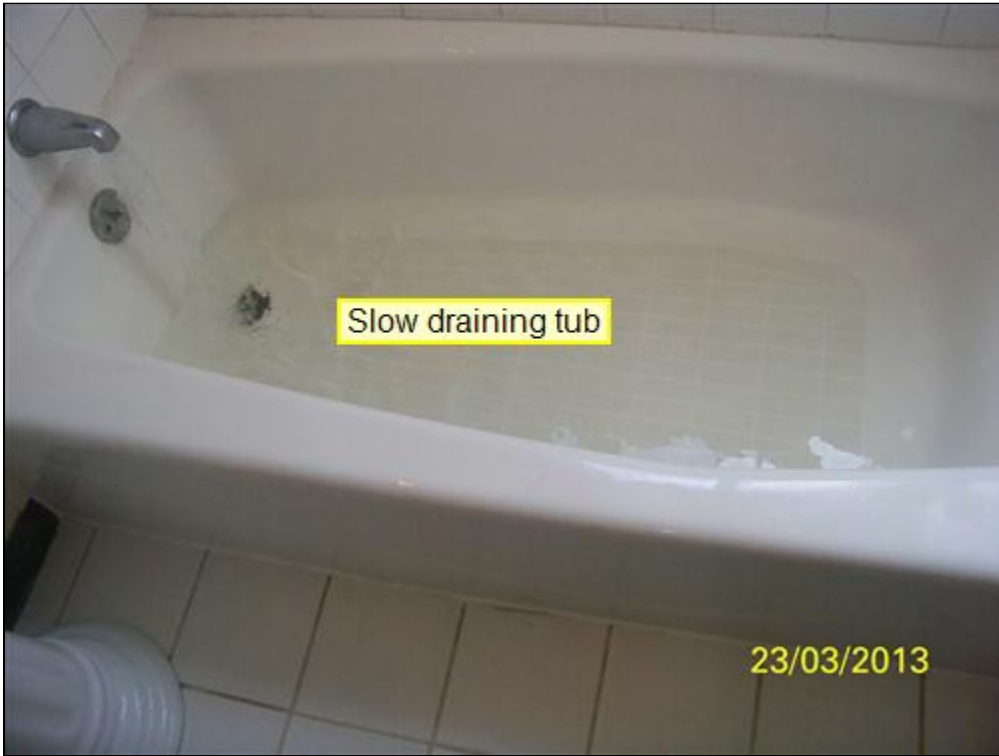
5.7.A Picture 1

**5.7.A** Please have tub investigated and repaired so it drains properly.

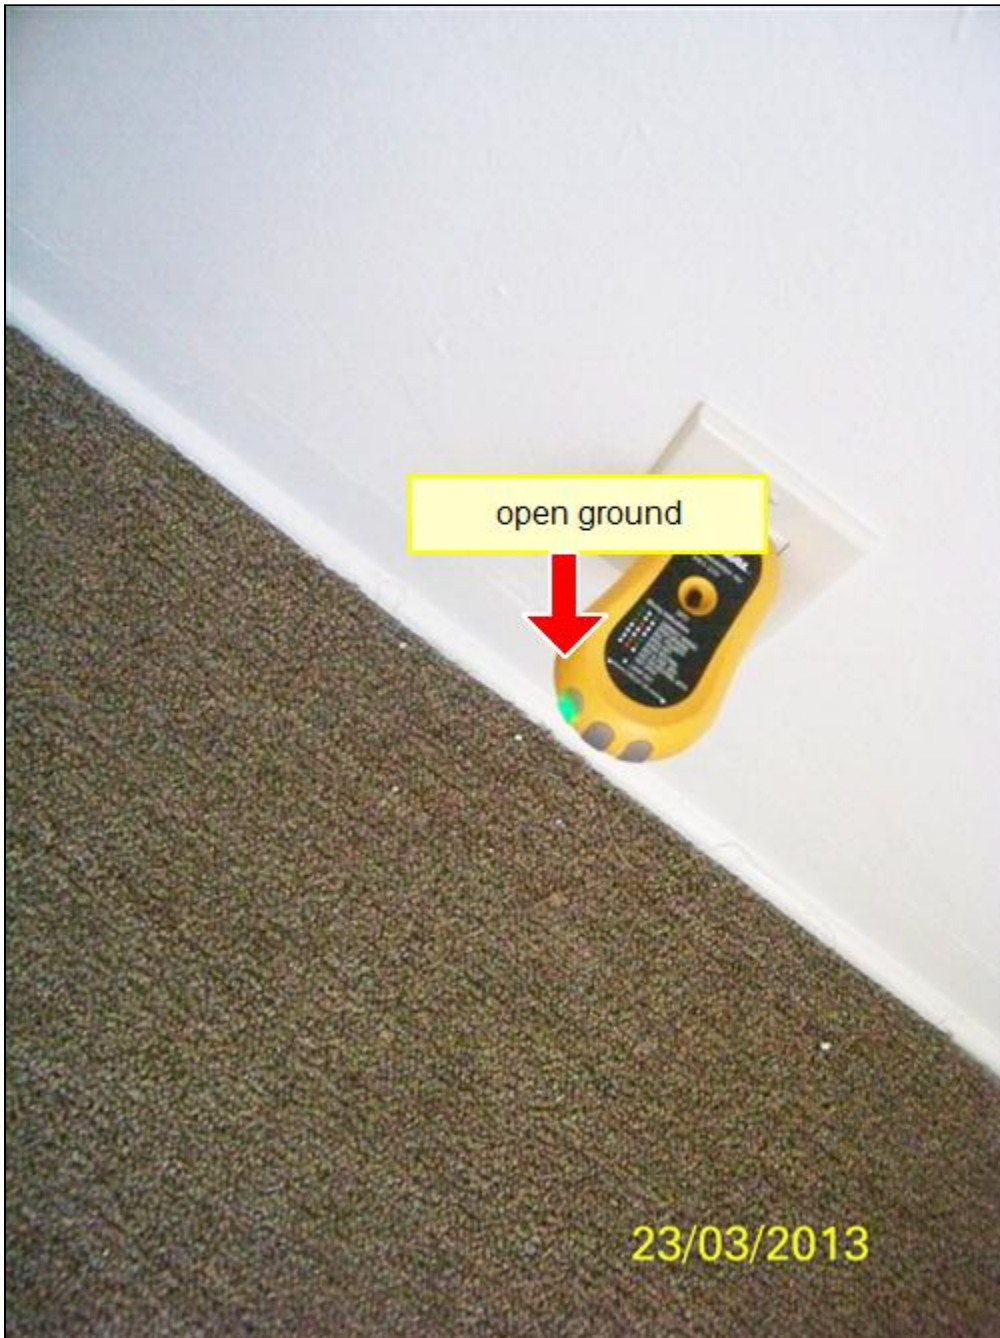
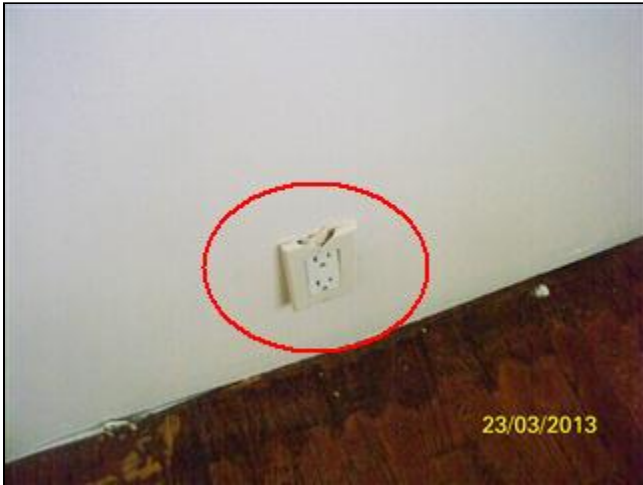
5.9.A Picture 1

**5.9.A** Inspector found that each room outlet is open ground. Please have licensed electrician repair each unit by properly grounding each unit. Also please replace broken coverplate.

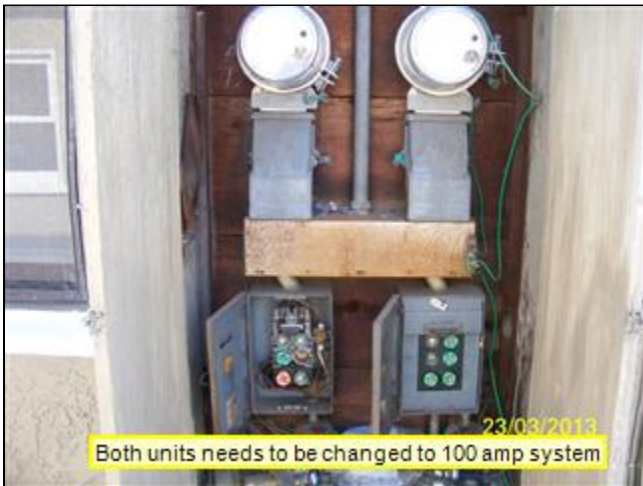
5.25.A Picture 1

**5.25.A** Inspector found that both units needs to be changed over from fuses to breakers by licensed electrician.

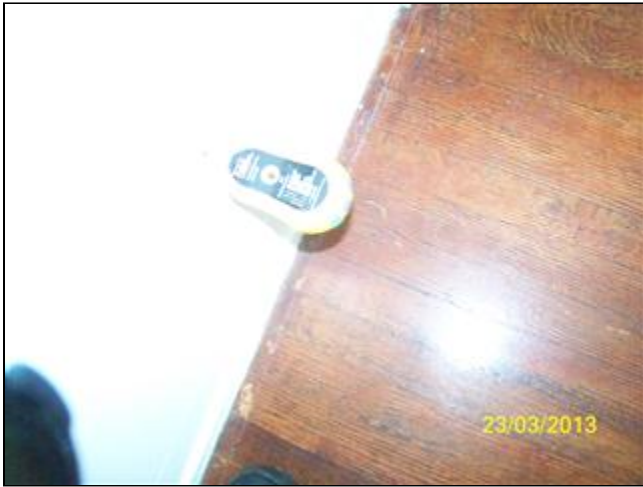
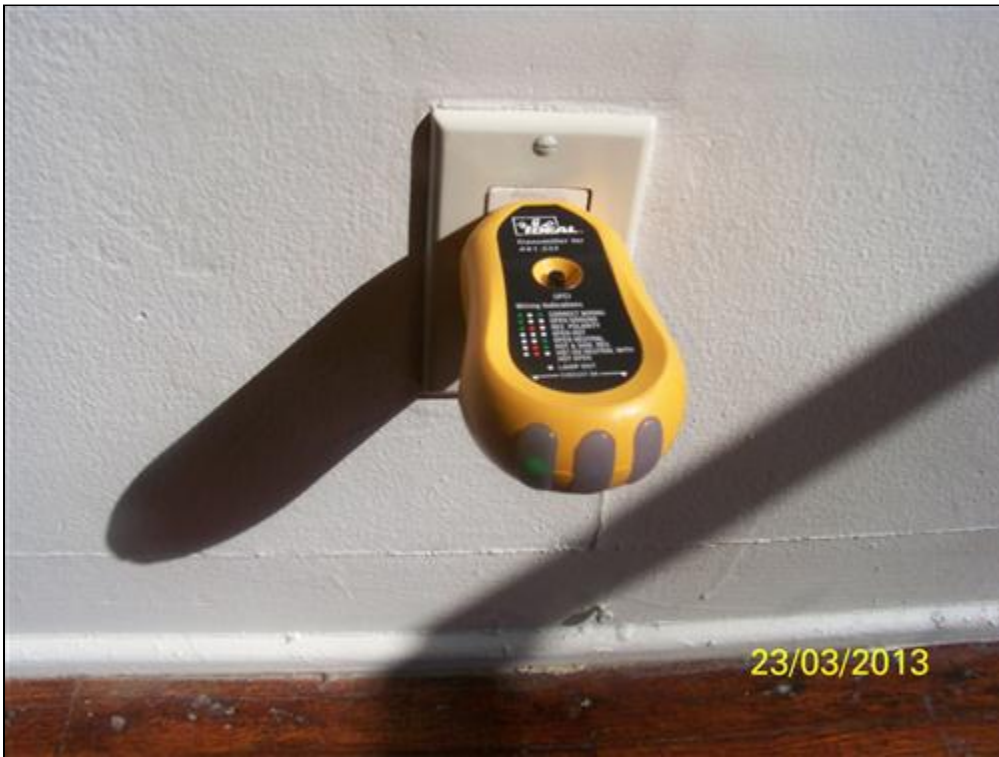
5.27.A Picture 1

**5.27.A** Inspector found open ground at every outlet; please have a licensed electrician properly ground each unit.

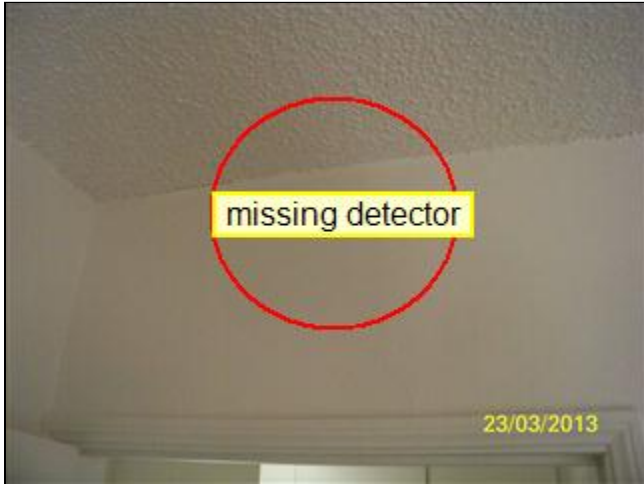
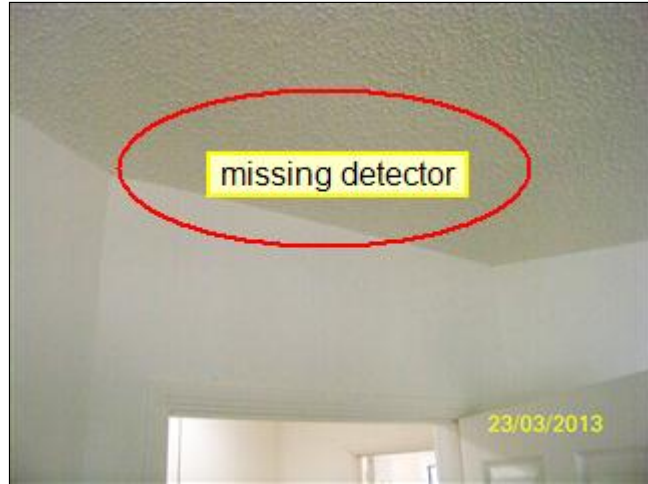
5.29.A Picture 1

**5.29.A** Inspector found no working smoke detectors during inspection. Please install smoke detector in each bedroom and common area hall.

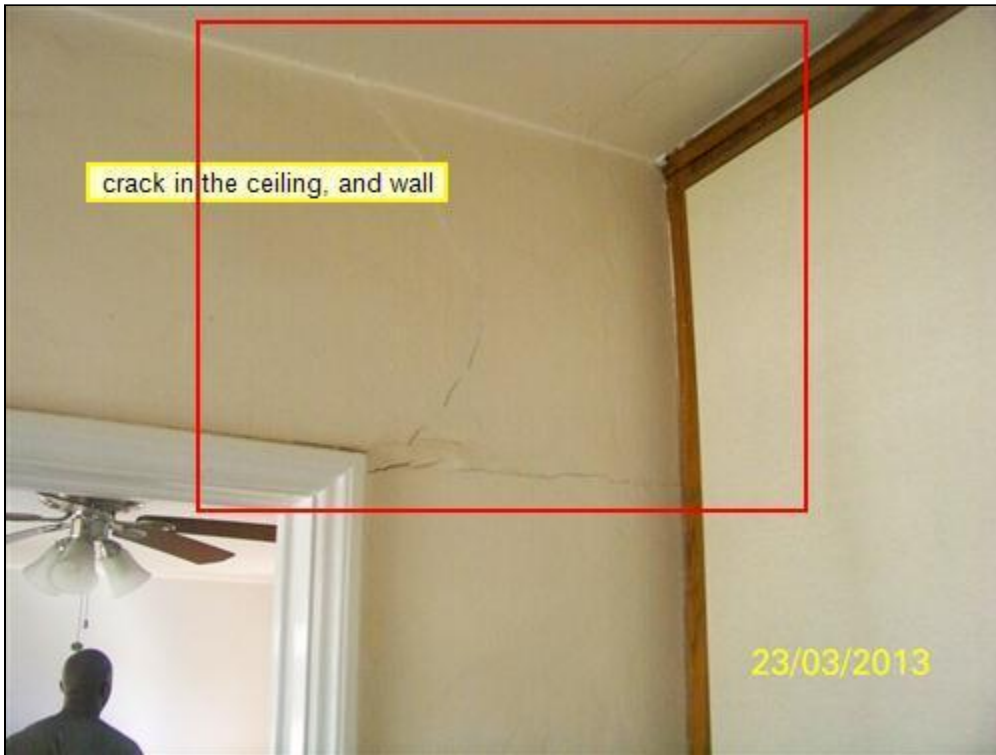
5.0.B Picture 1

**5.0.B** Inspector found cracks in wall and ceiling. Please have a licensed contractor repair each area.

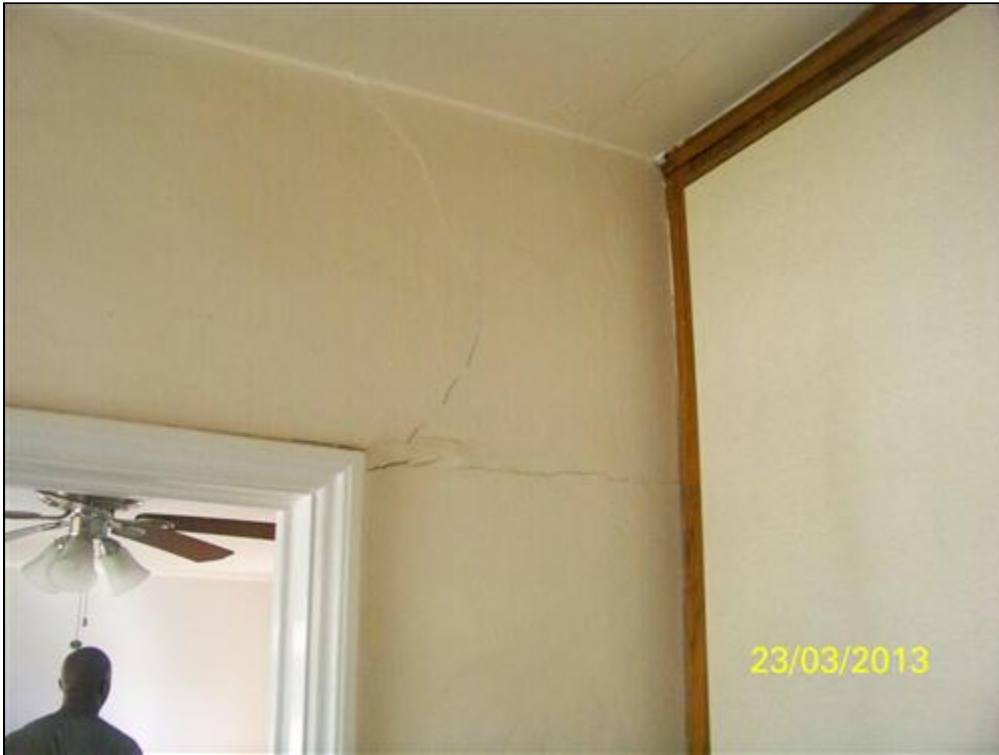
5.1.B Picture 1

**5.1.B** Inspector found crack in the wall of the unit. Please repair area of concern.

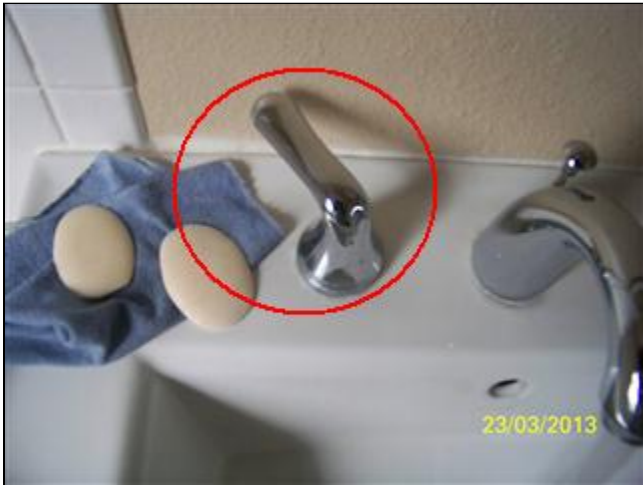
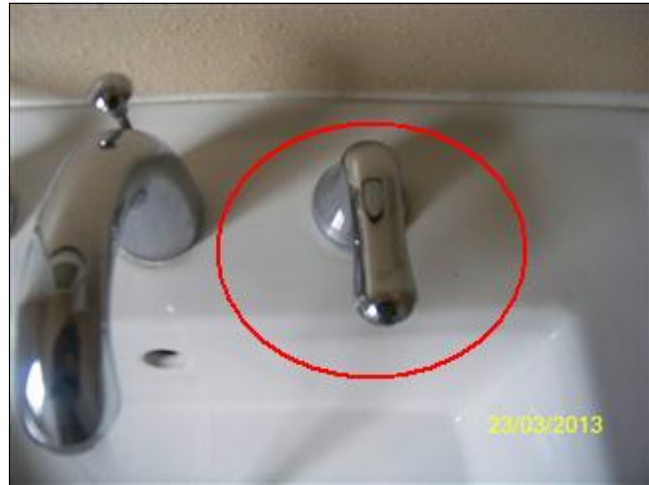
5.6.B Picture 1

**5.6.B** (1) Inspector found each bathroom sink faucet loose, please tighten each faucet.

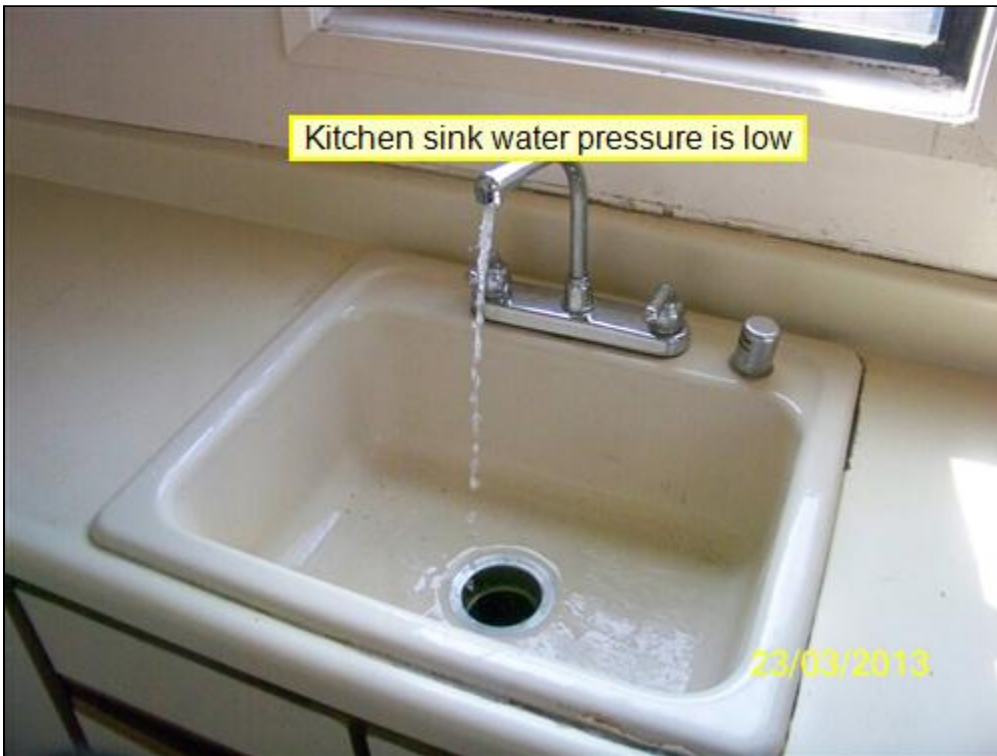
5.6.B Picture 3

**5.6.B** (2) Inspector found the water pressure in the kitchen low, please have a licensed plumber investigate and repair unit.

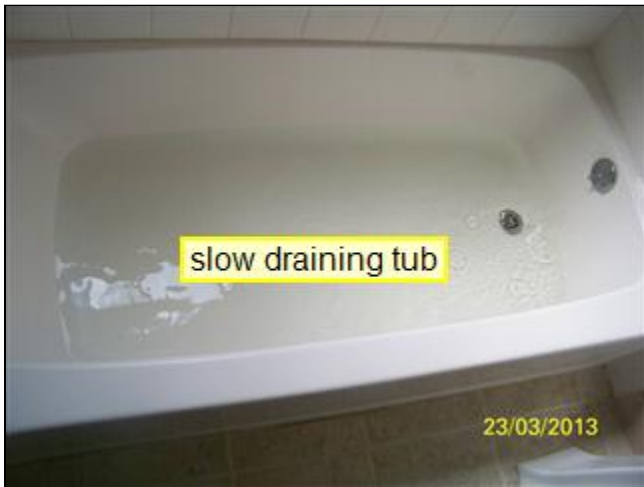
5.7.B Picture 1

**5.7.B** (1) Inspector found tub slow draining, please have licensed plumber check and repair unit to work normally.

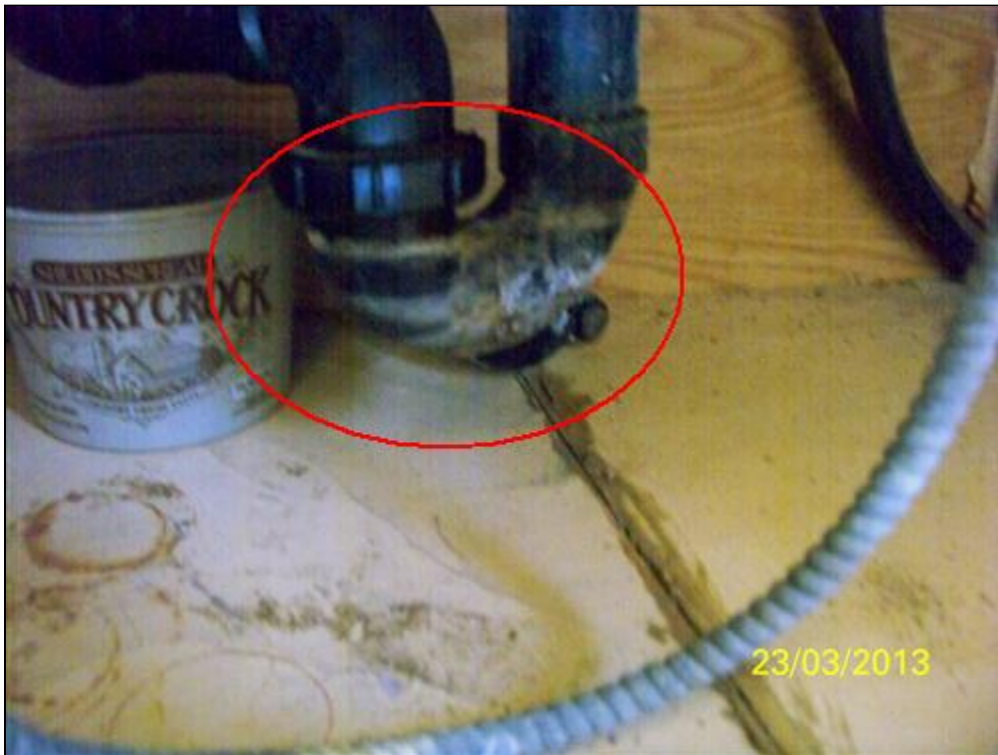
5.7.B Picture 2

**5.7.B** (2) Inspector found the kitchen drain pipe fixed with a glue substance. Please change out for surety of water draining properly without leaks over time.

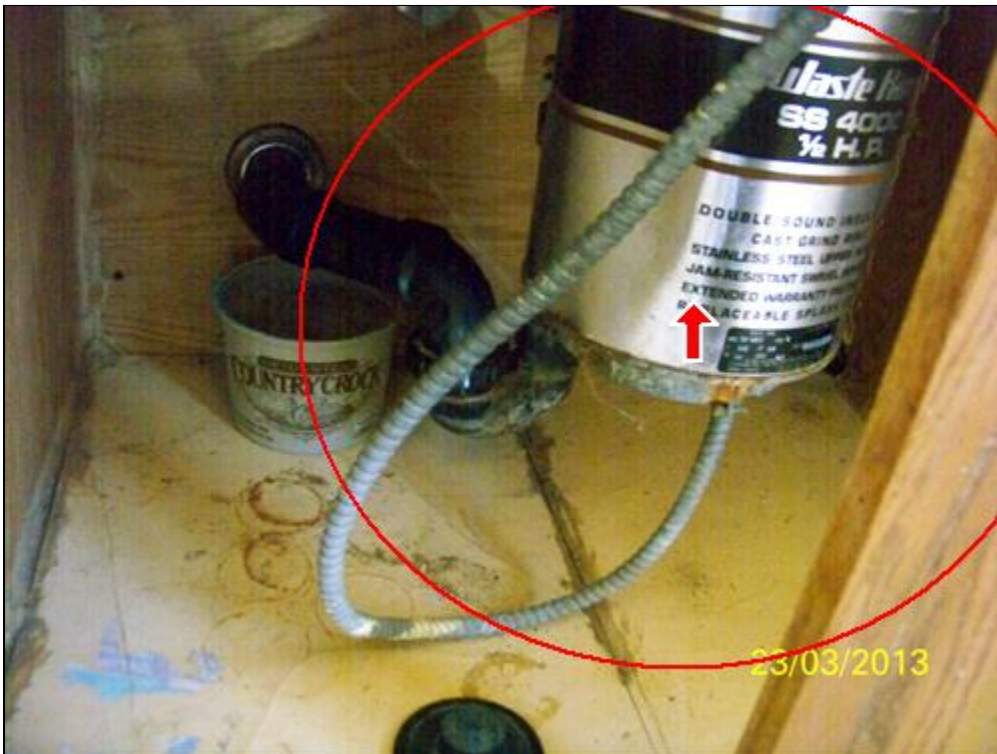
5.14.B Picture 1

**5.14.B** Inspector found the waste disposer not working properly. Please have disposer fixed or replaced.

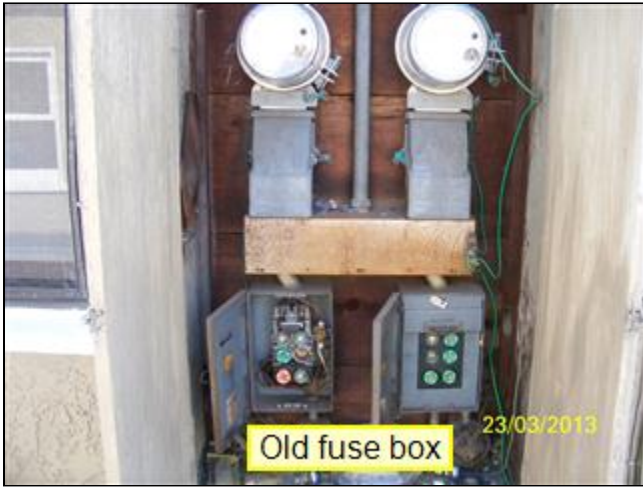
5.26.B Picture 1

**5.26.B** Inspector found a old fuse panel, please consider upgrading to .100 amp service

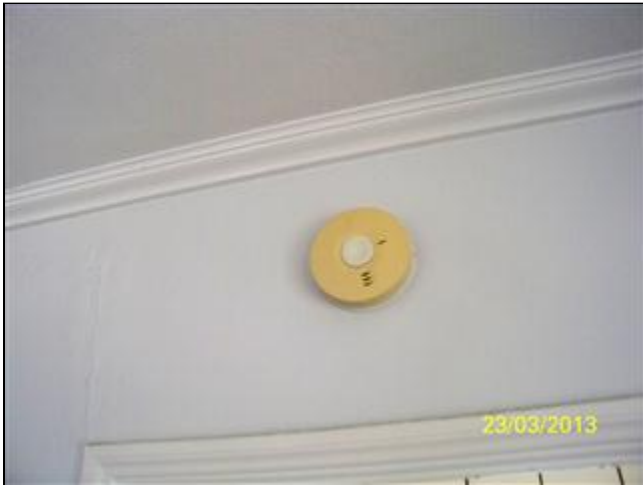
5.30.B Picture 1

**5.30.B** Inspector found no working detectors, please install smoke detectors in each bedroom, and common area hall.

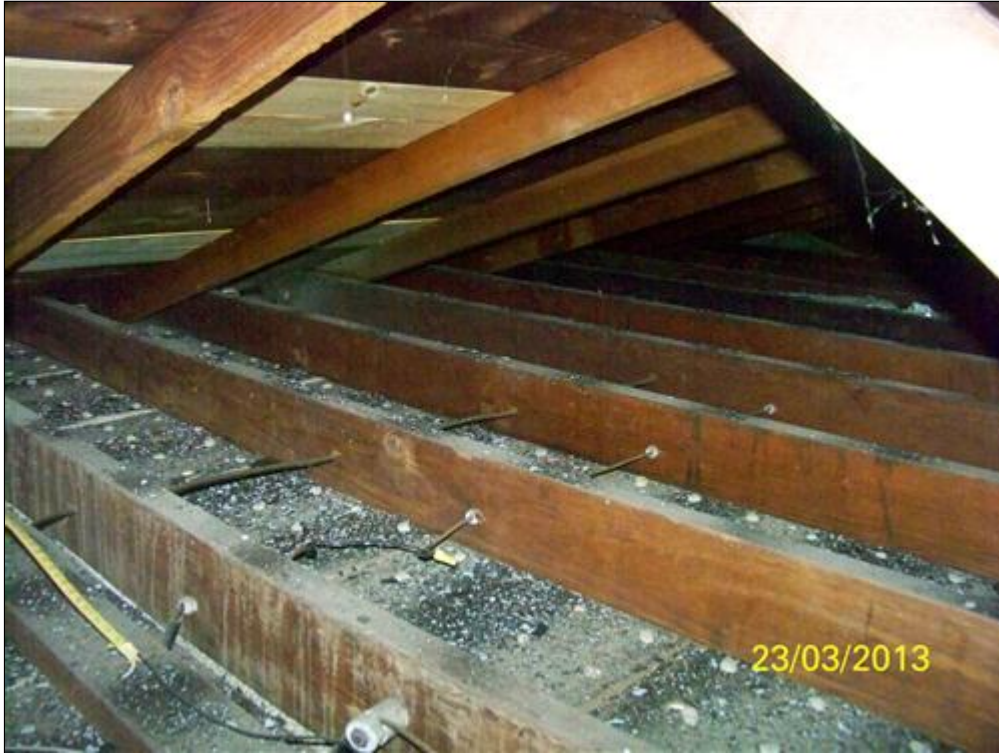
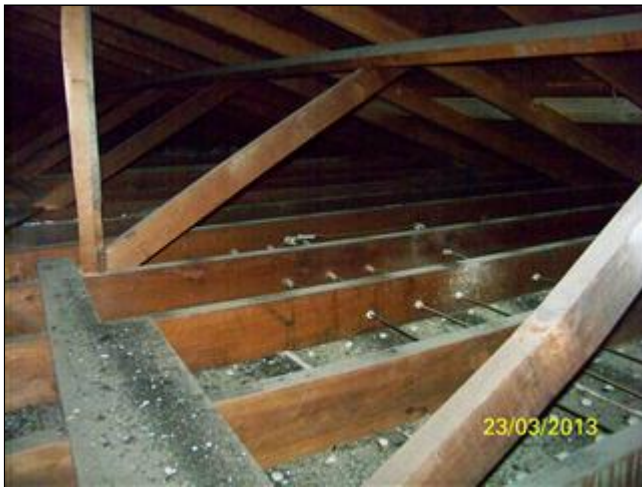
Inspector found no insulation in the attic. Please install insulation in attic by certified installer

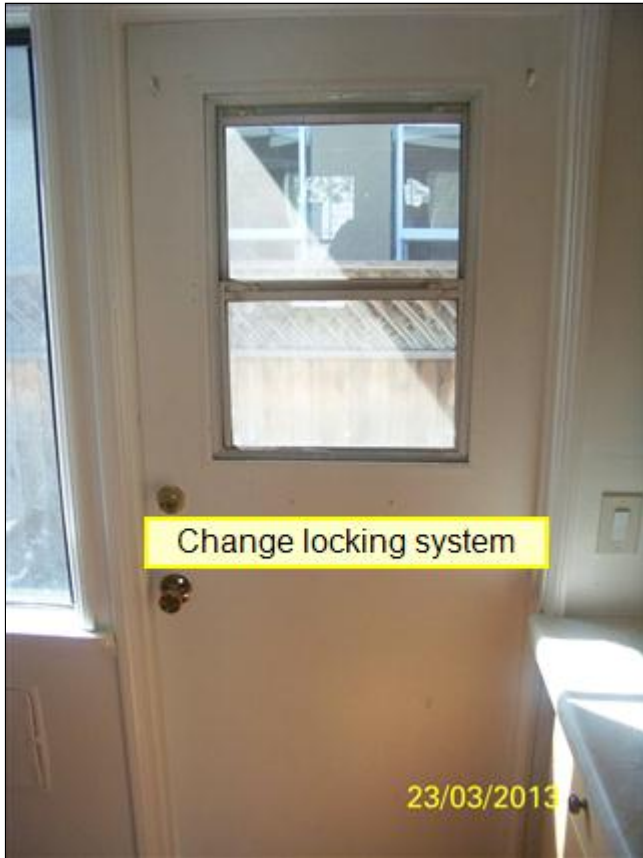
2.1 Picture 1

Inspector found that the rear entry door locking system is not secure. Please have locksmith fix or repair locking system.

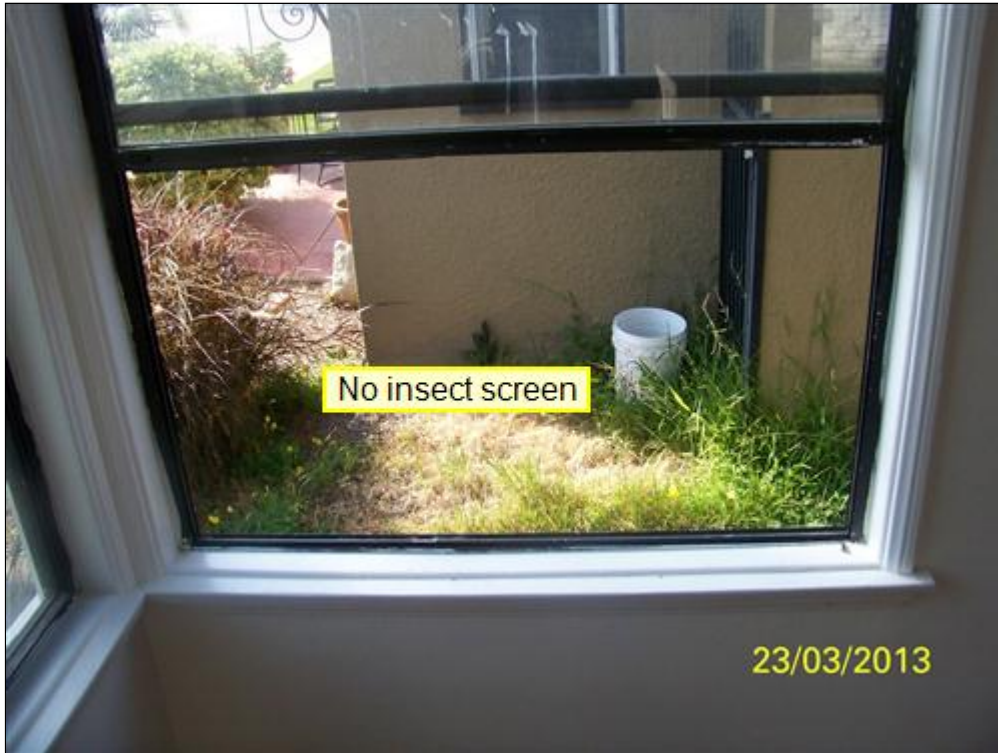
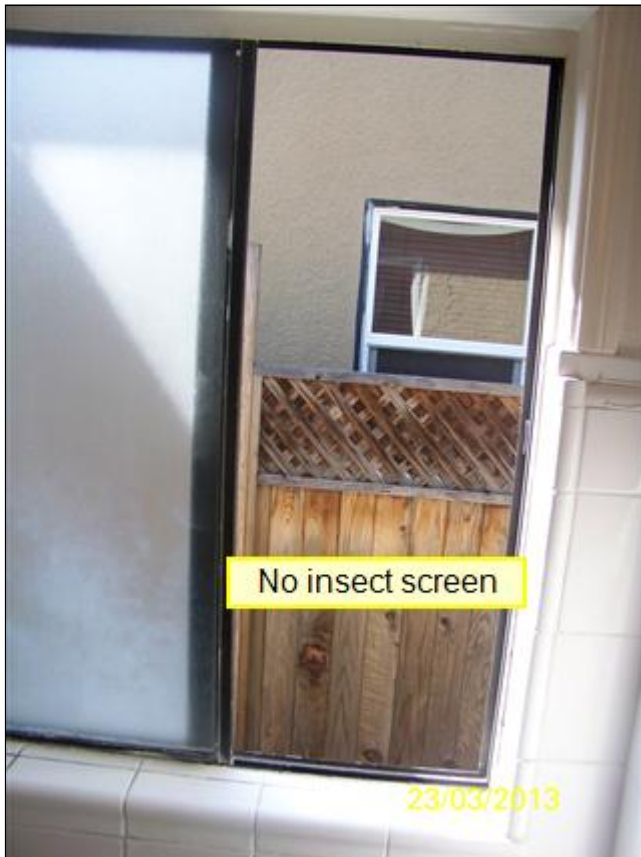
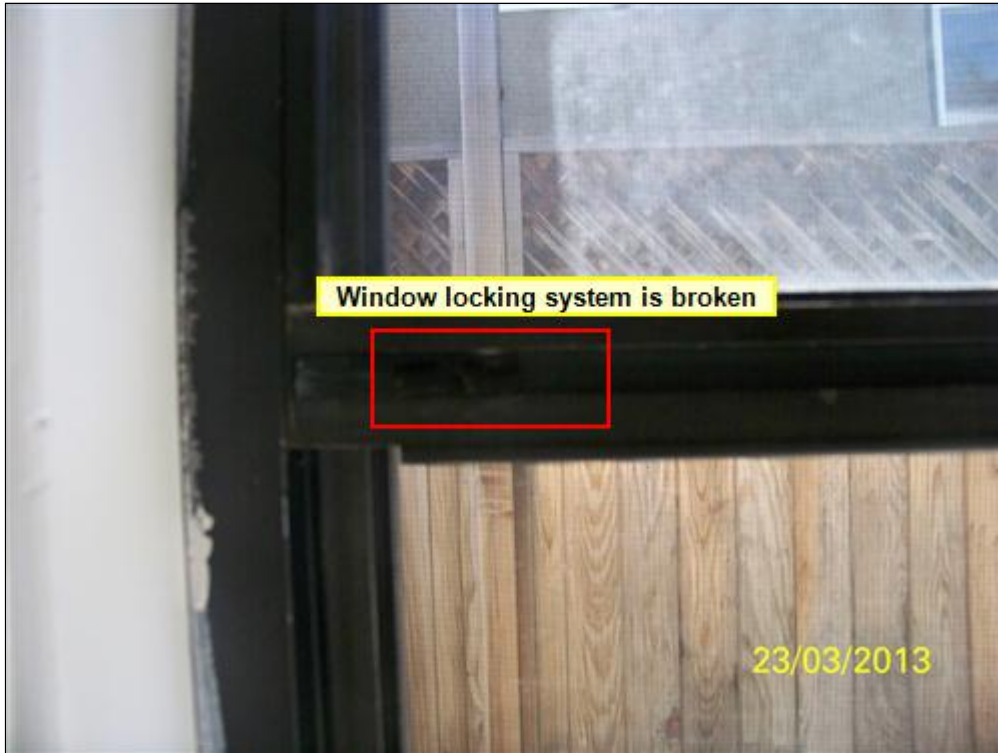
(1) Please have window screen replaced, and locking system repair by licensed contractor.
