# KLEEN INSPECTION

## Inspection Report

**Property Address:**  
3707/3709 Orange Ave.  
Long Beach CA 90807

<b>Date:</b> 3/26/2013	<b>Time:</b> 10:00 AM	<b>Report ID:</b> 032313
<b>Property:</b> 3707/3709 Orange Ave. Long Beach CA 90807	<b>Customer:</b> Ms. Earla Burnette	<b>Real Estate Professional:</b> DJ Bonner Keller Williams

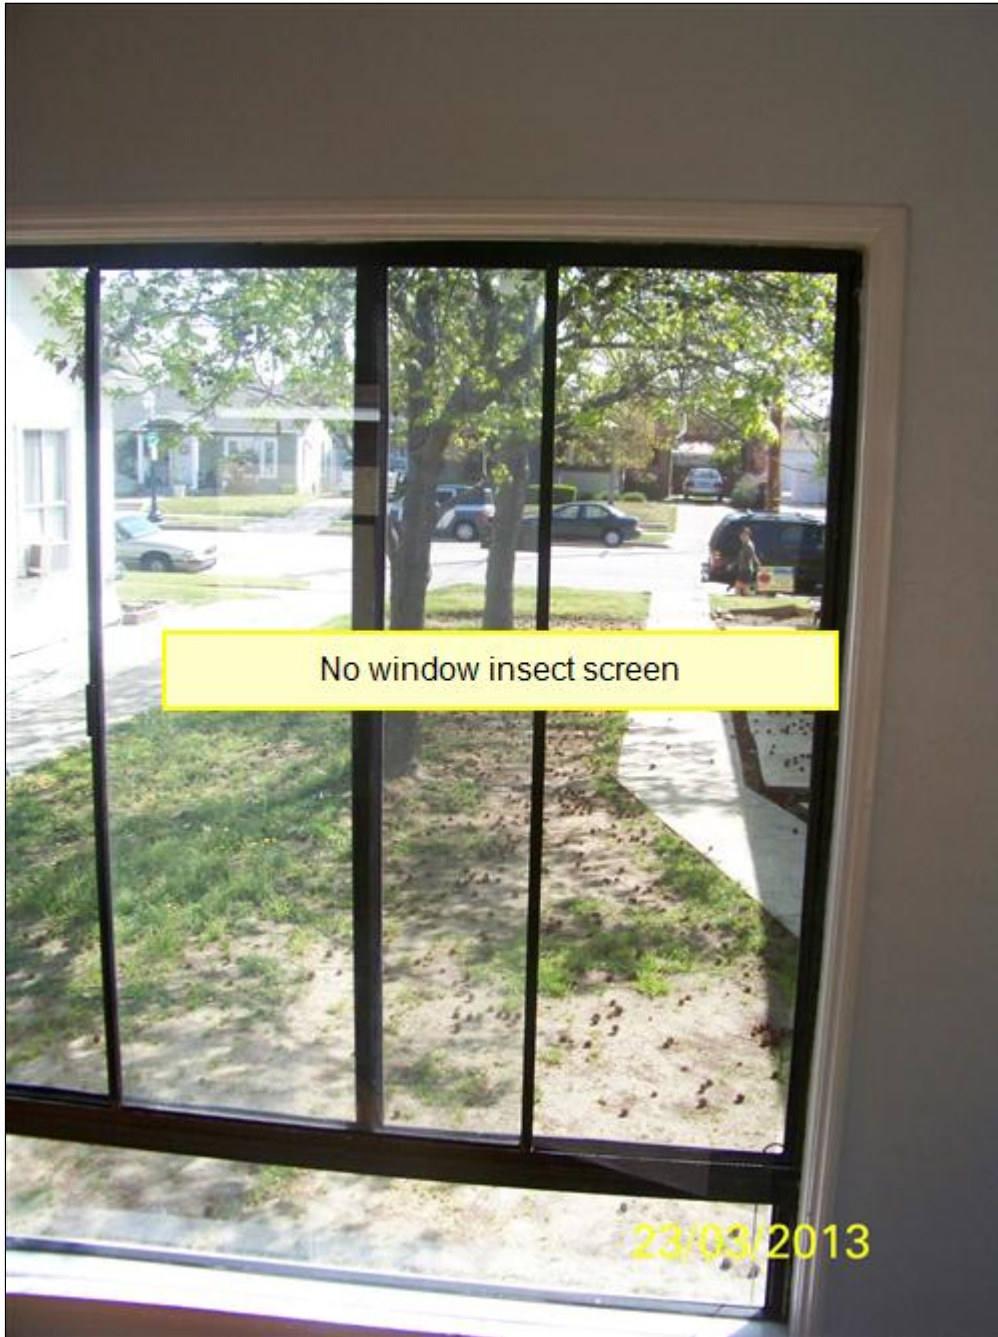
2.2 Picture 4

(2) Inspector found window and door screens either missing or torn. Please have each screen replaced by contractor.

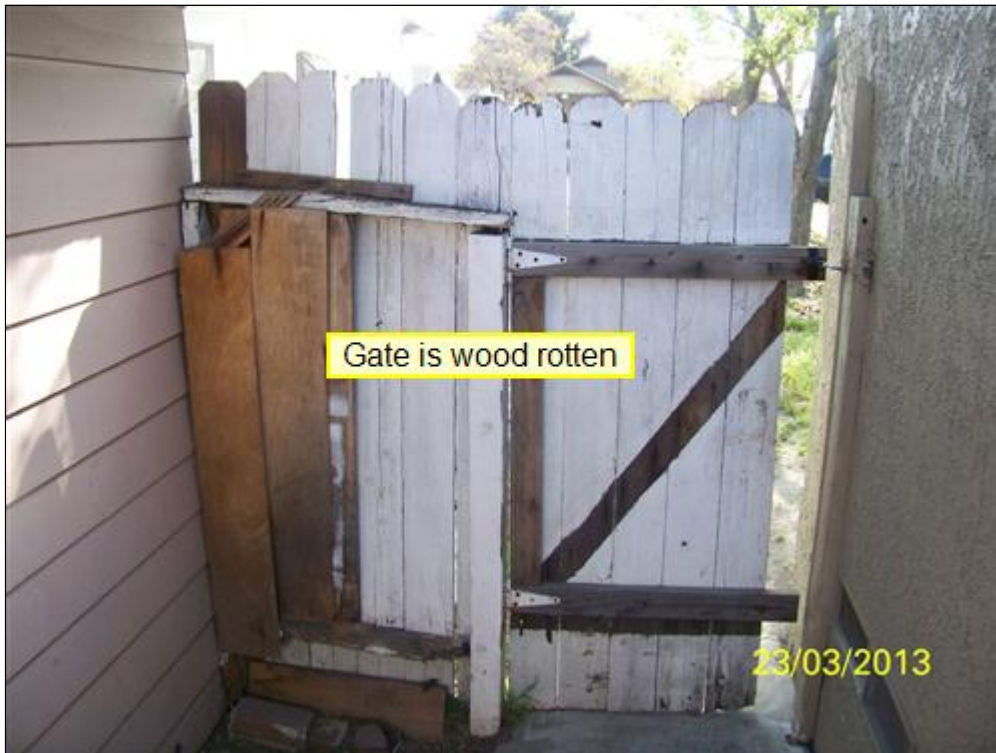
2.5 Picture 1

Inspector found that the rear entry gate a wood rotten, and need to be repaired.

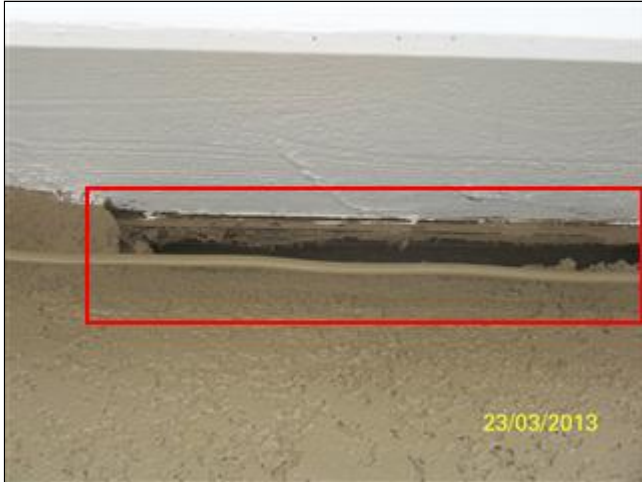
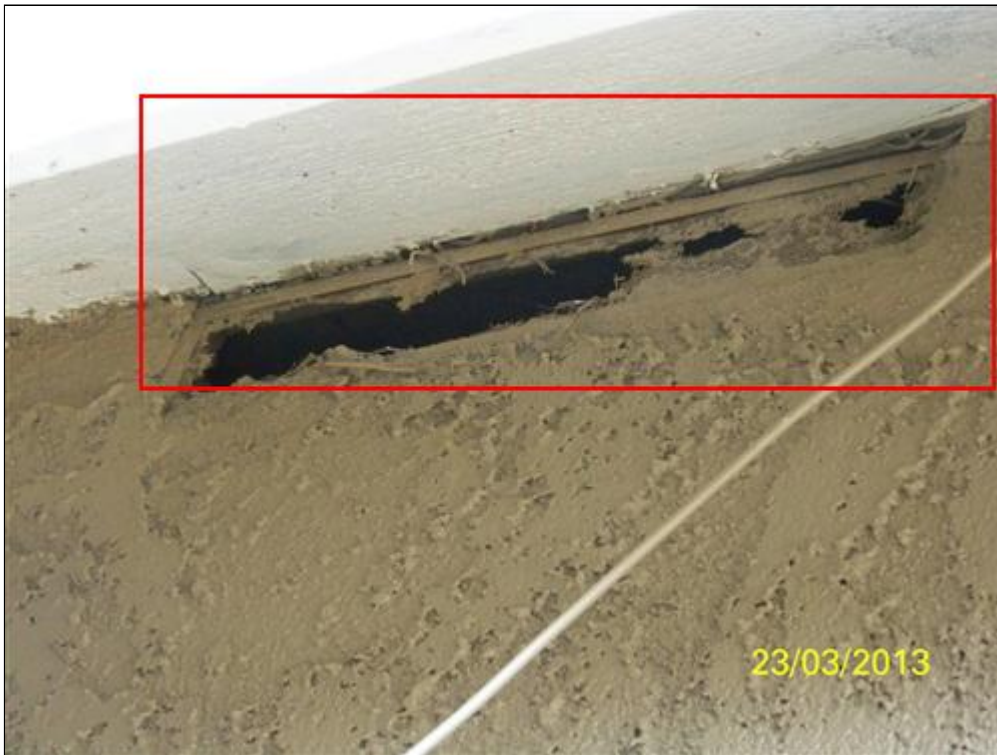
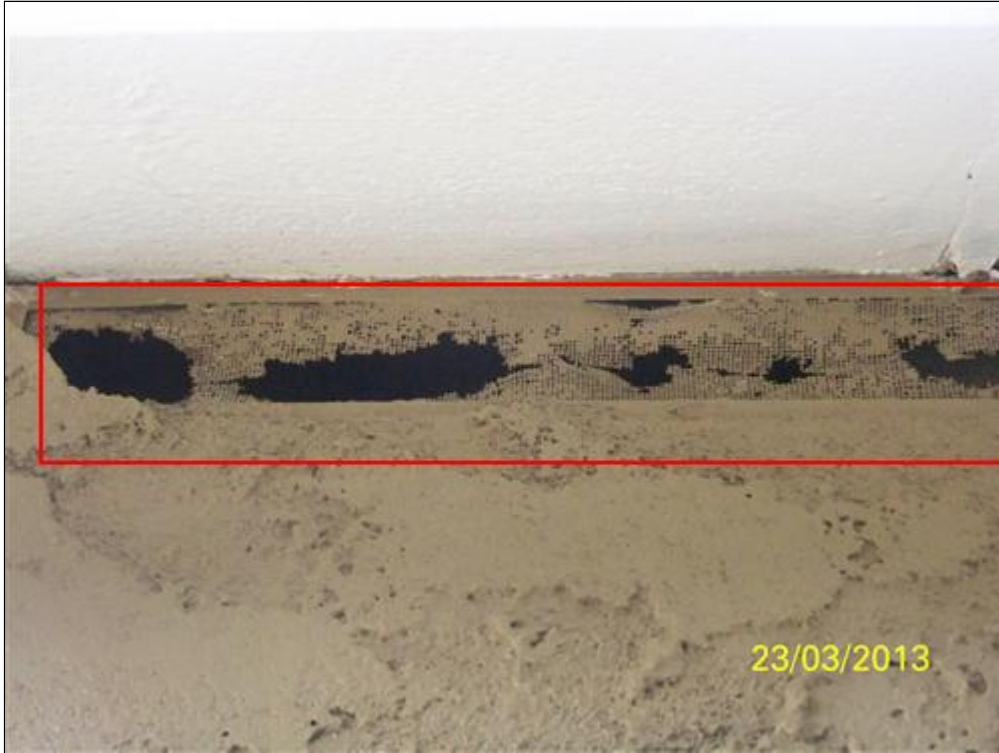
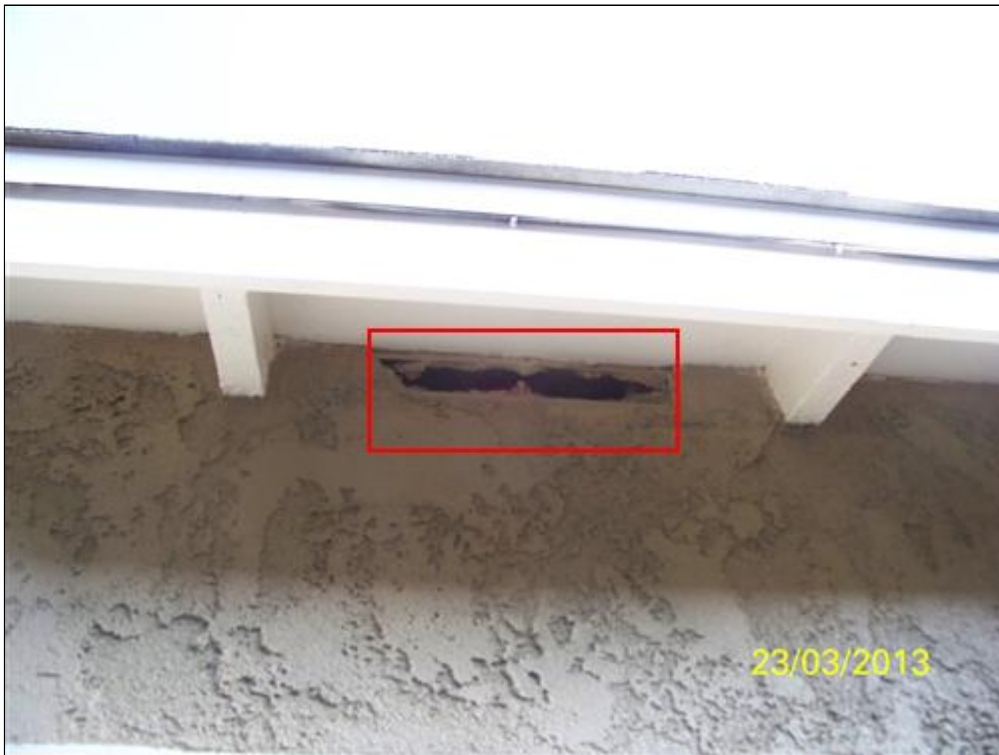
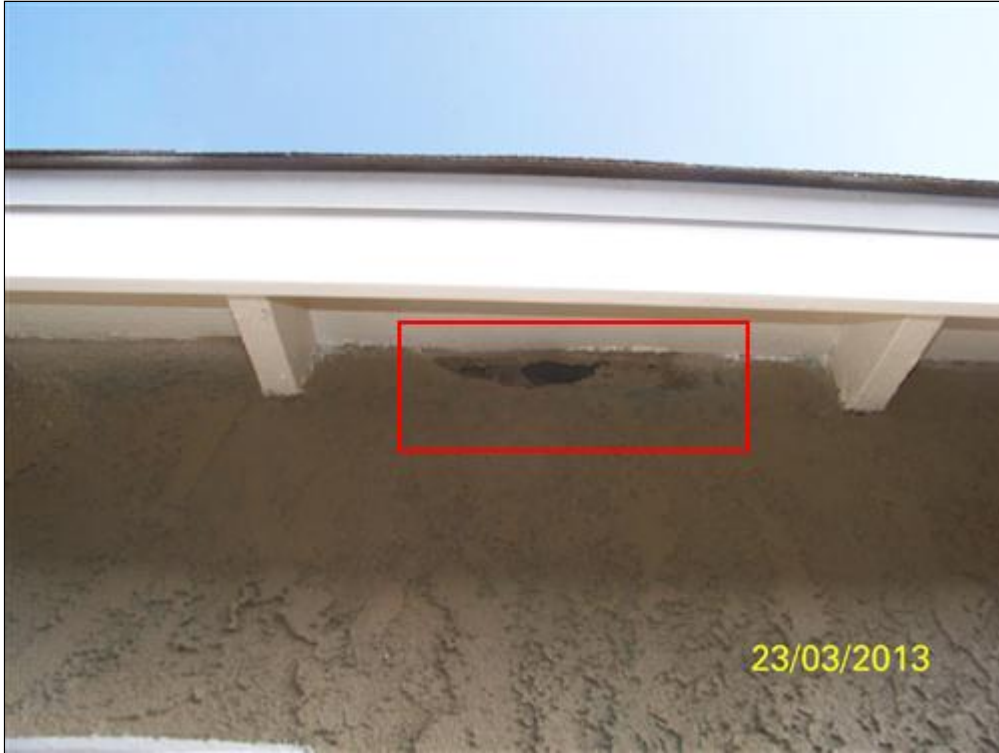
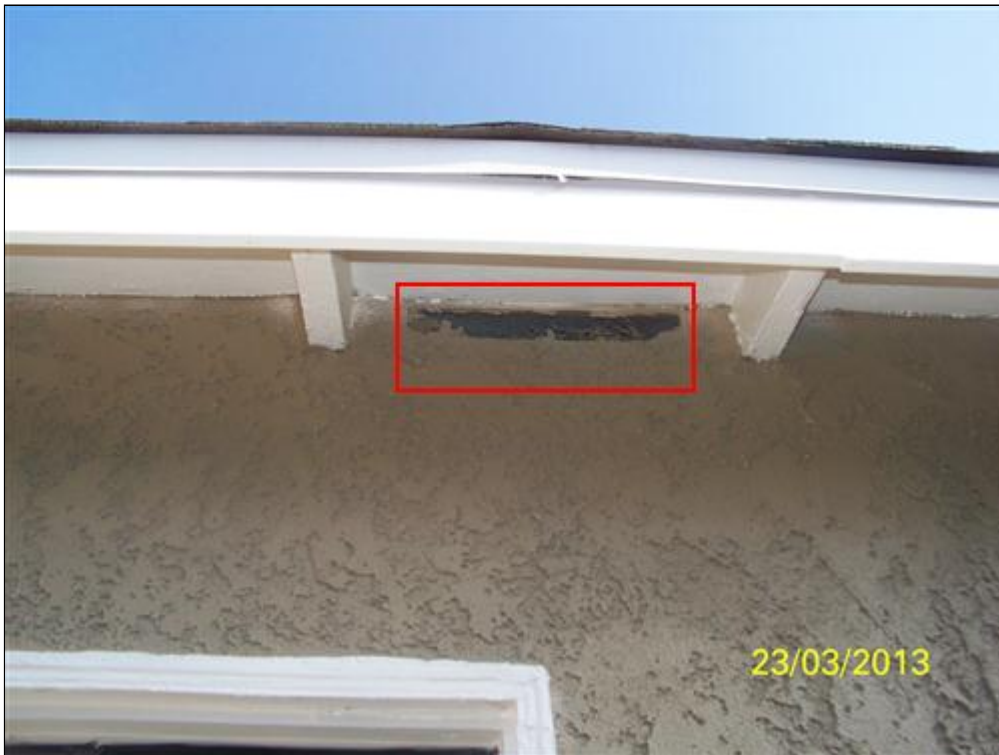
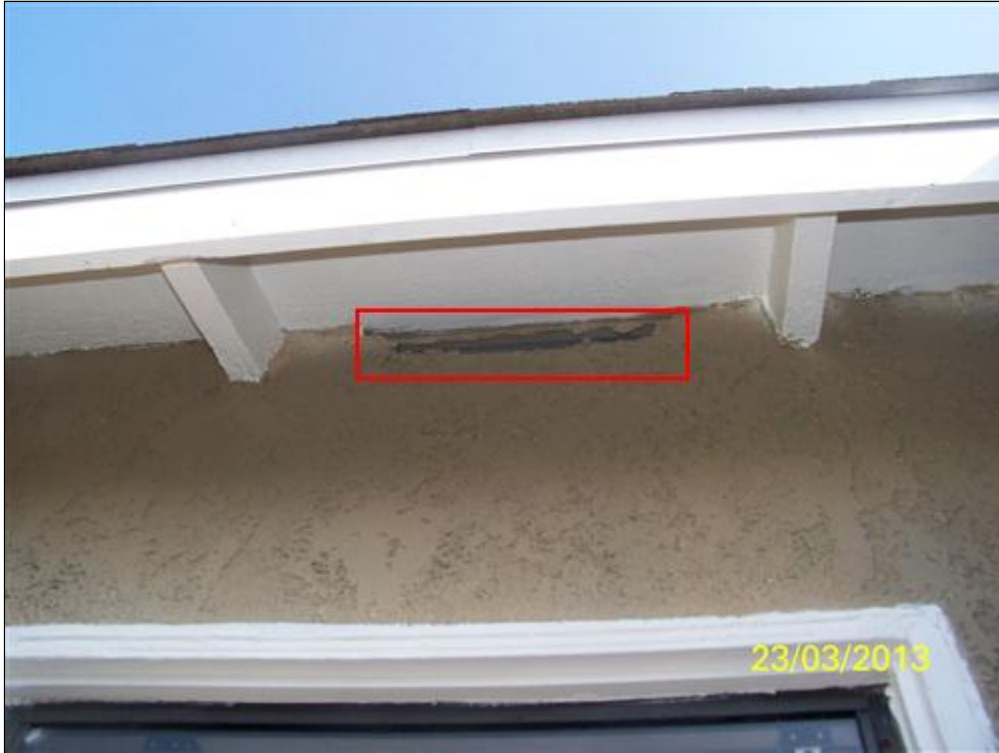
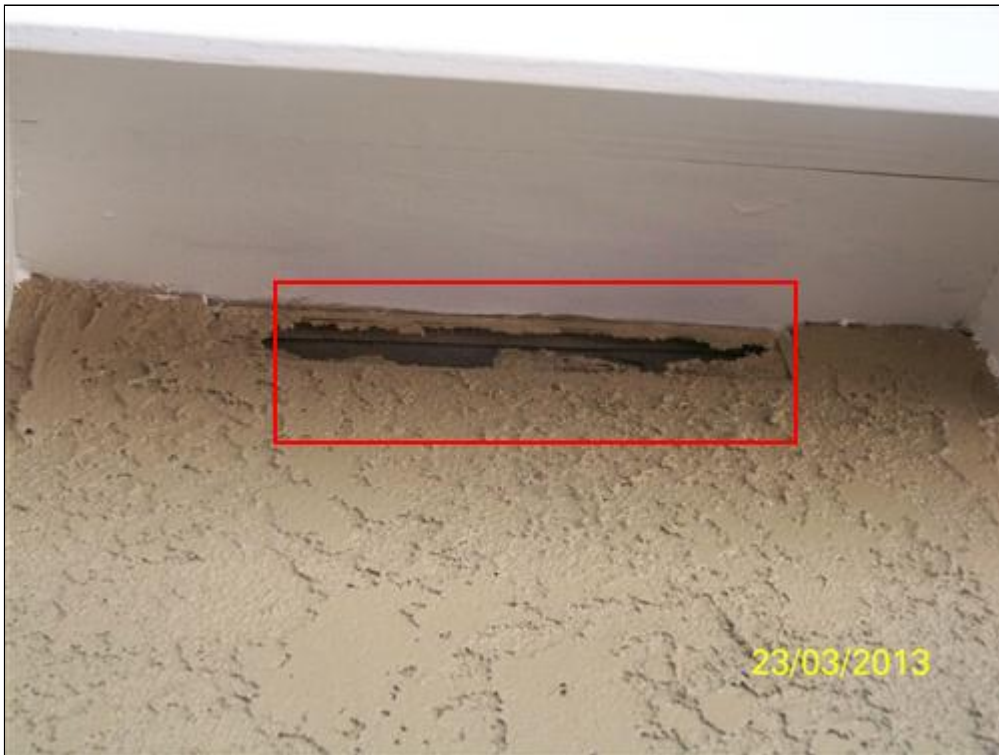
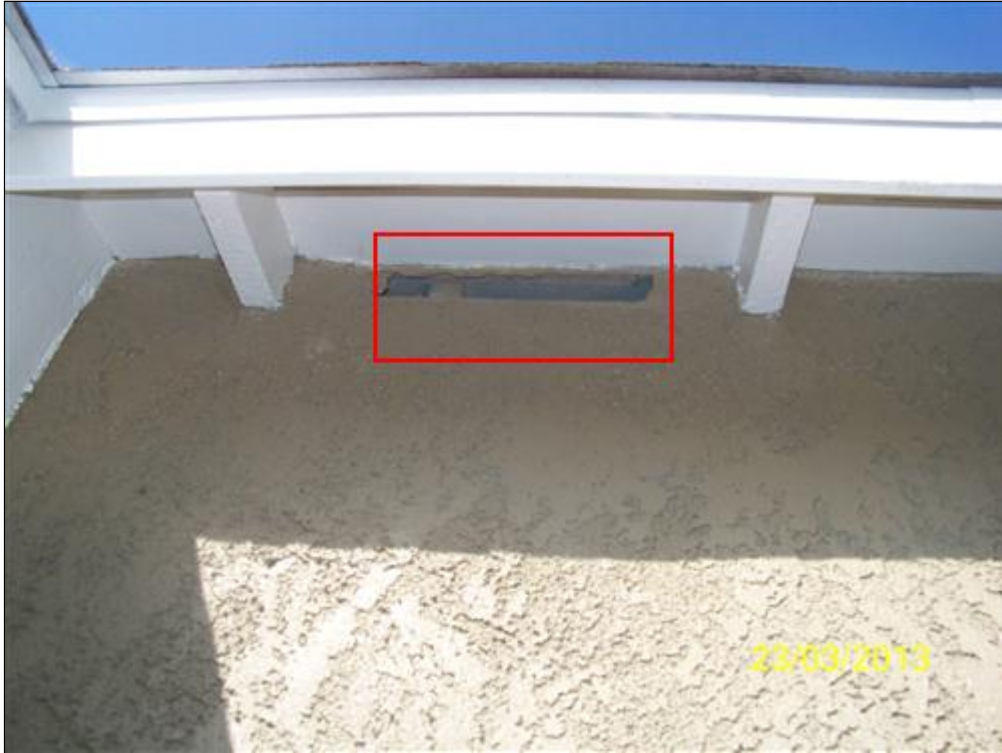
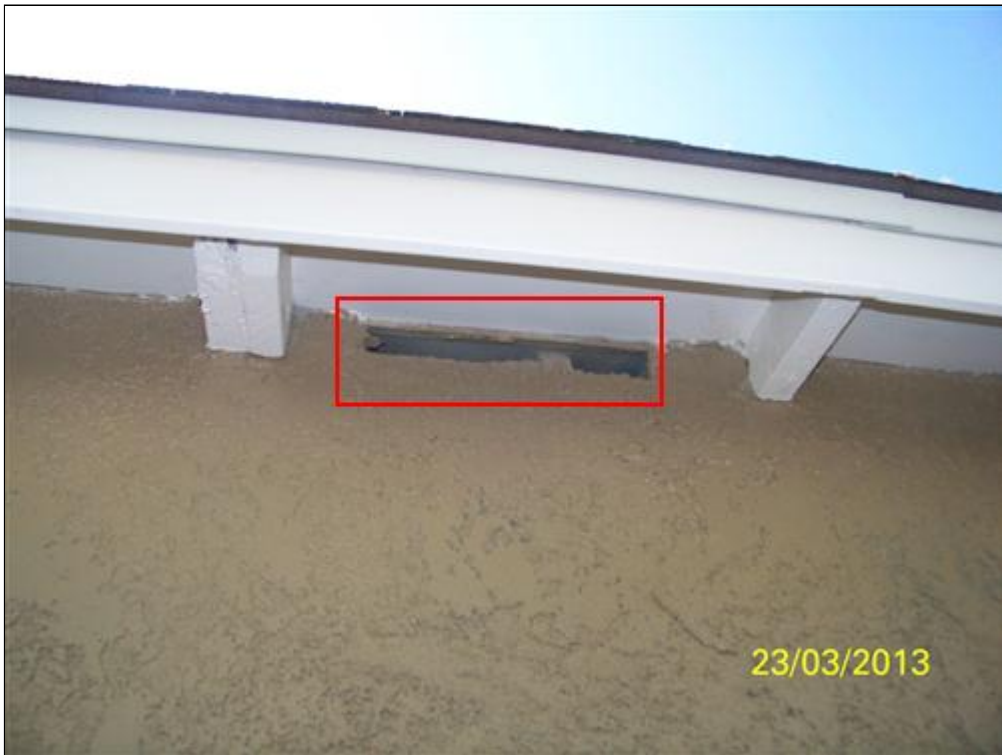
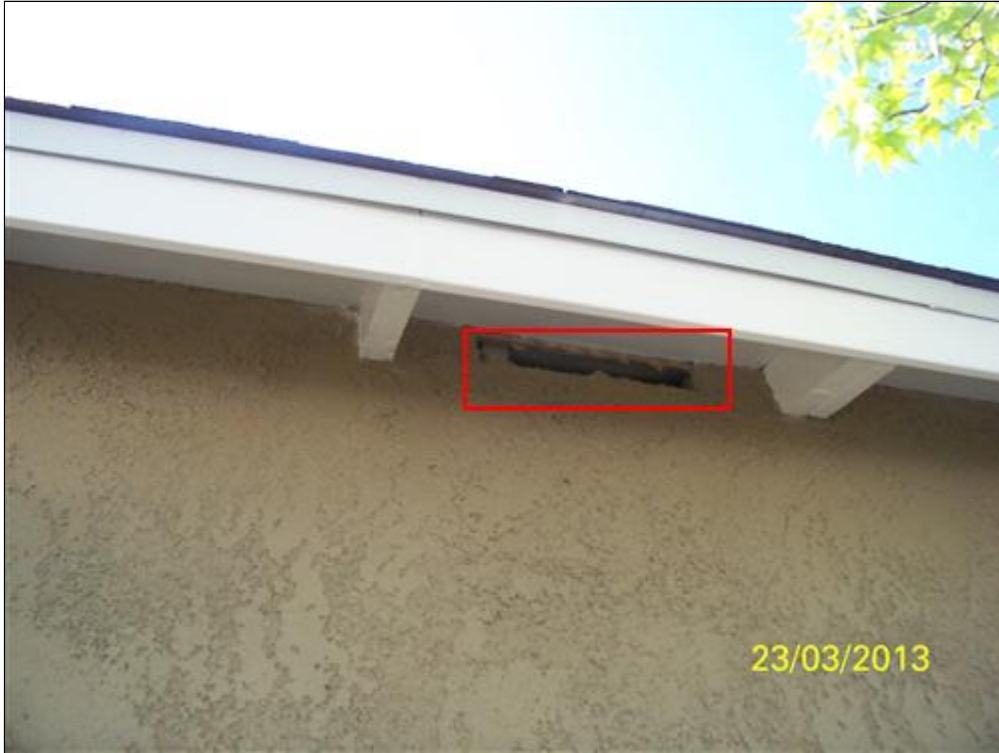
Inspector found the attic screen to be missing or torn. Please have new screens installed to prevent rodent, or bird entry.

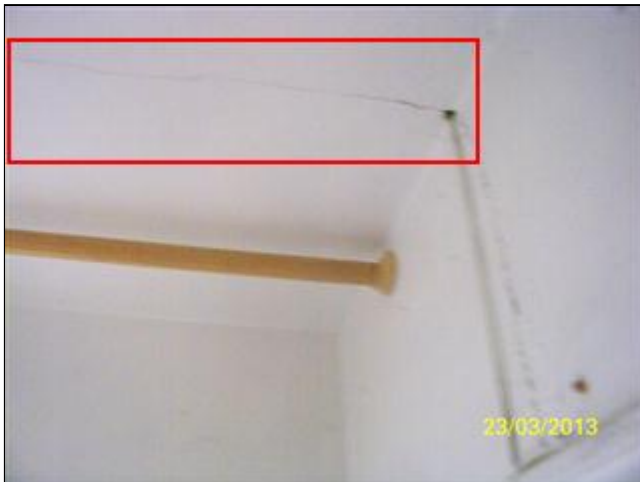
5.0.A Picture 1

Inspector found a crack in the ceiling. Please have a licensed contractor repair ceiling.

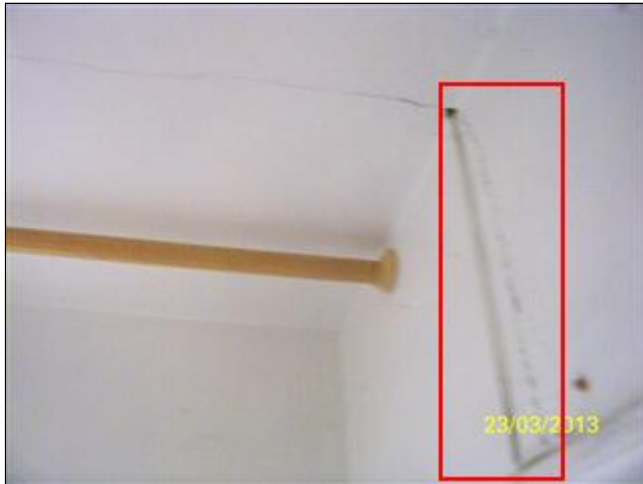
5.1.A Picture 1

Inspector found crack in the wall, please have a licensed contractor repair wall.

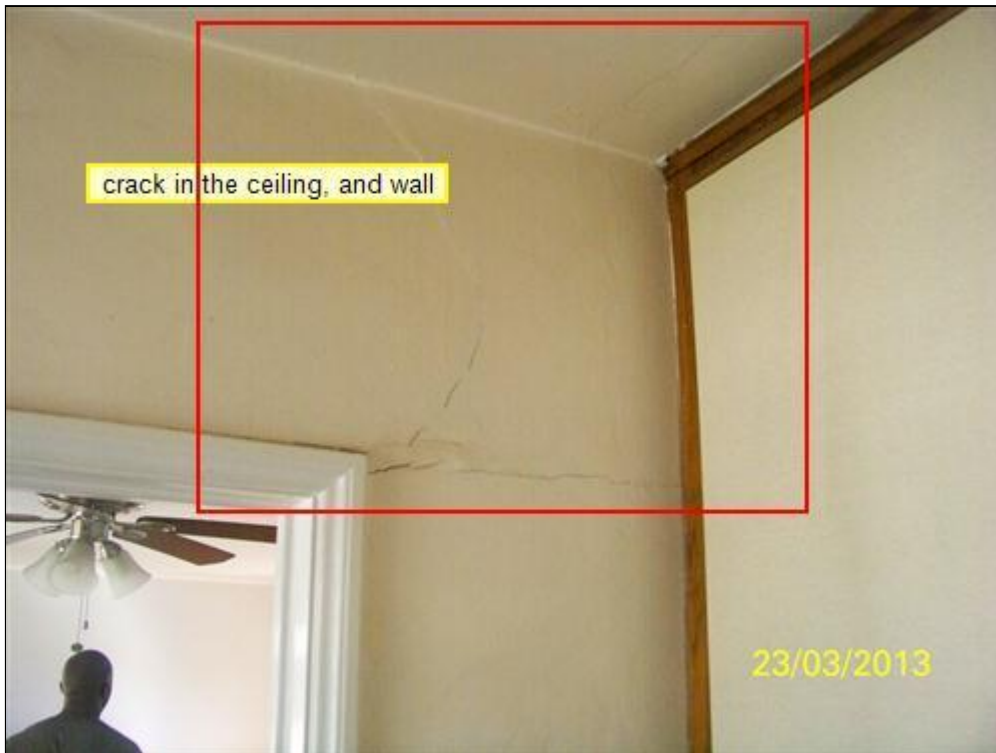
5.0.B Picture 1

Inspector found cracks in wall and ceiling. Please have a licensed contractor repair each area.

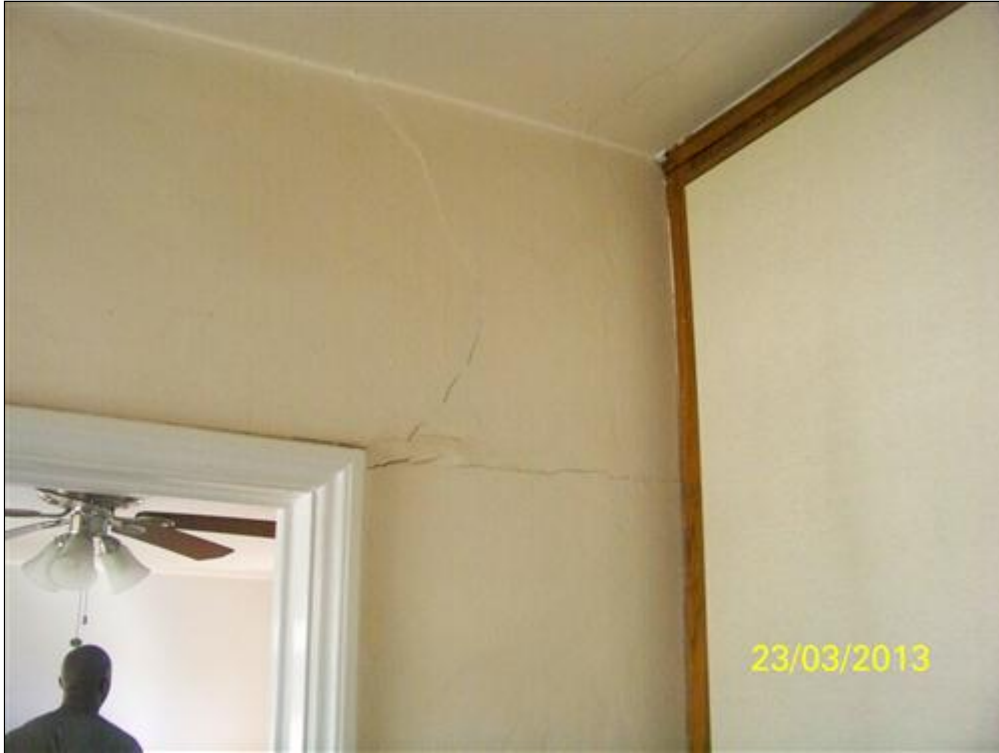
5.1.B Picture 1

Inspector found crack in the wall of the unit. Please repair area of concern.

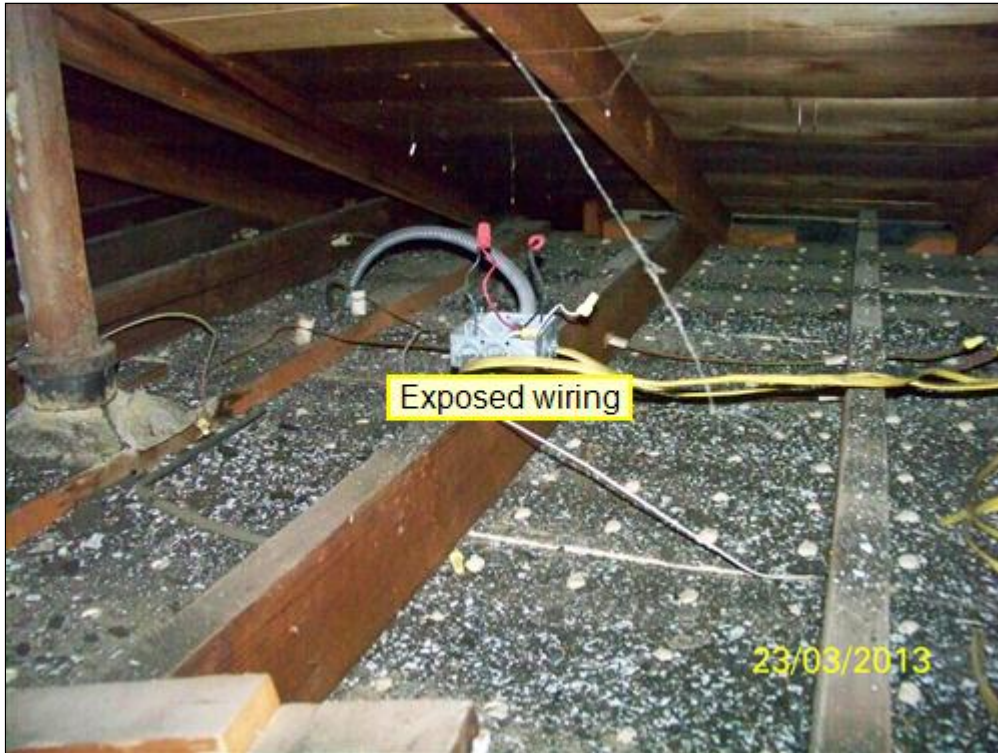
1.9 Picture 1

Inspector found exposed wiring in attic. Please have a licensed electrician enclose all wiring safely.

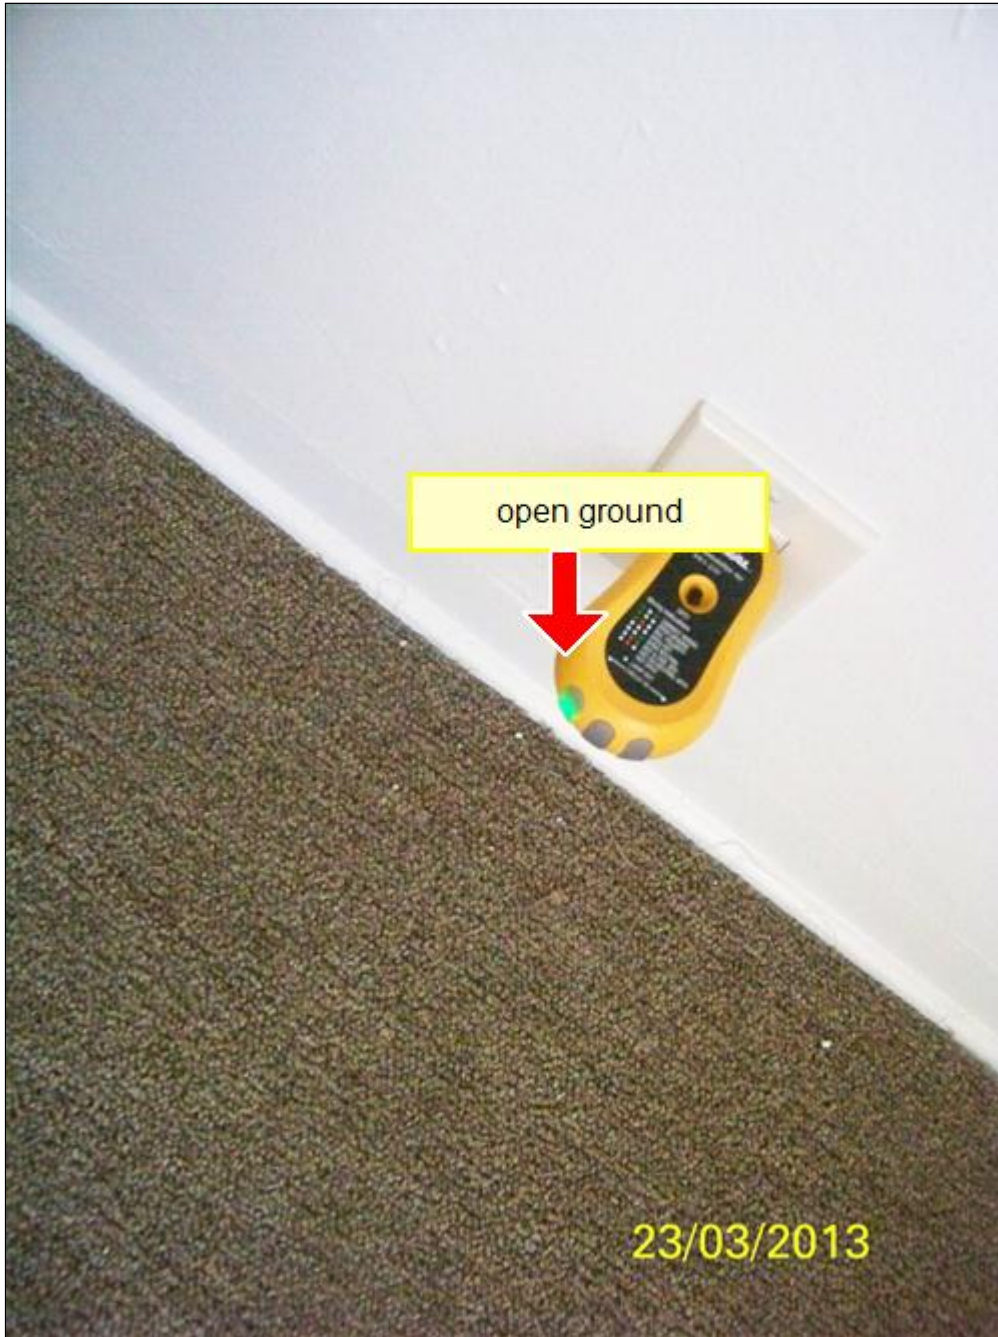
5.9.A Picture 1

Inspector found that each room outlet is open ground. Please have licensed electrician repair each unit by properly grounding each unit. Also please replace broken coverplate.

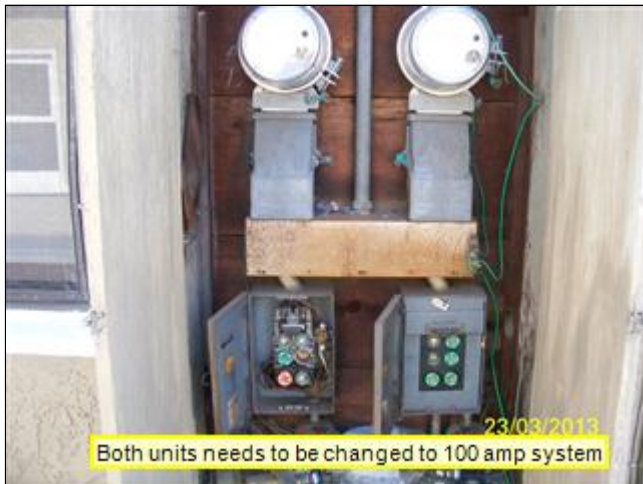
5.25.A Picture 1

Inspector found that both units needs to be changed over from fuses to breakers by licensed electrician.

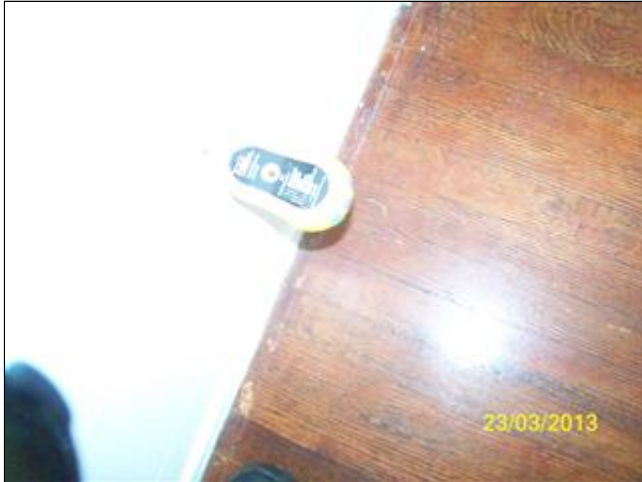
5.27.A Picture 1

Inspector found open ground at every outlet; please have a licensed electrician properly ground each unit.

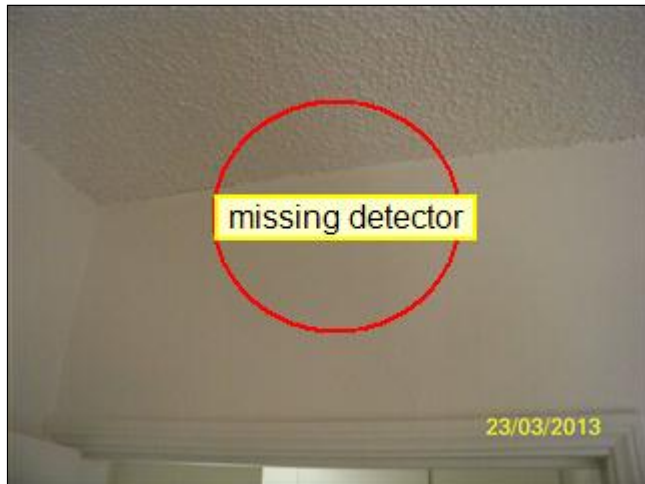
5.29.A Picture 1

Inspector found no working smoke detectors during inspection. Please install smoke detector in each bedroom and common area hall.

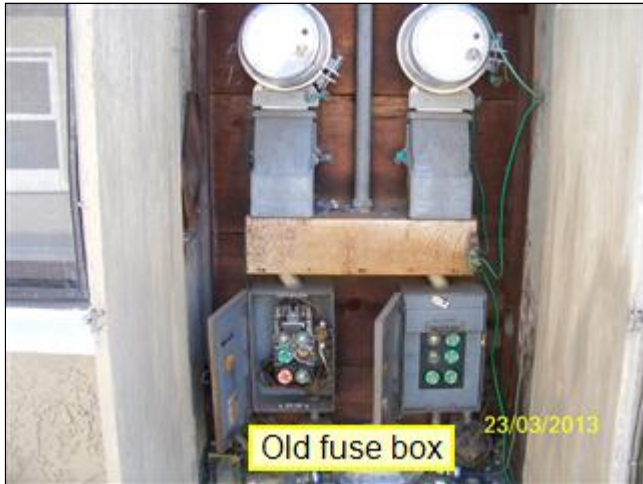
5.26.B Picture 1

- Inspector found a old fuse panel, please consider upgrading to .100 amp service

**5.26.B** Inspector found a old fuse panel, please consider upgrading to .100 amp service

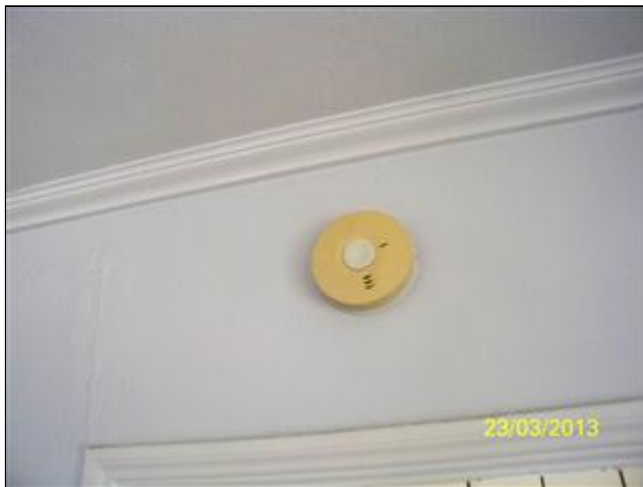
5.30.B Picture 1

⚡ Inspector found no working detectors, please install smoke detectors in each bedroom, and common area hall.

**5.30.B** Inspector found no working detectors, please install smoke detectors in each bedroom, and common area hall.

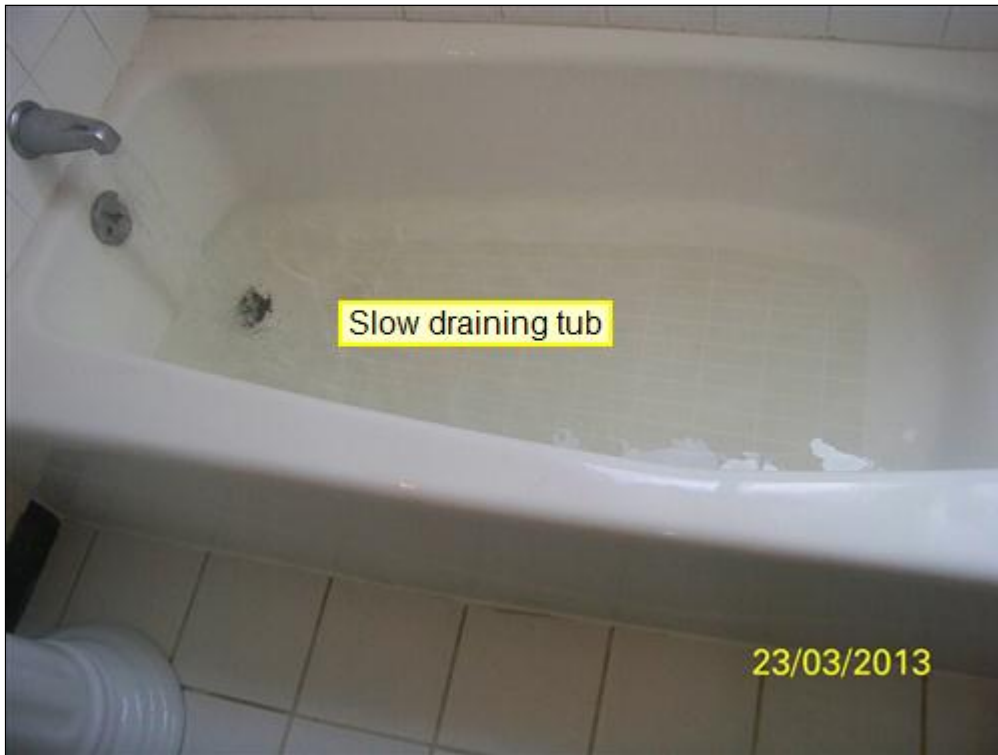
5.7.A Picture 1

Please have tub investigated and repaired so it drains properly.

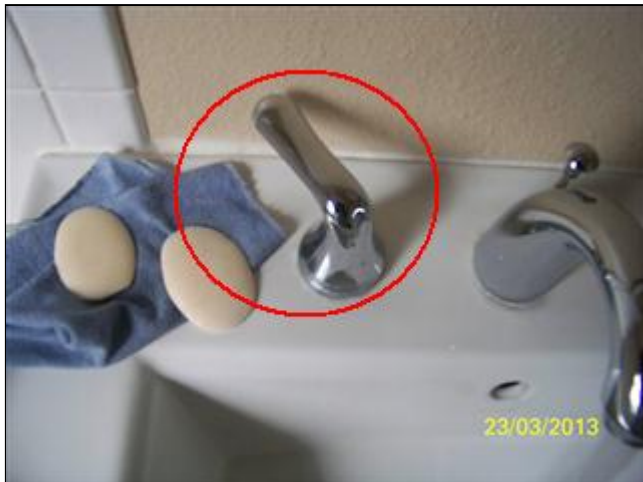
5.6.B Picture 1

(1) Inspector found each bathroom sink faucet loose, please tighten each faucet.

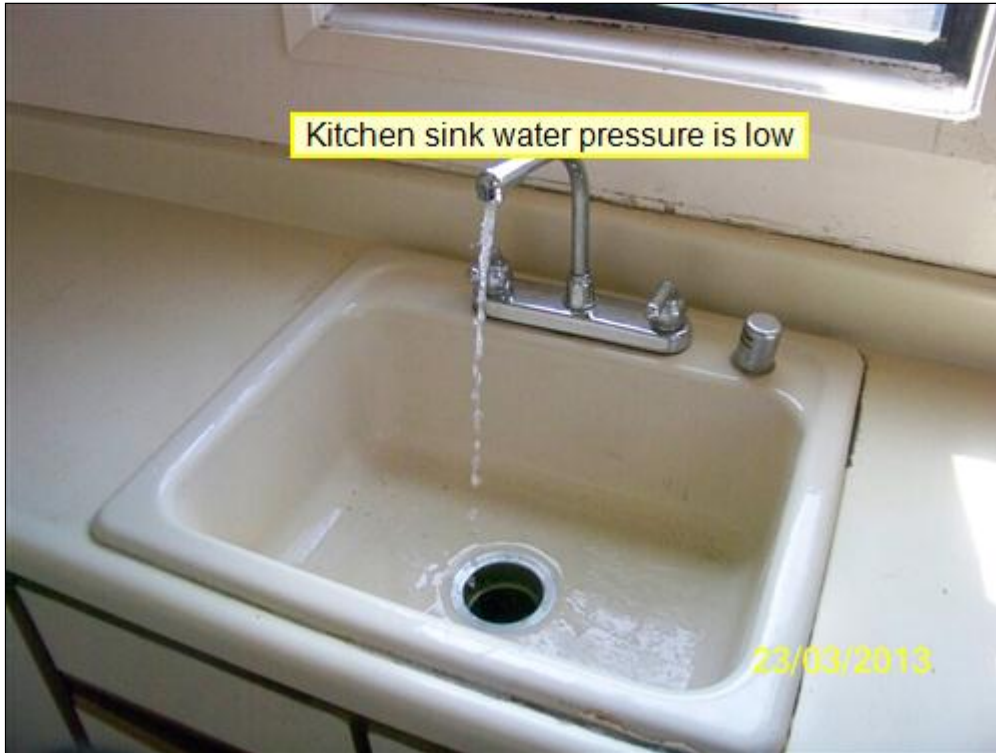
5.6.B Picture 3

(2) Inspector found the water pressure in the kitchen low, please have a licensed plumber investigate and repair unit.

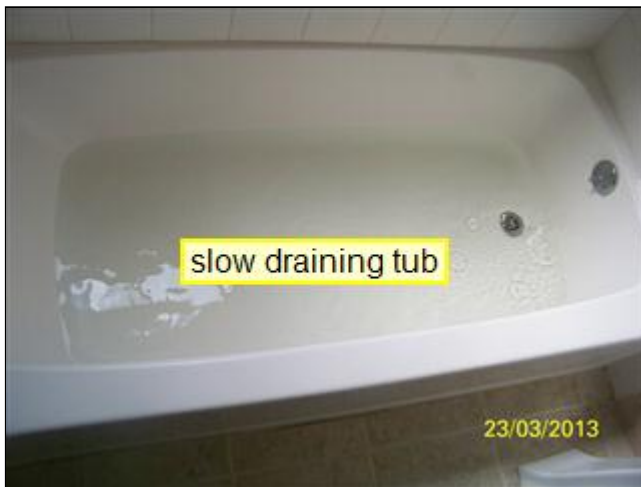
5.7.B Picture 1

(1) Inspector found tub slow draining, please have licensed plumber check and repair unit to work normally.

**5.7.B** (1) Inspector found tub slow draining, please have licensed plumber check and repair unit to work normally.

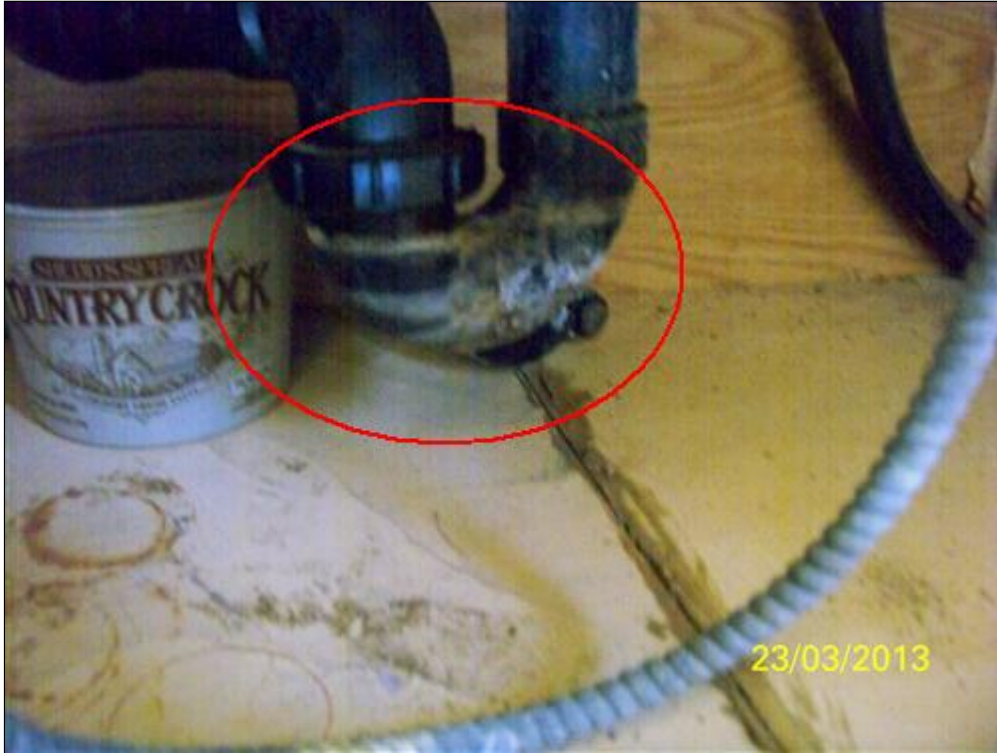
5.7.B Picture 2

(2) Inspector found the kitchen drain pipe fixed with a glue substance. Please change out for surety of water draining properly without leaks over time.

**5.7.B** (2) Inspector found the kitchen drain pipe fixed with a glue substance. Please change out for surety of water draining properly without leaks over time.

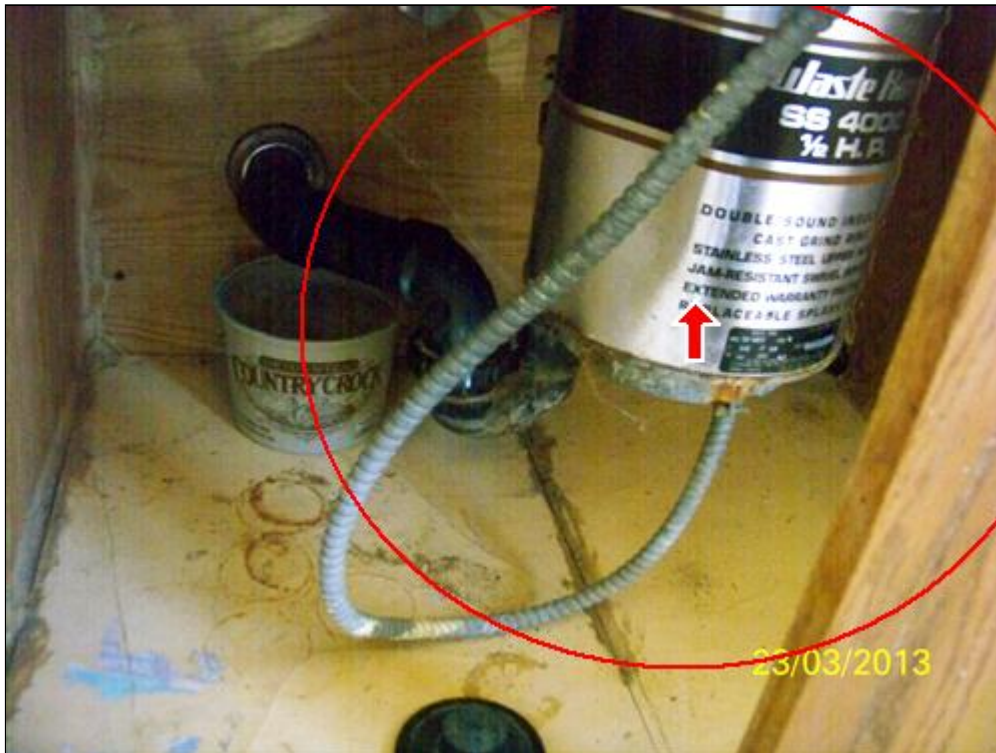
5.14.B Picture 1

Inspector found the waste disposer not working properly. Please have disposer fixed or replaced.

**5.14.B** Inspector found the waste disposer not working properly. Please have disposer fixed or replaced.
