# Inspection Report

1889 Cyrene Dr.  
Carson CA 90746

**Kleen Inspections**

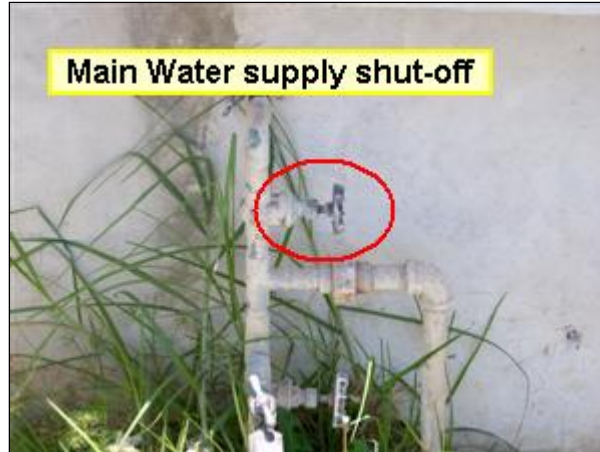
4.3 Picture 1

4.3 The main water supply shut-off in the front of the exterior part of the dwelling. No apparent problems to report at this time.
